CONDITION REPORT

Report No: 2016887184

MFC Auction House  
M57 Pretoria Rd, Glenmarais, KEMPTON PARK  
Gauteng

| Manufacturer | RENAULT | Registration Number | JF99NHGP |

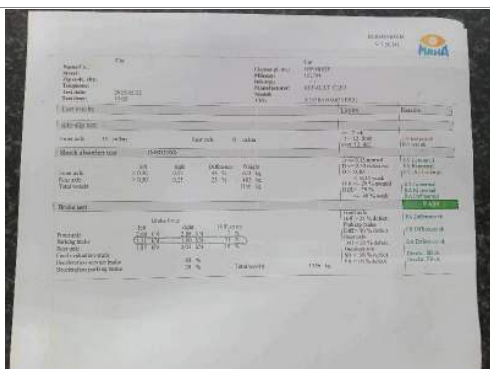
Shock and brake report

| Damage | Repair Way |
|---|---|
| Parking Brake Performance Left / Right Difference out of legal range | Repair |

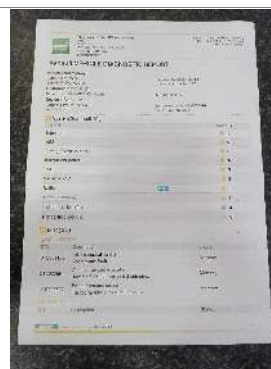
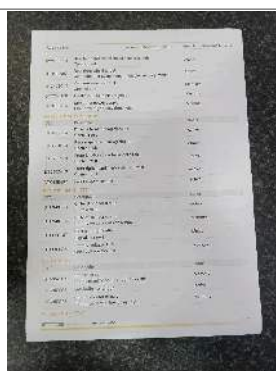
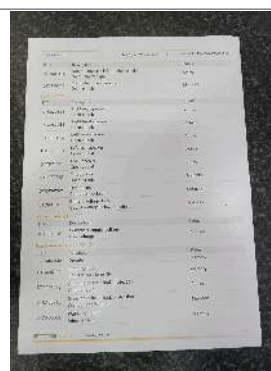
Diagnostic report

| No | System | Code | Description | Status |
|---|---|---|---|---|
| 1 | ACTIVE | DTC800113 | DRIVER'S FRONT AIRBAG CIRCUIT 1 OPEN CIRCUIT | |

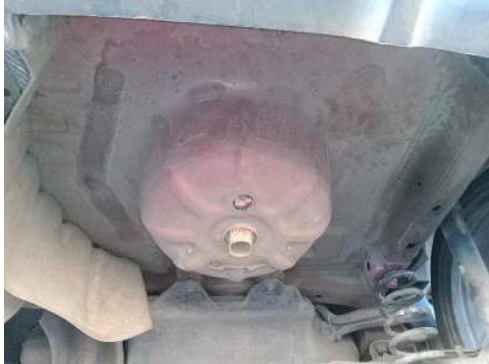
No spare wheel

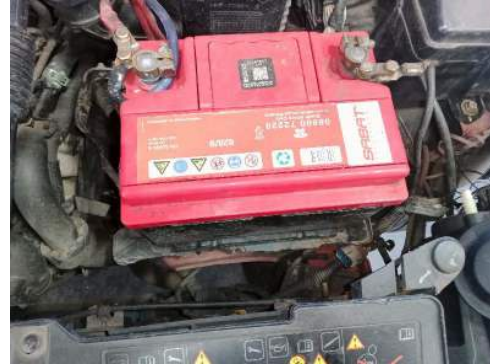
| Damage | Repair Way |
|---|---|
| Battery loose | Repair |

Battery loose

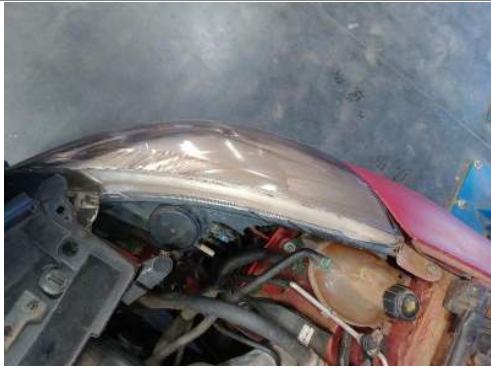
| Damage | Repair Way |
|---|---|
| Headlight Right Damaged | Repair |

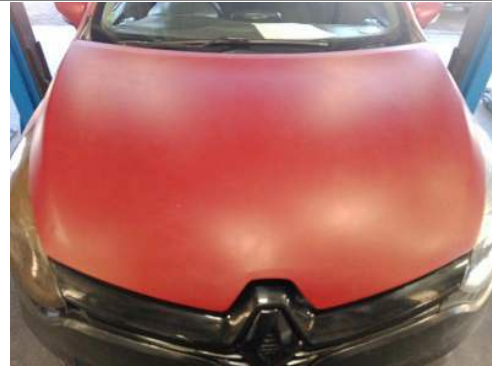
| Damage | Repair Way |
|---|---|
| Bonnet Residual Traces of Repair | Repair |

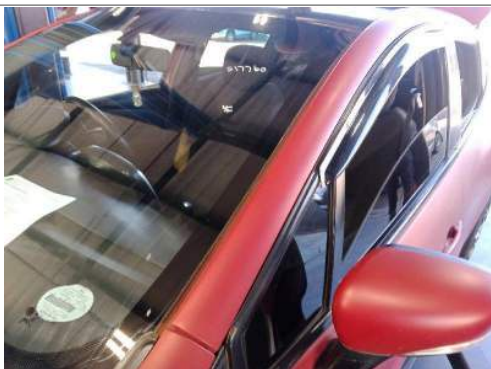
| Damage | Repair Way |
|---|---|
| A • Pillar Left Residual Traces of Repair | Repair |

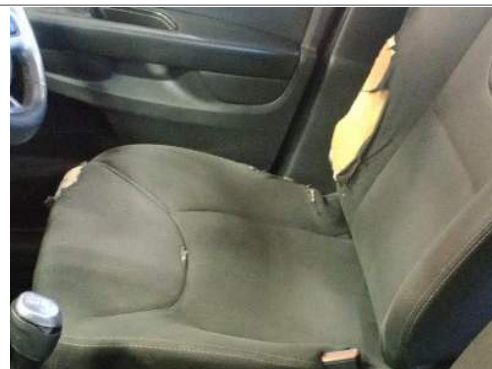
| Damage | Repair Way |
|---|---|
| Seat Front Right Damaged | Repair |

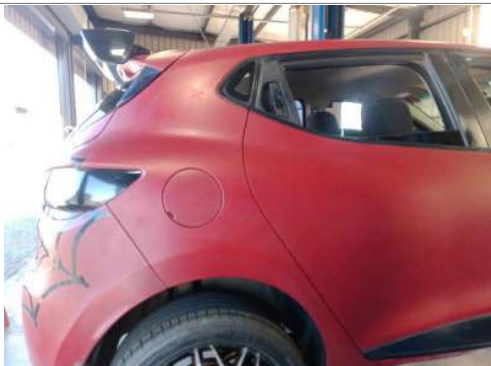
| Damage | Repair Way |
|---|---|
| Rear Fender Right Residual Traces of Repair | Repair |

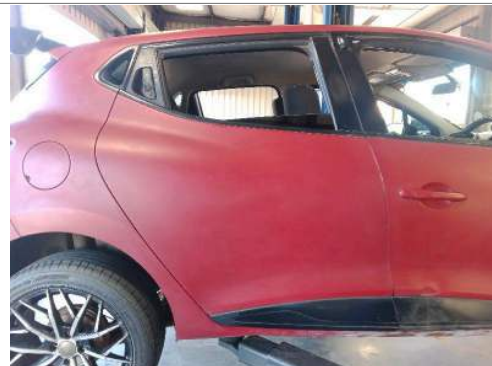
| Damage | Repair Way |
|---|---|
| Door Rear Right Residual Traces of Repair | Repair |

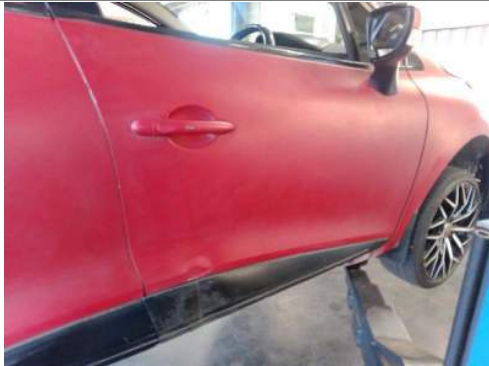
| Damage | Repair Way |
|---|---|
| Door Front Right Dented | Repair |

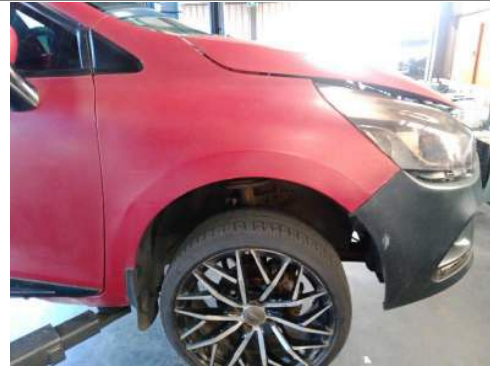
| Damage | Repair Way |
|---|---|
| Front Fender Right Residual Traces of Repair | Repair |

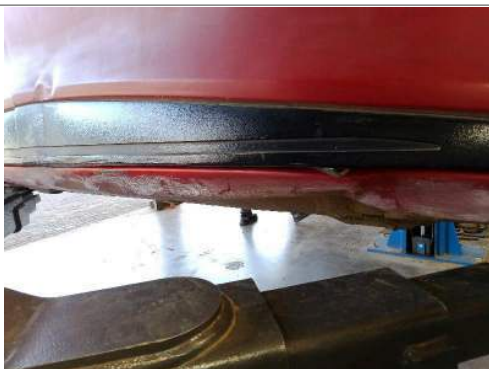
| Damage | Repair Way |
|---|---|
| Sill Panel Right Dented | Repair |

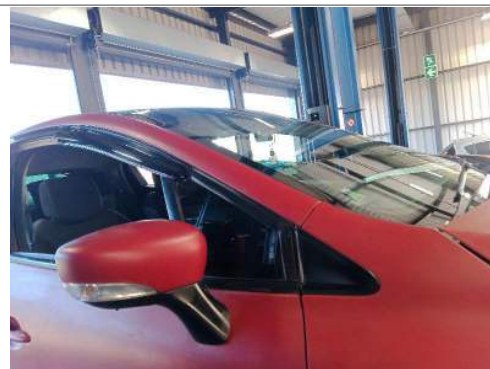
| Damage | Repair Way |
|---|---|
| A • Pillar Right Residual Traces of Repair | Repair |

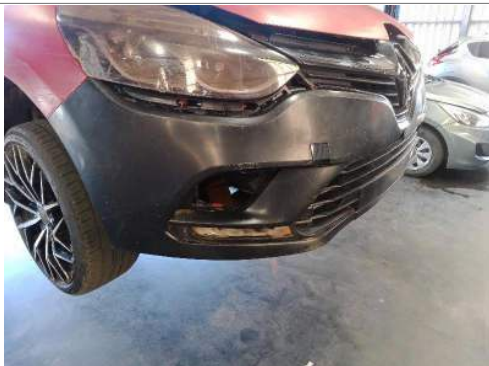
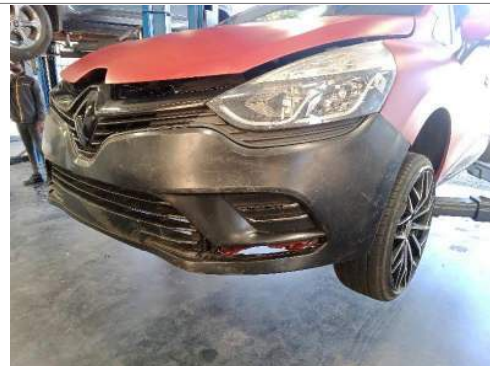
| Damage | Repair Way |
|---|---|
| Front Bumper Damaged | Repair |

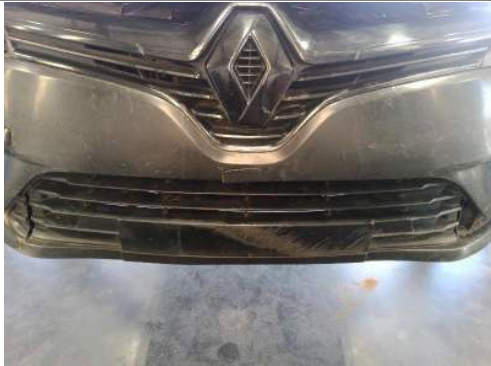
| Damage | Repair Way |
|---|---|
| Number Plate Front Missing | Repair |

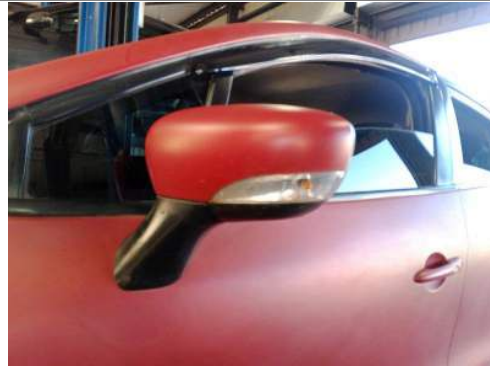
| Damage | Repair Way |
|---|---|
| Side Mirror Left Residual Traces of Repair | Repair |

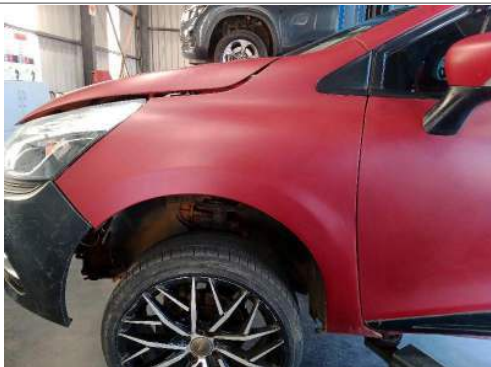
| Damage | Repair Way |
|---|---|
| Front Fender Left Residual Traces of Repair | Repair |

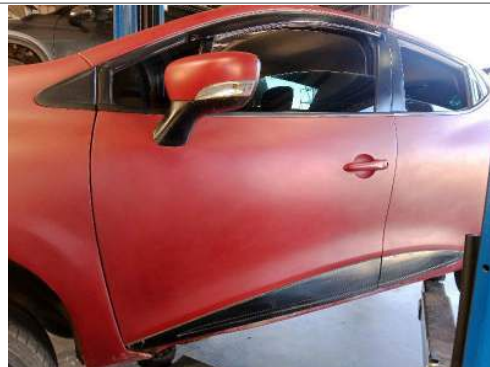
| Damage | Repair Way |
|---|---|
| Door Front Left Residual Traces of Repair | Repair |

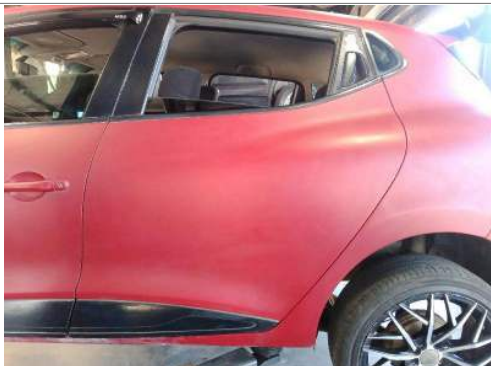
| Damage | Repair Way |
|---|---|
| Door Rear Left Residual Traces of Repair | Repair |

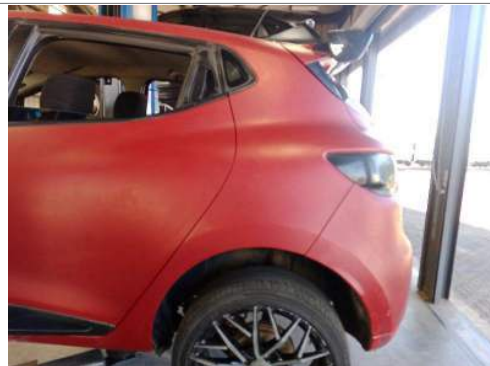
| Damage | Repair Way |
|---|---|
| Rear Fender Left Residual Traces of Repair | Repair |

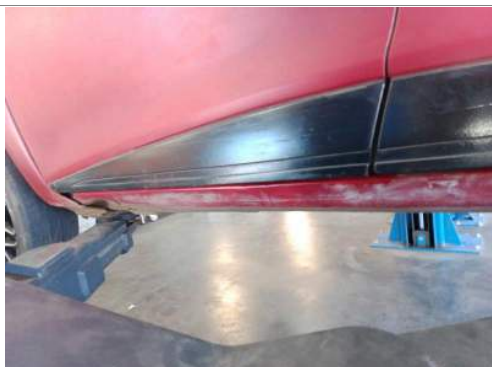
| Damage | Repair Way |
|---|---|
| Sill Panel Left Dented | Repair |

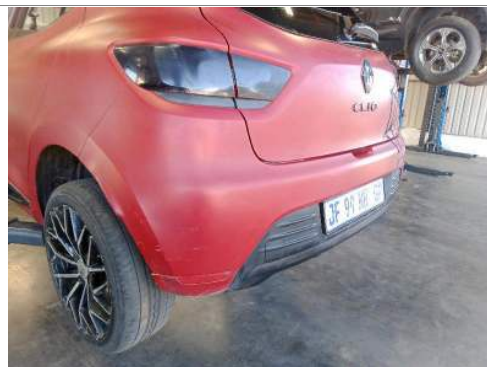
| Damage | Repair Way |
|---|---|
| Rear bumper Residual Traces of Repair | Repair |

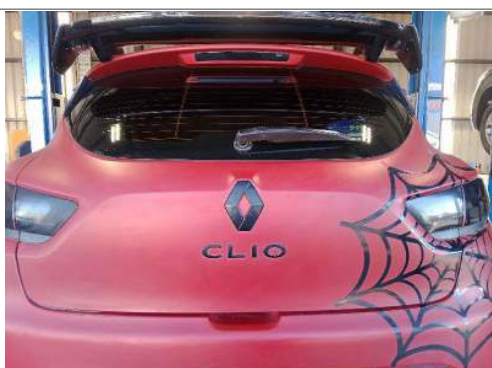
| Damage | Repair Way |
|---|---|
| Boot Lid / Hatch door Residual Traces of Repair | Repair |

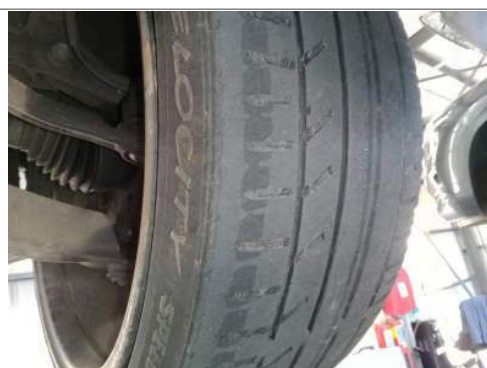
| Damage | Repair Way |
|---|---|
| Tyre Front Right Smooth | Replace |

| | Size | Load/Speed Index | Manufacture | Model | Type* | Production Date | Tread Depth (mm) |
|---|---|---|---|---|---|---|---|
| Front Right | 205/40R17 | 84W | Velocity | Speed max | V | 4519 | 0 mm |

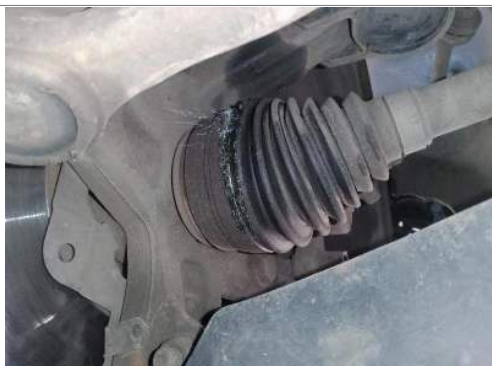
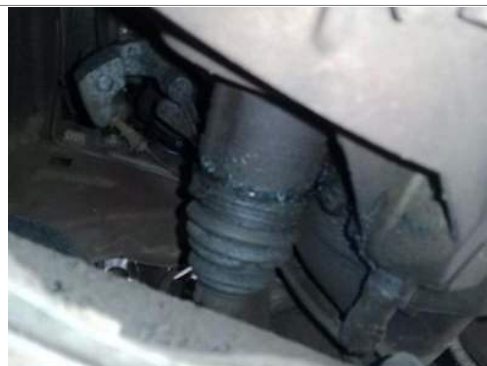
| Damage | Repair Way |
|---|---|
| CV Joint(s) Boot(s) Front Left (inner/outer) Damaged | Repair |

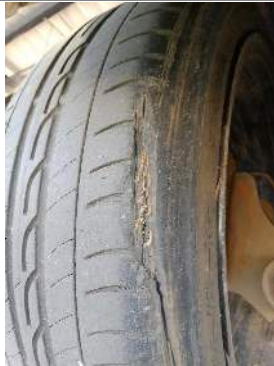
| Damage | Repair Way |
|---|---|
| Tyre Rear Left Damaged | Replace |
| Rear tyres size differs | Replace |

| | Size | Load/Speed Index | Manufacture | Model | Type* | Production Date | Tread Depth (mm) |
|---|---|---|---|---|---|---|---|
| Rear Left | 205/45R17 | 88V | Michelin | Primacy | V | 0315 | 2 mm |

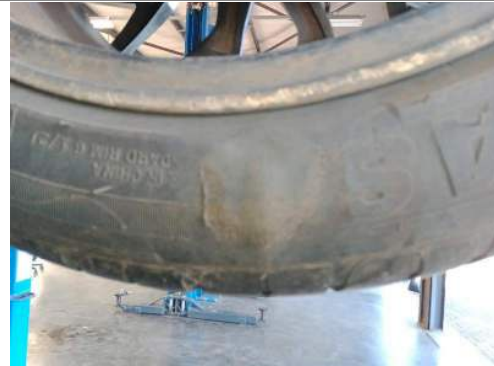
| Damage | Repair Way |
|---|---|
| Tyre Rear Right Defective | Repair |

| | Size | Load/Speed Index | Manufacture | Model | Type* | Production Date | Tread Depth (mm) |
|---|---|---|---|---|---|---|---|
| Rear Right | 205/50R17 | 93W | Atlas | Sport green | V | 0418 | 3 mm |

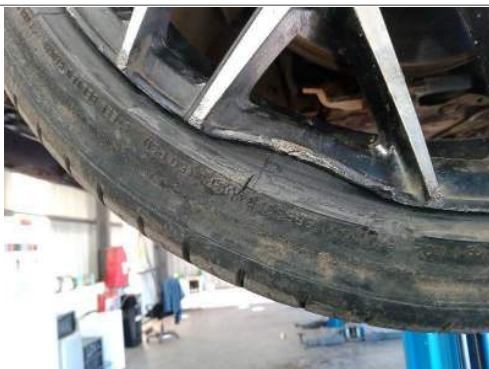
| Damage | Repair Way |
|---|---|
| Tyre Front Left Torn / Cut | Repair |

| | Size | Load/Speed Index | Manufacture | Model | Type* | Production Date | Tread Depth (mm) |
|---|---|---|---|---|---|---|---|
| Front Left | 205/40R17 | 84W | Sumitomo | Bc100 | V | 2321 | 3 mm |

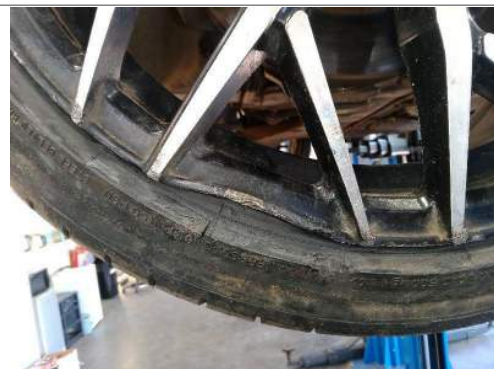
| Damage | Repair Way |
|---|---|
| Rim Front Left Dented | Repair |

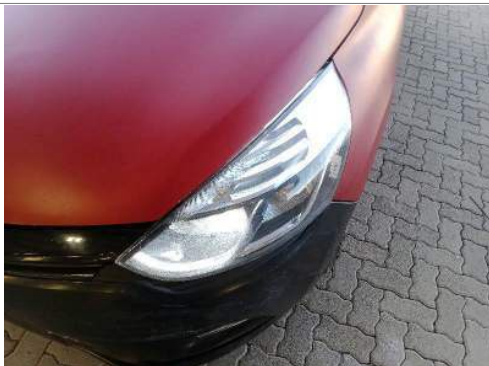
| Damage | Repair Way |
|---|---|
| Indicator Light Front Left Malfunction | Repair |

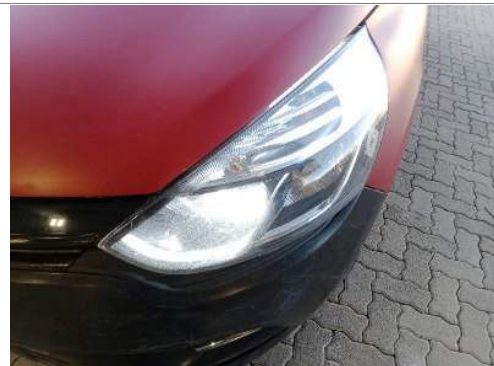
| Damage | Repair Way |
|---|---|
| Bright Light Left Malfunction | Repair |
