CONDITION REPORT

Report No: 2016206362

DATE
19/12/2023

Vehicle Type	PASSENGER VEHICLE	Registered Owner	MFC
Manufacturer	RENAULT	Registration Number	FT51GNGP
Model	SANDERO	Register Number	
VIN	VF15SRAAC56415418	Date Of First Licensing	
Engine Number		Last COR	
Doors	5	License Expiry Date	30/11/2023
Color	SILVER	Power / Displacement	
Year Model		Paint Finish	M - METALLIC
Km Reading	115,645 KM	Fuel	PETROL
Cab / Body Type	HATCHBACK	Transmission	MANUAL

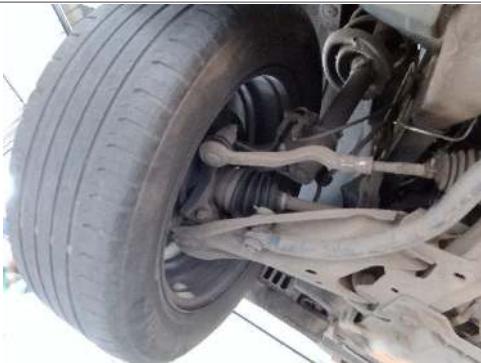
LF TYRE TREAD

Size	Load/Speed Index	Manufacture	Model	Type*	Production Date	Tread Depth (mm)
Front Left	205/55R16	91H	Continental	Contact	V	3816	1 mm
Front Right	205/55R16	91H	Continental	Contact	V	4016	5 mm
Rear Left	205/55R16	91W	Rovelo	RPX	V	0321	5 mm
Rear Right	205/55R16	91H	Continental	Contact	V	3219	5 mm
Spare	185/65R15	88T	Barum	Brilliantis	V	////	6 mm

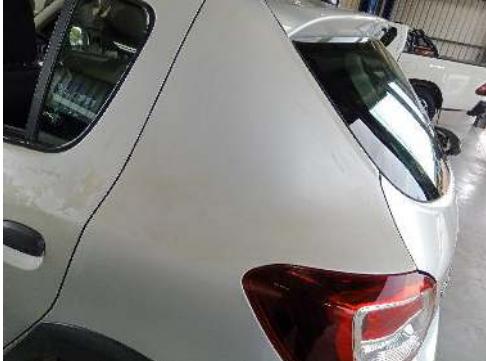
Damage	Repair Way
Fog Light Rear Left Defective	Repair
Rear Fender Left Paintwork • Dull	Repair
Door Rear Left Paintwork • Dull	Repair
Windscreen Chipped	Replace
Rim Rear Left Dented	Repair
Bolt(s) / Nut(s) Front Wheel Left Missing	Replace
