MFC Auction House
M57 Pretoria Rd, Glenmarais, KEMPTON PARK
Gauteng

Vehicle Type	PASSENGER VEHICLE	Registered Owner	
Manufacturer	RENAULT	Registration Number	FX17TCGP
Model	SANDERO	Register Number	
VIN	VF15SRAAC56972120	Date Of First Licensing	
Engine Number		Last COR	
Doors	5	License Expiry Date	
Color	WHITE	Power / Displacement	
Year Model		Paint Finish	TWO COAT UNI
Km Reading	188,820 KM	Fuel	PETROL
Cab / Body Type	HATCHBACK	Transmission	MANUAL

VEHICLE INSPECTION

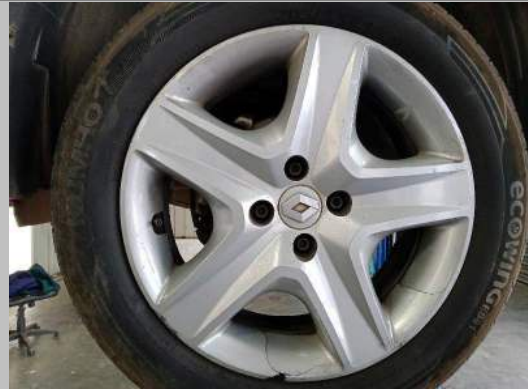
Front left hubcap

Tyres and rims	Front and rear hubcaps scratched.

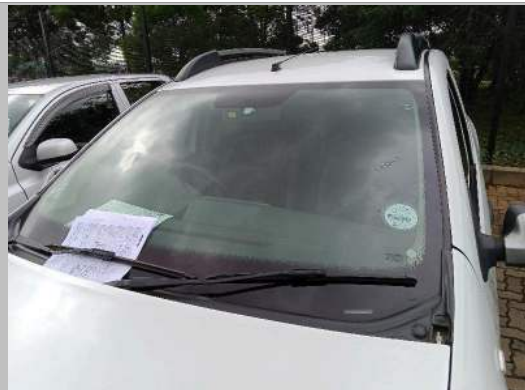
Damage	Repair Way
Door Rear Right Paintwork • Scratched	Repair
Boot Lid / Hatch door Dented	Repair
Boot Lid / Hatch Door Rubbers Damaged	Replace
Rear bumper Damaged	Repair
Inner Boot Floor Pan and Spare Wheel Well Damaged	Repair
Sill Panel Left Paintwork • Scratched	Repair
Roof Damaged	Repair
Windscreen Cracked	Replace
Parking Brake Performance Left / Right Difference out of legal range	Repair
Brake fluid level Insufficient	Replace
Spare Tyre Damaged	Replace
Rim Front Right Dented	Repair
Rim Spare Wheel Dented	Repair
Engine	Foreign substance on oil cap
Engine	Signs of rodent in engine bay.
Warning lights illuminated on dashboard	Repair
Tyres and rims	Front left hubcap damaged
Body and Exterior	Dents and scratches on some body panels
Interior	Vehicle interior dirty and some panels scratched
Undercarriage	Bottom of engine and gearbox fully covered.
Body and Exterior	Stone chips and spray work on some body panels

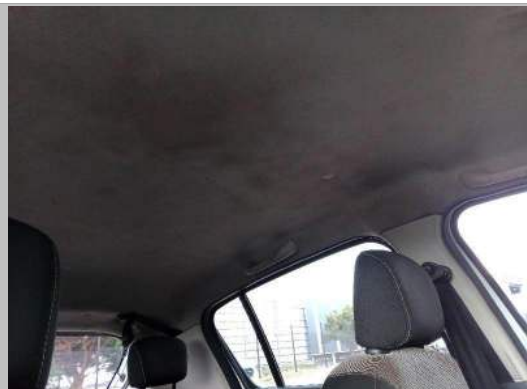
Damage	Repair Way
 	Engine Oil Leak	Repair
	Air Conditioner Insufficient	Replace
	Tail Light Left Scratched	Replace
	Seat Front Left Dirty	Repair
	Seat Front Right Damaged	Repair
	Hood Lining Dirty	Repair
	Door Sealing Rubber Front Right Damaged	Replace
	Steering Wheel Trim Defective	Repair
	Side Mirror Left Damaged	Replace
	Side Mirror Right Damaged	Replace
	Front Bumper Damaged	Repair
	Bonnet Damaged	Repair
	Front Fender Left Damaged	Repair
	Front Fender Right Paintwork • Scratched	Repair
	Rear Fender Left Paintwork • Scratched	Repair
	Rear Fender Right Paintwork • Scratched	Repair
	Rear Fender Left / Inner Tray Damaged	Repair
	Door Front Left Damaged	Repair
	Door Front Right Paintwork • Scratched	Repair
	Door Rear Left Paintwork • Scratched	Repair
