## CONDITION REPORT

Report No:  
2016962656  
DATE  
30/07/2025

| Manufacturer | RENAULT | Registration Number | FY97WDGP |
| Model | SANDERO | Register Number | |

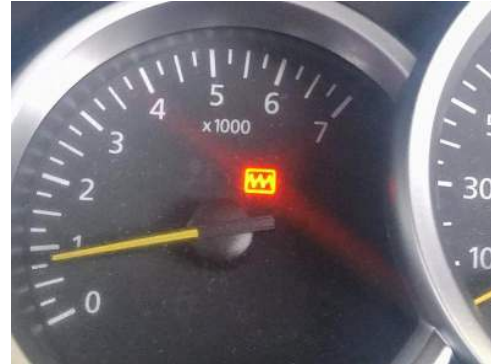
Warning lights illuminated

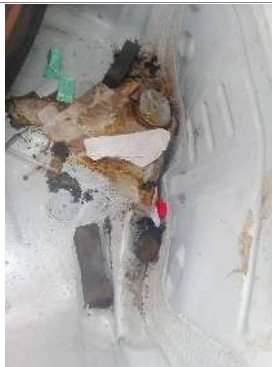
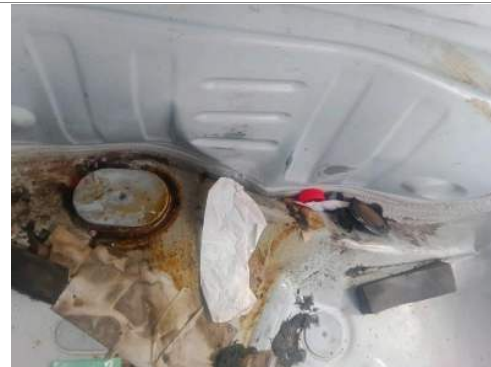
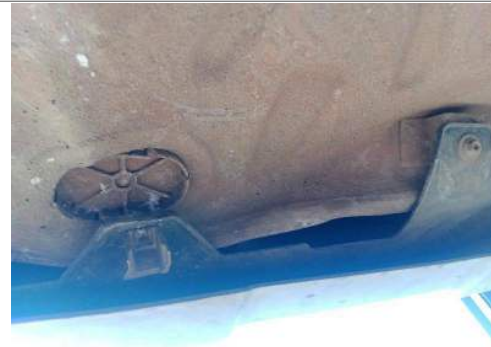
| Sparewheel well damage | Repair |

Sparewheel well damage

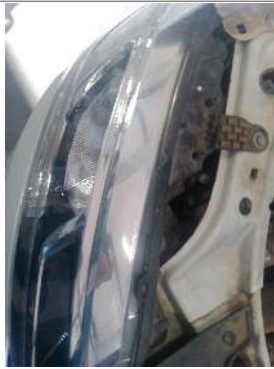
R/F headlight clips broken

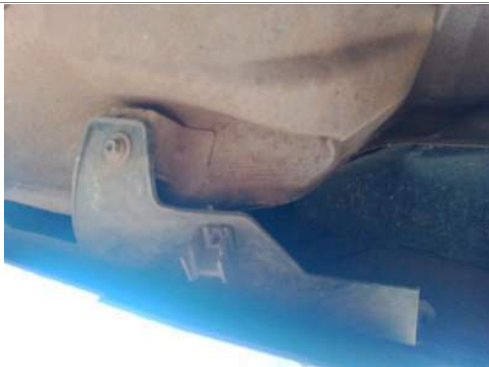
Sparewheel damage

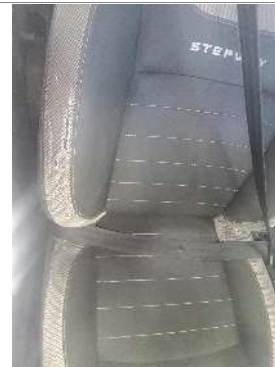
| Seat Front Right Torn / Cut | Repair |

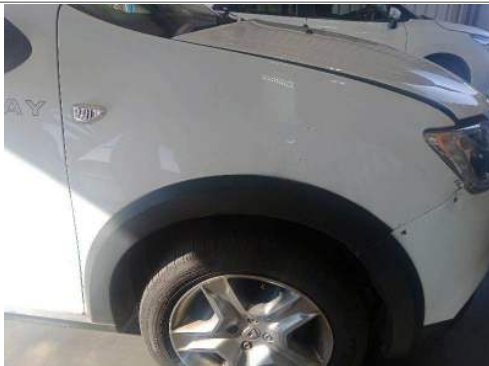
| Front Fender Right Dented | Repair |

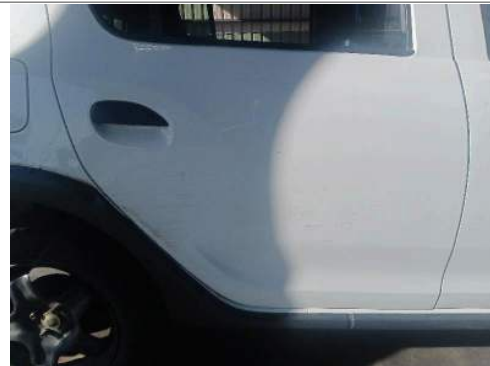
| Door Rear Right Paintwork • Scratched | Repair |

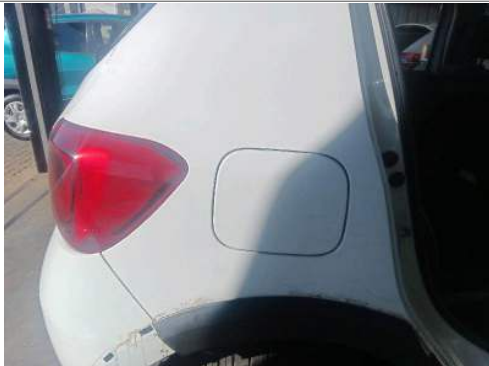
| Rear Fender Right Paintwork • Scratched | Repair |

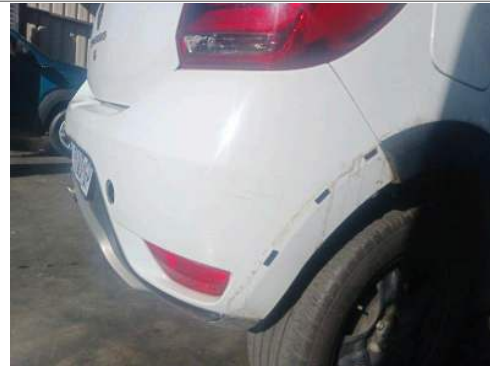
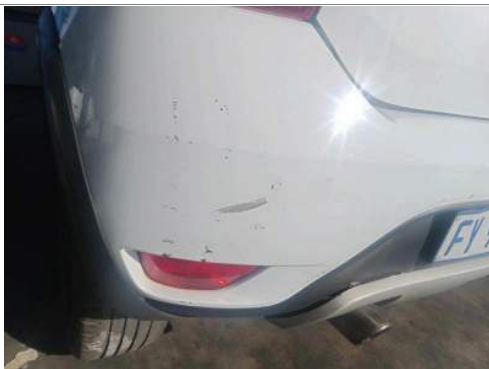
| Rear bumper Damaged | Repair |

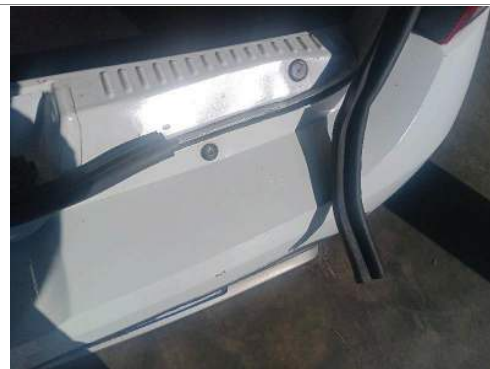
| Door Sealing Rubber Rear Right Damaged | Replace |

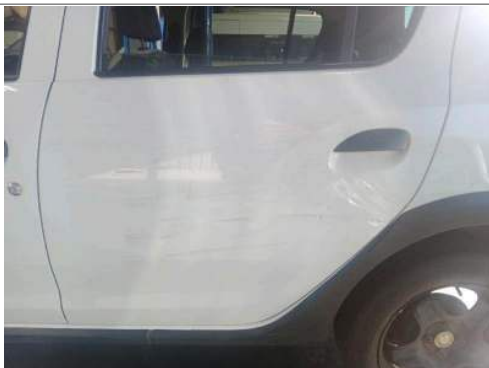
| Door Rear Left Paintwork • Scratched | Repair |

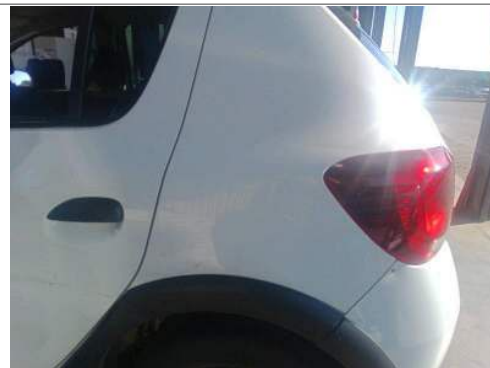
| Rear Fender Left Paintwork • Scratched | Repair |

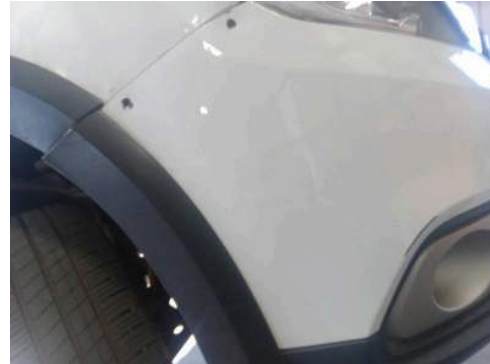
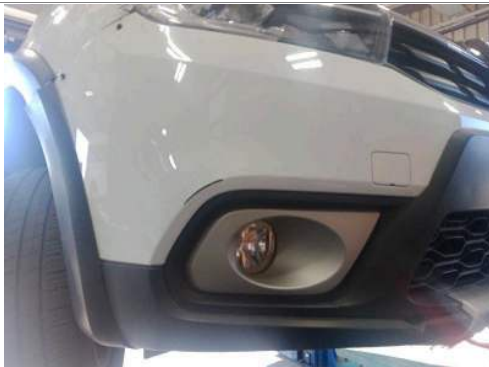
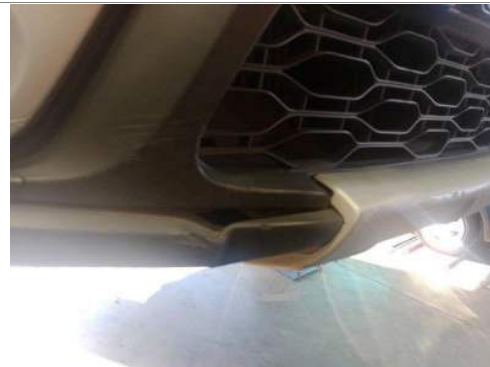
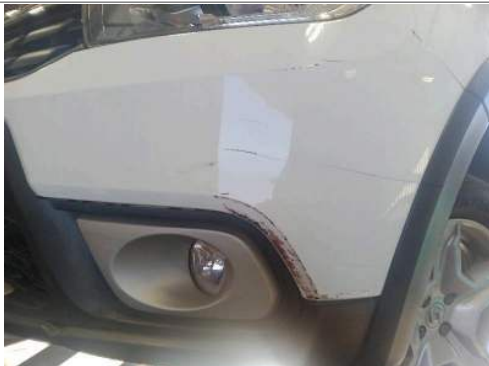
| Front Bumper Damaged | Repair |

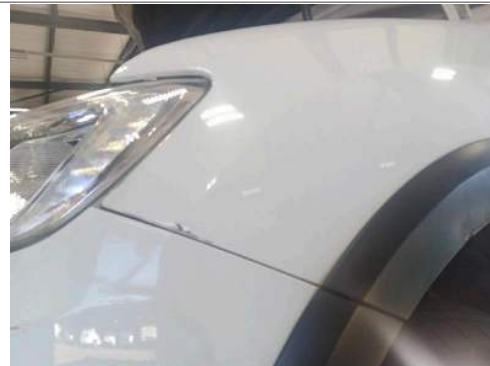
| Front Fender Left Dented | Repair |

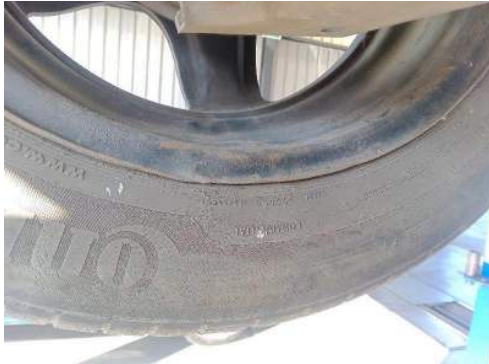
| Rim Rear Left Dented | Repair |

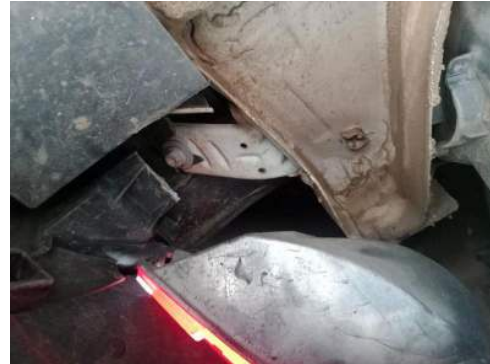
| Rear Lower Valance Damaged | Repair |

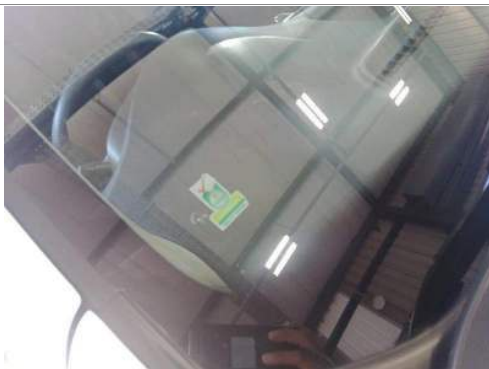
| Windscreen Cracked | Repair |
