## CONDITION REPORT

Report No:  
2017299616  
DATE  
16/09/2026

| Manufacturer | RENAULT | Registration Number | JK01TDGP |
| Model | SANDERO STEPWAY | Register Number | |

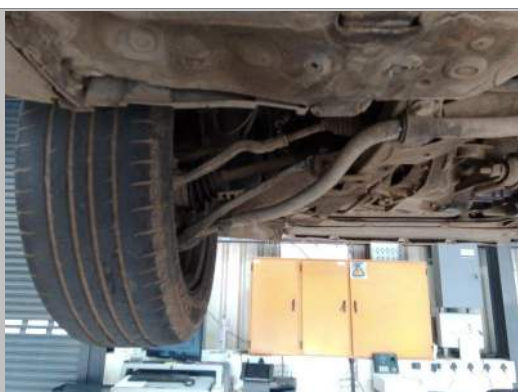
LF TYRE TREAD

| | Size | Load/Speed Index | Manufacture | Model | Type* | Production Date | Tread Depth (mm) |
|---|---|---|---|---|---|---|---|
| Front Left | 205/55R16 | 91V | Linglong | Radial | V | 5221 | 1 mm |

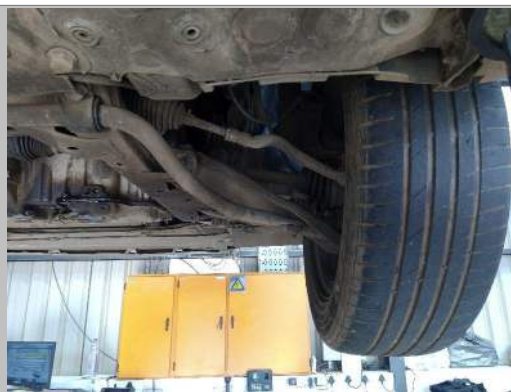
RF TYRE TREAD

| | Size | Load/Speed Index | Manufacture | Model | Type* | Production Date | Tread Depth (mm) |
|---|---|---|---|---|---|---|---|
| Front Right | 205/55R16 | 91V | Kapsen | Radial | V | 0823 | 2 mm |

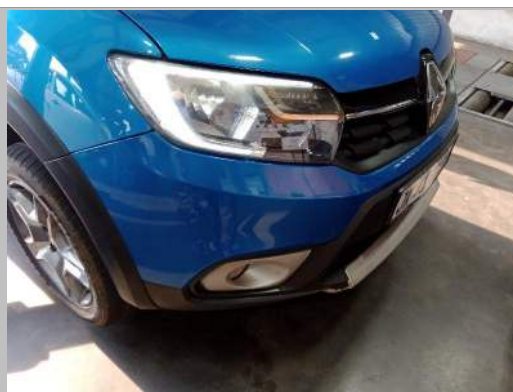
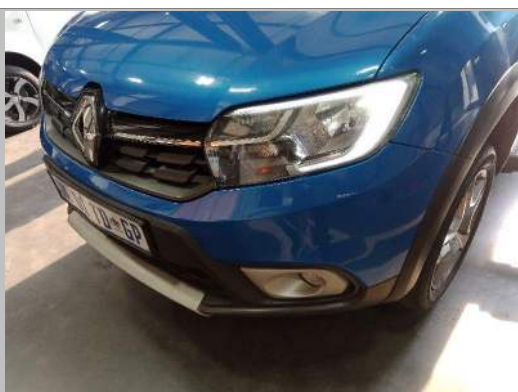
| Front Bumper Damaged | Repair |

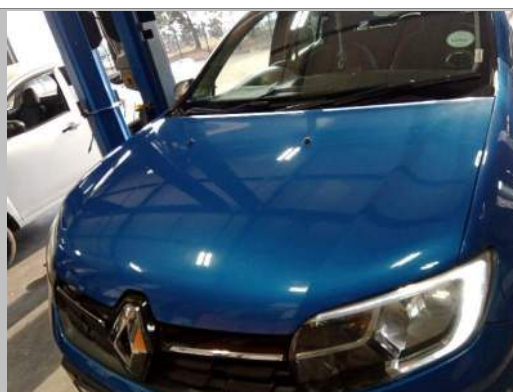
| Bonnet Damaged | Repair |

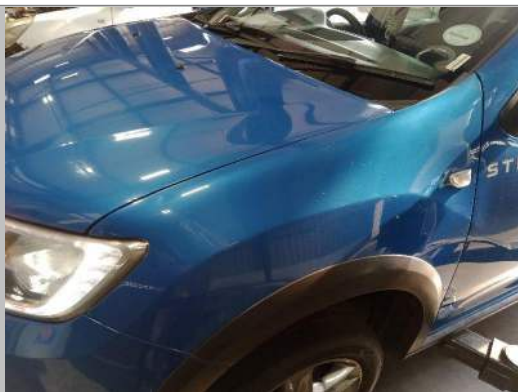
| Front Fender Left Damaged | Repair |

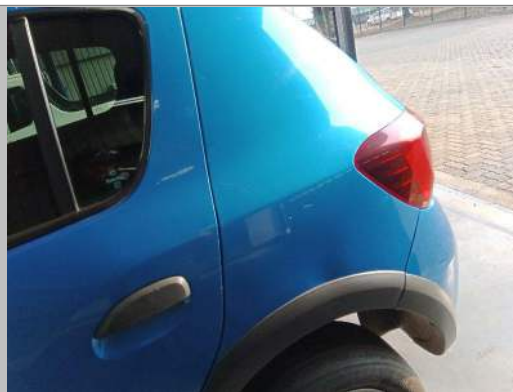
| Rear Fender Left Damaged | Repair |

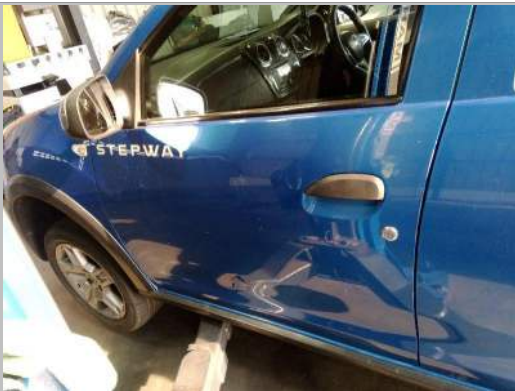
| Door Front Left Damaged | Repair |

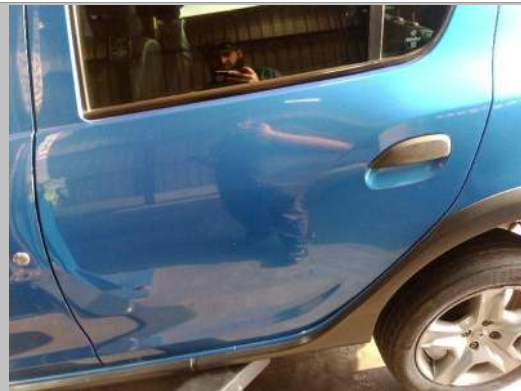
| Door Rear Left Damaged | Repair |

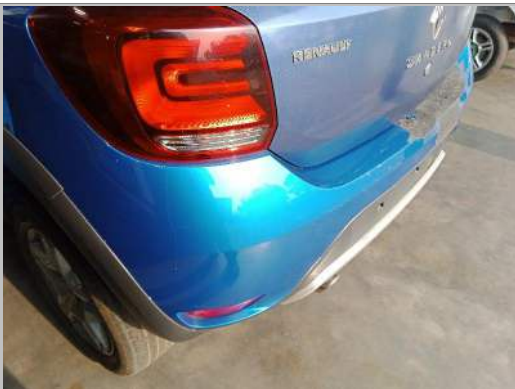
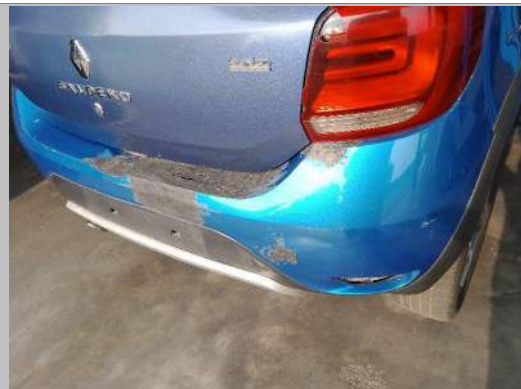
| Rear bumper Damaged | Repair |

Body • Exterior: Minor dents and scratches and stone chips to body panels. Signs of repair work done to body panels. Poor alignment to somebody panels. Repair work done to vehicle below standard. Vehicle body in poor condition. Signs of impact damage to rear of vehicle.

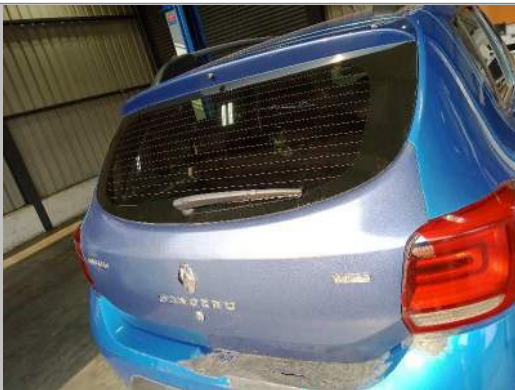
| Boot Lid / Hatch door Damaged | Repair |

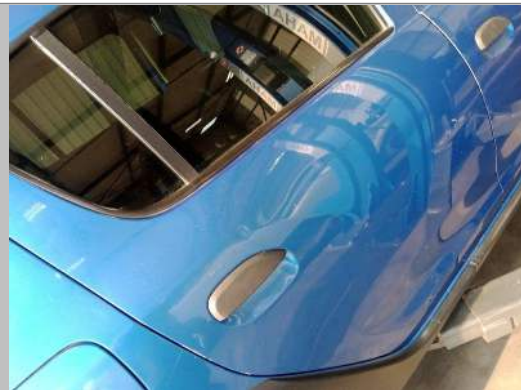
| Door Rear Right Damaged | Repair |

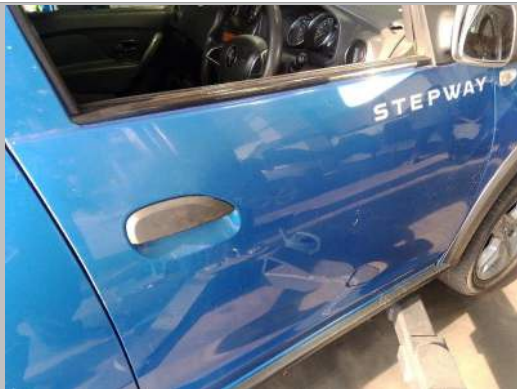
| Door Front Right Damaged | Repair |

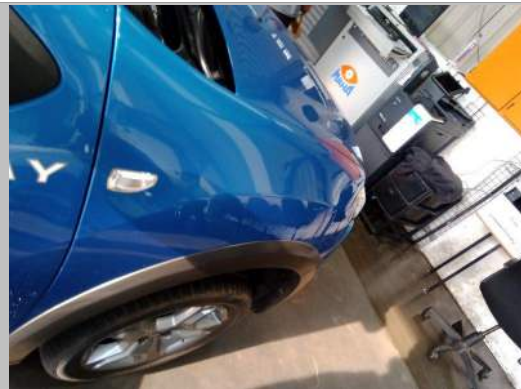
| Front Fender Right Damaged | Repair |

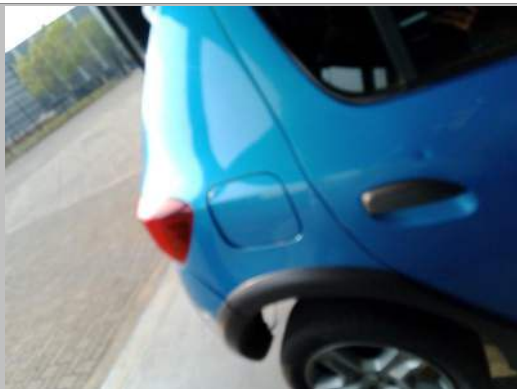
| Rear Fender Right Damaged | Repair |

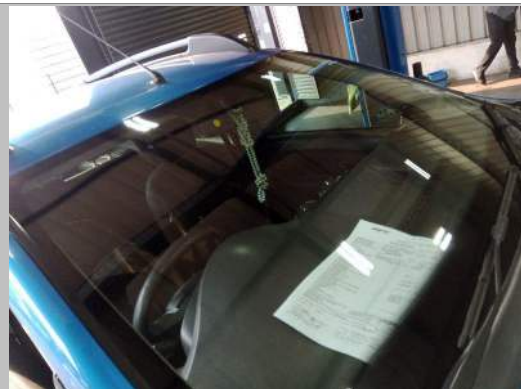
| Windscreen Damaged | Repair |

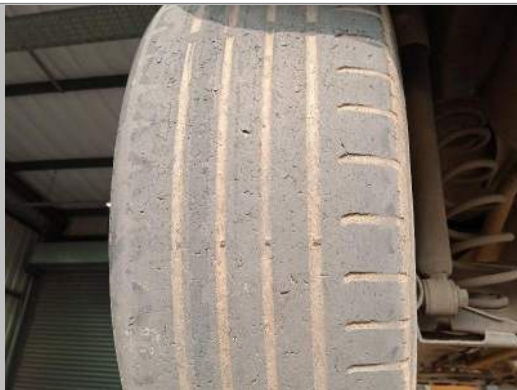
| Tyre Rear Left Worn | Replace |

| | Size | Load/Speed Index | Manufacture | Model | Type* | Production Date | Tread Depth (mm) |
|---|---|---|---|---|---|---|---|
| Rear Left | 205/55R16 | 91H | Continental | Contieco | V | 24119 | 0 mm |

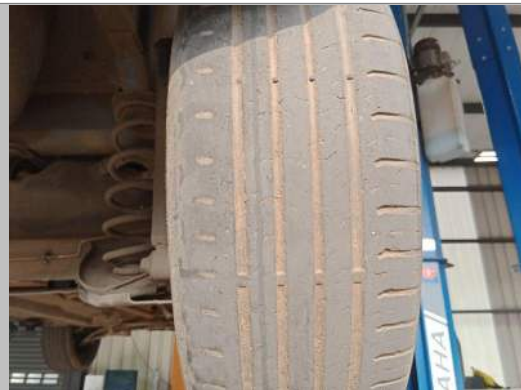
| Tyre Rear Right Worn | Replace |

| | Size | Load/Speed Index | Manufacture | Model | Type* | Production Date | Tread Depth (mm) |
|---|---|---|---|---|---|---|---|
| Rear Right | 205/55R16 | 91H | Continental | Contieco | V | 2419 | 0 mm |

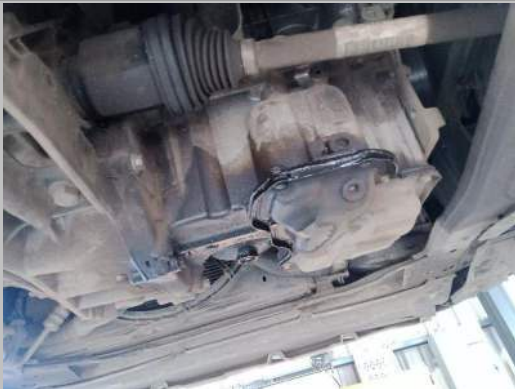
| Engine Oil Leak | Repair |
| Engine Performance Insufficient | Repair |
| Engine Noise Excessive | Repair |

General Comments: ACCORDING TO THE AGE AND MILEAGE OF THE VEHICLE, NORMAL WEAR AND TEAR MARKS ARE VISIBLE ON THE INTERIOR, EXTERIOR, ELECTRICAL AND MECHANICAL PARTS. 34 DTC'S AT TIME OF TESTING SEE DTC REPORT. STARTER MALFUNCTIONING.Engine Compartment: Battery loose. engine struggles to start.

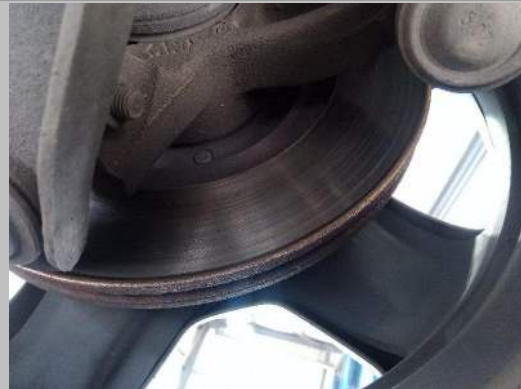
| Brake disc 1. Axle right Worn | Replace |

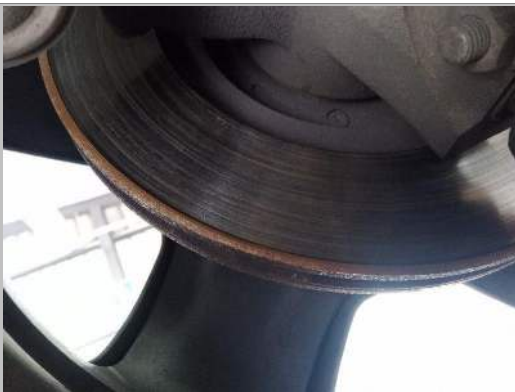
| Brake disc 1. Axle left Worn | Replace |

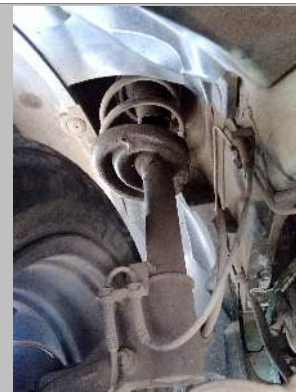
| Shock Absorber Front Left Worn | Replace |

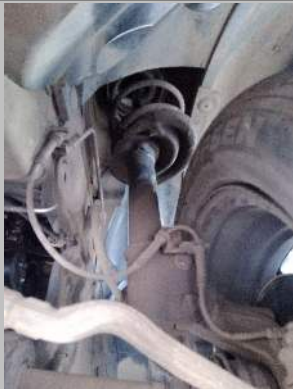
| Shock Absorber Front Right Worn | Replace |

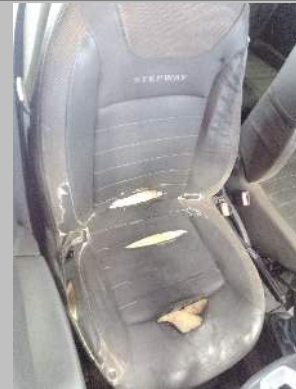
| Seat Front Right Damaged | Repair |

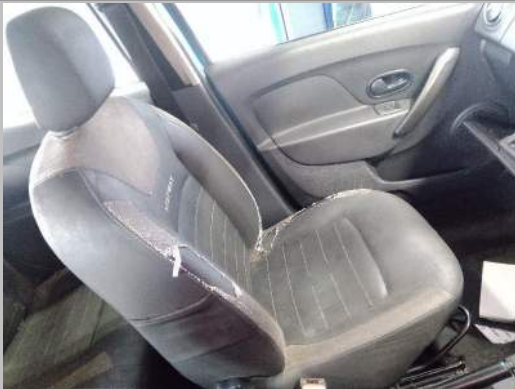
| Seat Front Left Damaged | Repair |

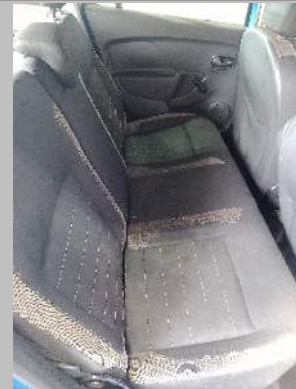
| Seat Rear Damaged | Repair |

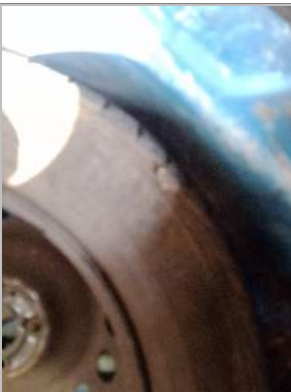
| Spare Tyre Damaged | Replace |

| | Size | Load/Speed Index | Manufacture | Model | Type* | Production Date | Tread Depth (mm) |
|---|---|---|---|---|---|---|---|
| Spare | 185/65R15 | 88T | Barum | Radial | V | 0000 | 0 mm |

Tyres and Rims: spare wheel deflated.

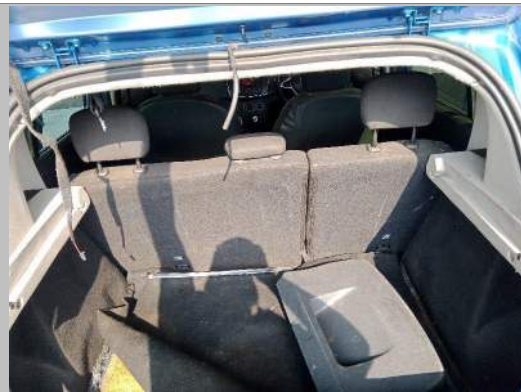
| Parcel Tray Missing | Replace |

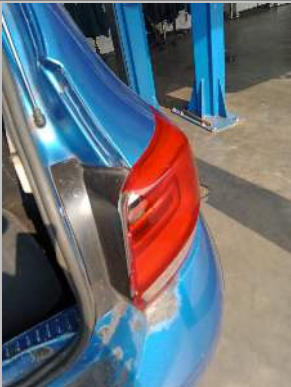
| Tail Light Right Damaged | Replace |

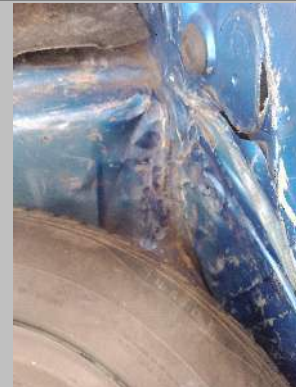
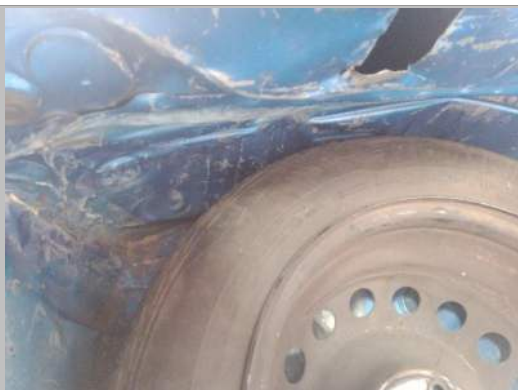
| Inner Boot Floor Pan and Spare Wheel Well Damaged | Repair |

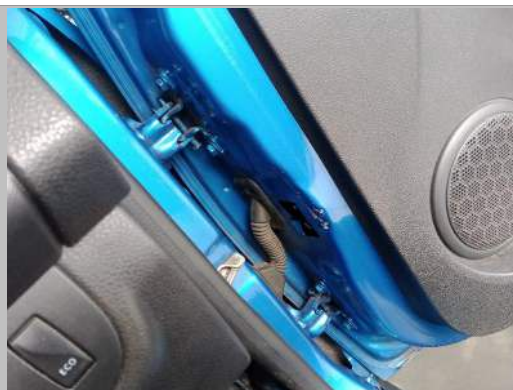
| Doorstopper Front Right Damaged | Replace |

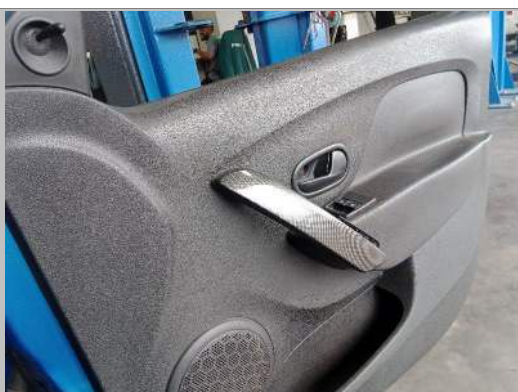
| Door Panel Front Right Damaged | Replace |

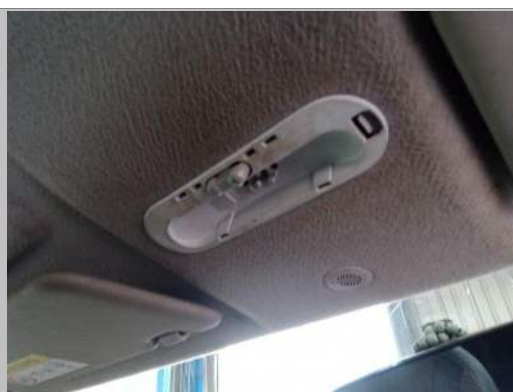
| Interior Lights Damaged | Replace |

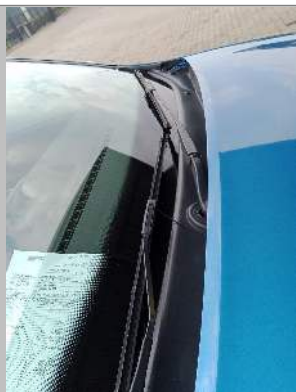
| Windscreen Wiper Damaged | Replace |

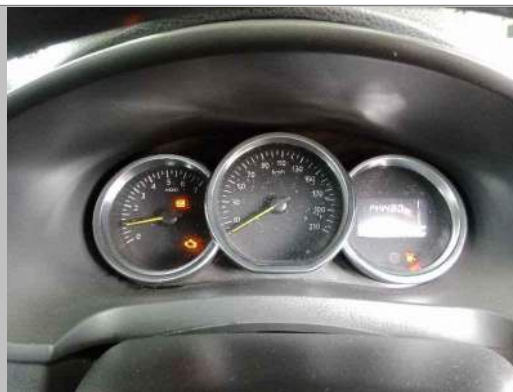
| Engine Management Lights Set | Repair |

| No | System | Code | Description | Status |
|---|---|---|---|---|
| 1 | INJ | DTC001192 | INLET CAMSHAFT SHIFTER PHASER CONTROL OUTSIDE OF LIMITS. | ACTIVE |
