## CONDITION REPORT

Report No:  
2017304158  
DATE  
28/09/2026

MFC Auction House  
M57 Pretoria Rd, Glenmarais, KEMPTON PARK  
Gauteng

| Manufacturer | PEUGEOT | Registration Number | DF51LBGP |

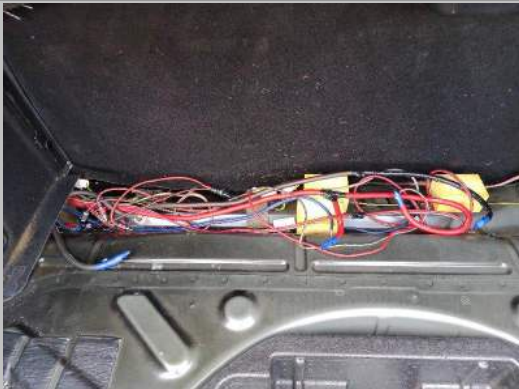
| Damage | Repair Way |
|---|---|
| Loose sound wiring inside boot of vehicle | Replace |

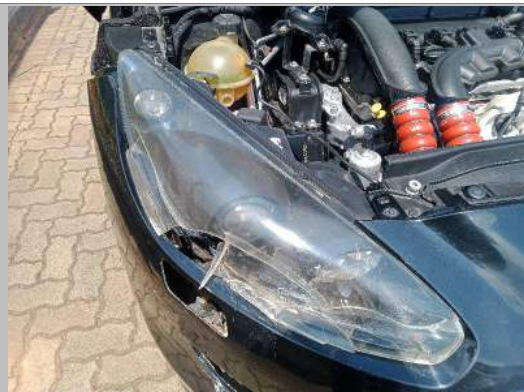
| Damage | Repair Way |
|---|---|
| Headlight Right Damaged | Replace |

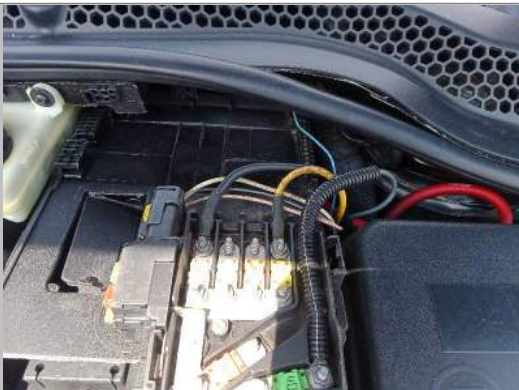
| Damage | Repair Way |
|---|---|
| Engine Wiring Defective | Repair |

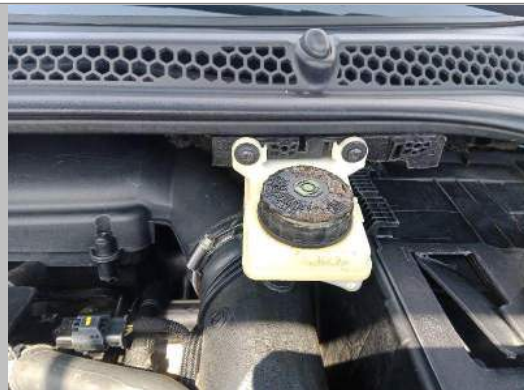
| Damage | Repair Way |
|---|---|
| Caps Damaged | Replace |

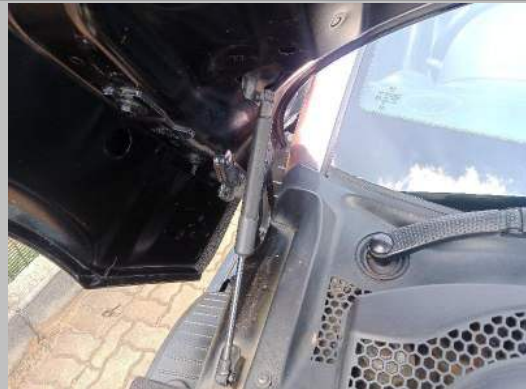
| Damage | Repair Way |
|---|---|
| Bonnet stay and shocks Damaged | Replace |

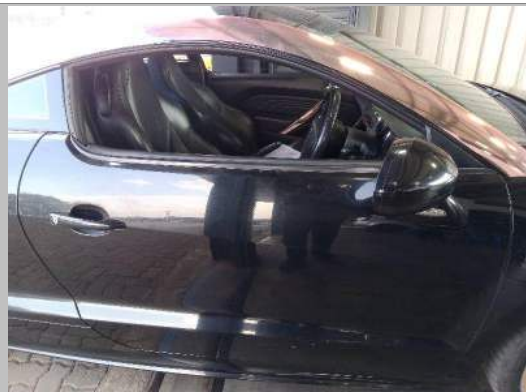
| Damage | Repair Way |
|---|---|
| Door Front Right Paintwork • Scratched | Repair |

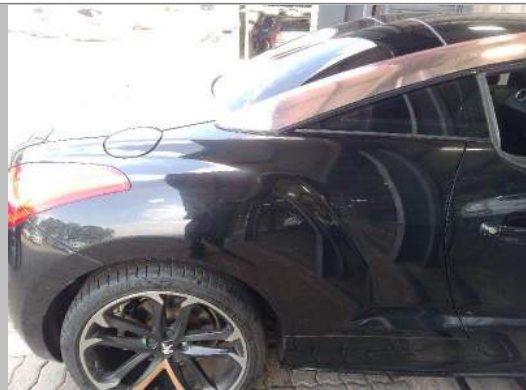
| Damage | Repair Way |
|---|---|
| Rear Fender Right Paintwork • Scratched | Repair |

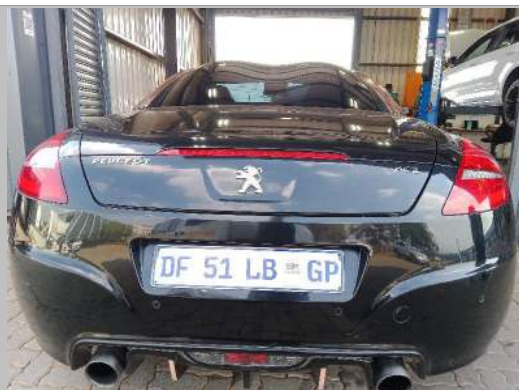
| Damage | Repair Way |
|---|---|
| Rear bumper Damaged | Repair |

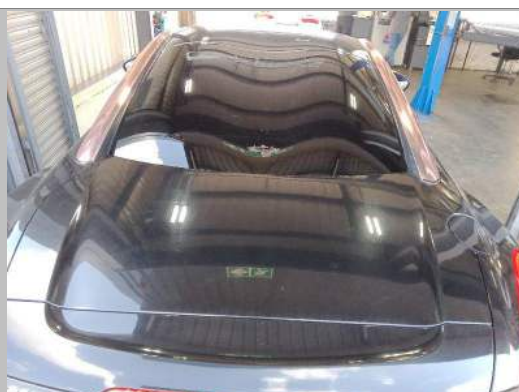
| Damage | Repair Way |
|---|---|
| Boot Lid / Hatch door Paintwork • Scratched | Repair |

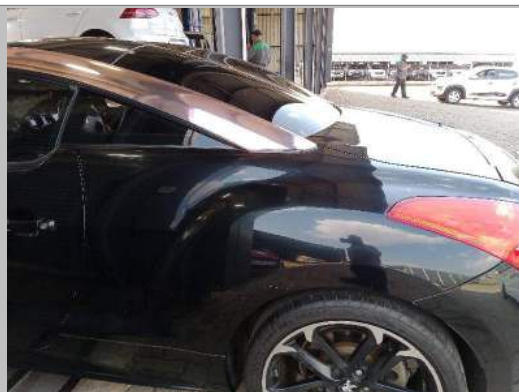
| Damage | Repair Way |
|---|---|
| Rear Fender Left Paintwork • Scratched | Repair |

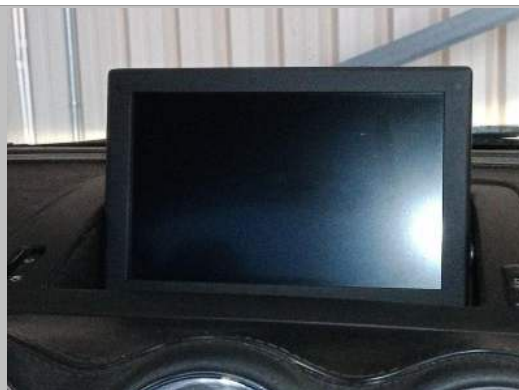
| Damage | Repair Way |
|---|---|
| Radio/CD/USB Defective | Repair |

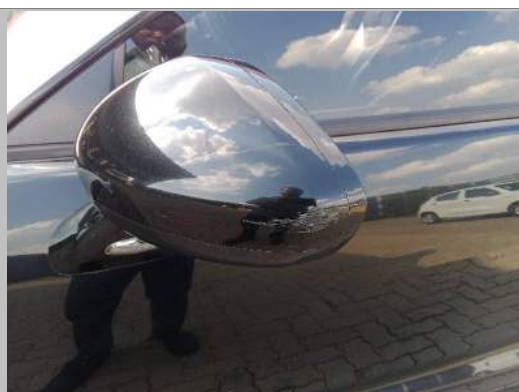
| Damage | Repair Way |
|---|---|
| Side Mirror Left Paintwork • Scratched | Repair |

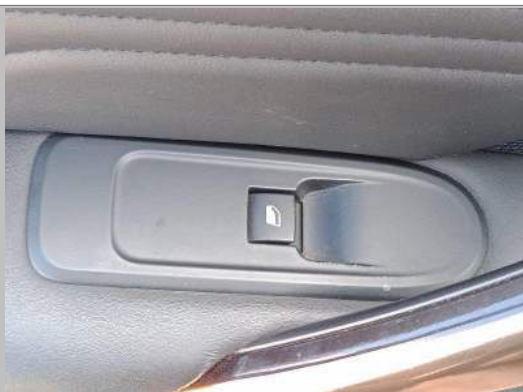
| Damage | Repair Way |
|---|---|
| Switch Electrical Window Winder front left Malfunction | Replace |

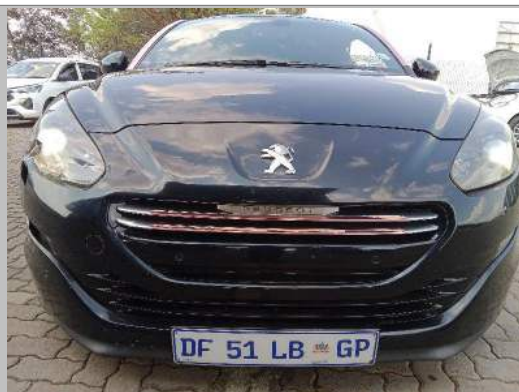
| Damage | Repair Way |
|---|---|
| Front Bumper Damaged | Repair |

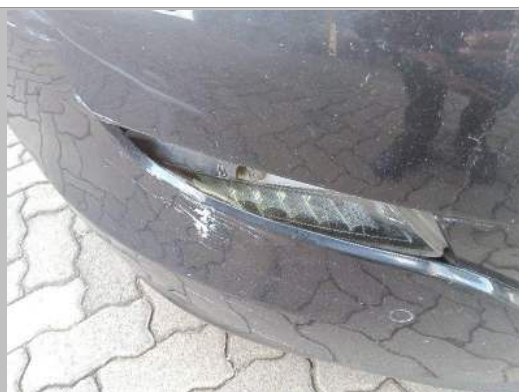
| Damage | Repair Way |
|---|---|
| Fog Light Front Right Damaged | Replace |

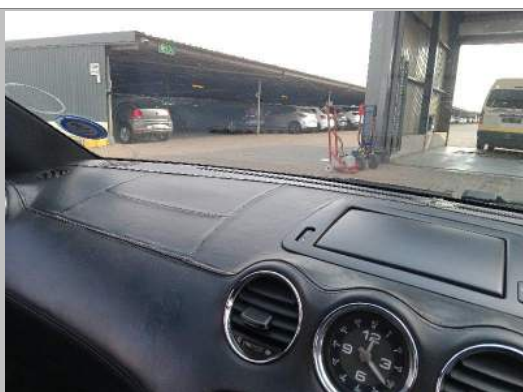
| Damage | Repair Way |
|---|---|
| Dash Padding Defective | Repair |

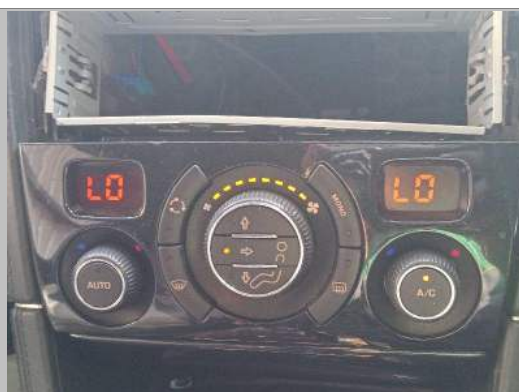
| Damage | Repair Way |
|---|---|
| Air Conditioner Insufficient | Repair |

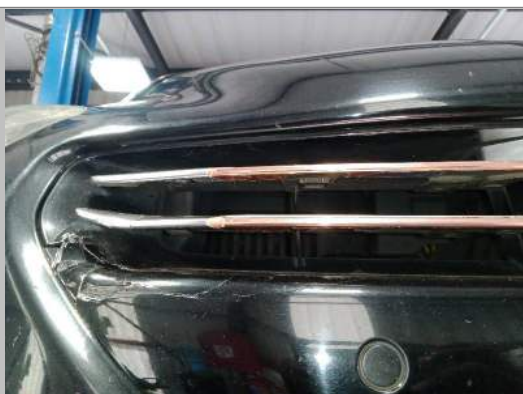
| Damage | Repair Way |
|---|---|
| Grill Damaged | Replace |

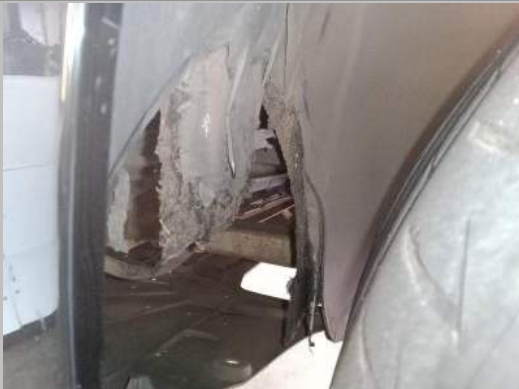
| Damage | Repair Way |
|---|---|
| Front Fender Left / Inner Tray Damaged | Replace |

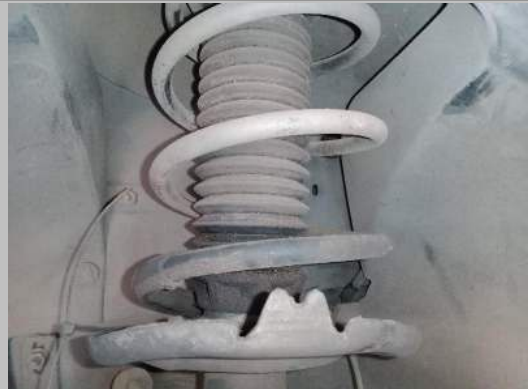
| Damage | Repair Way |
|---|---|
| Shock Absorber Front Left Sweat | Replace |

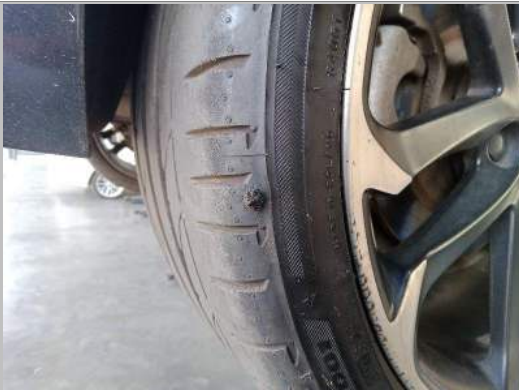
| Damage | Repair Way |
|---|---|
| Tyre Rear Right Damaged | Replace |

| | Size | Load/Speed Index | Manufacture | Model | Type* | Production Date | Tread Depth (mm) |
|---|---|---|---|---|---|---|---|
| Rear Right | 255/35 R19 | 92Y | Bridgestone | Turanza | V | 2322 | 2 mm |

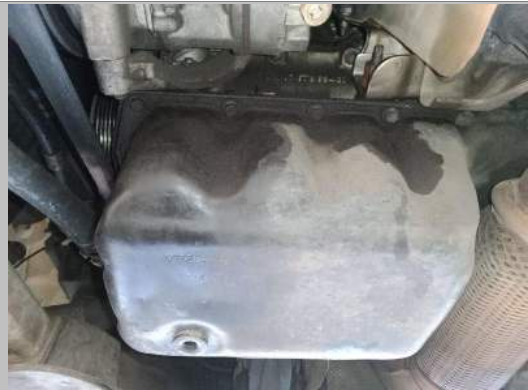
| Damage | Repair Way |
|---|---|
| Engine Oil Leak | Repair |

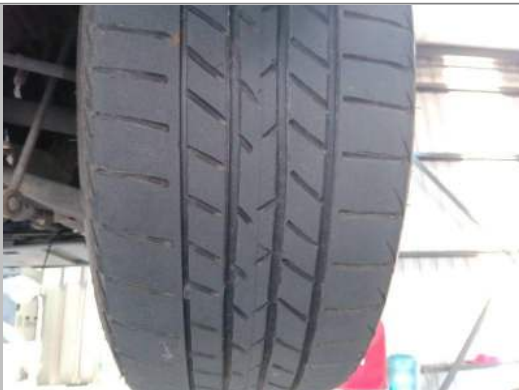
| Damage | Repair Way |
|---|---|
| Tyre Front Right Damaged | Replace |
| Front left and right tyres regrooved | Replace |

| | Size | Load/Speed Index | Manufacture | Model | Type* | Production Date | Tread Depth (mm) |
|---|---|---|---|---|---|---|---|
| Front Right | 225/40 R19 | 93W | Bridgestone | Turanza | V | 4322 | 0 mm |

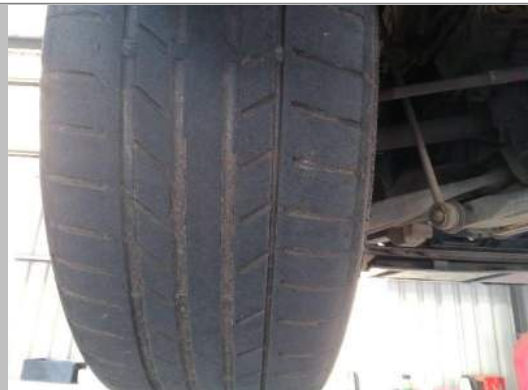
| Damage | Repair Way |
|---|---|
| Tyre Front Left Damaged | Replace |

| | Size | Load/Speed Index | Manufacture | Model | Type* | Production Date | Tread Depth (mm) |
|---|---|---|---|---|---|---|---|
| Front Left | 225/40 R19 | 93W | Bridgestone | Turanza | V | 1723 | 0 mm |

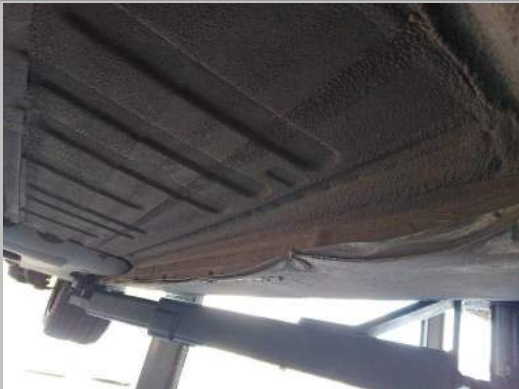
| Damage | Repair Way |
|---|---|
| Sill Panel Left Damaged | Repair |

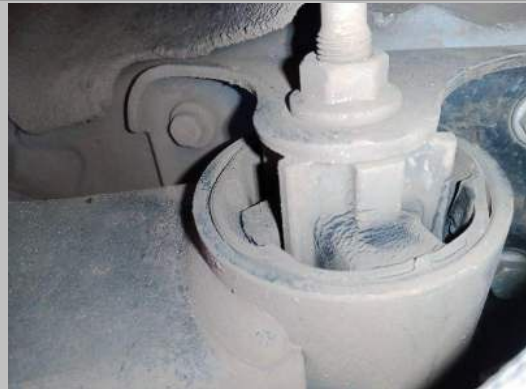
| Damage | Repair Way |
|---|---|
| Mounting Rubber(s) Rear Axle Right Cracked | Replace |

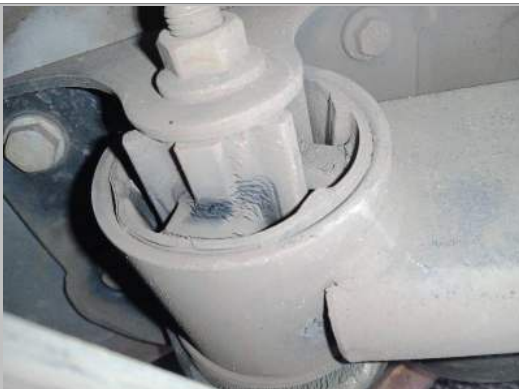
| Damage | Repair Way |
|---|---|
| Mounting Rubber(s) Rear Axle Left Cracked | Replace |

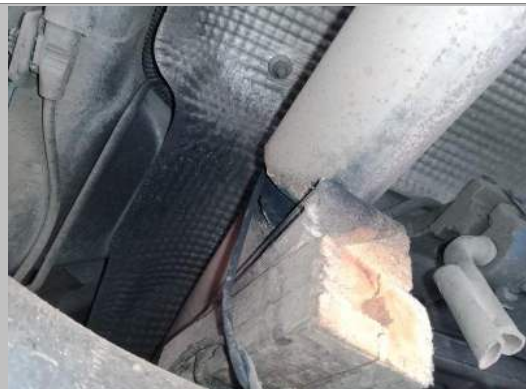
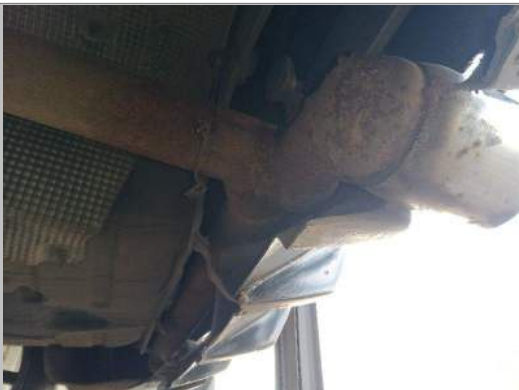
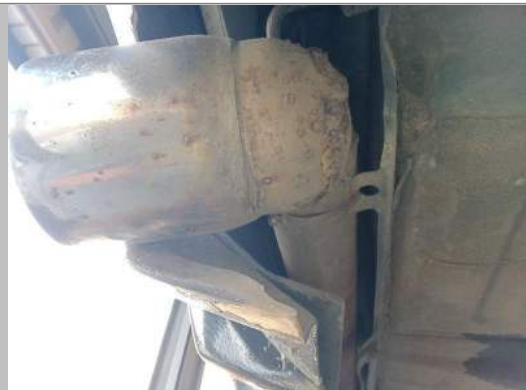
| Damage | Repair Way |
|---|---|
| Engine to silencer pipe Damaged | Replace |

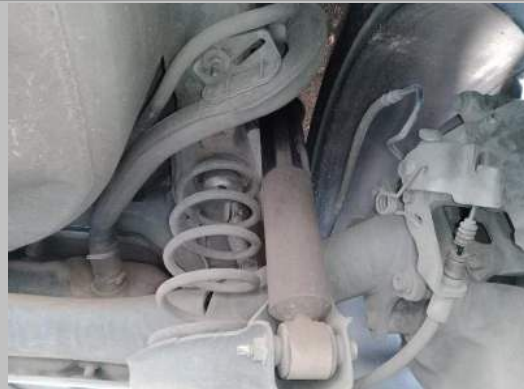
| Damage | Repair Way |
|---|---|
| Shock Absorber Rear Right Sweat | Replace |

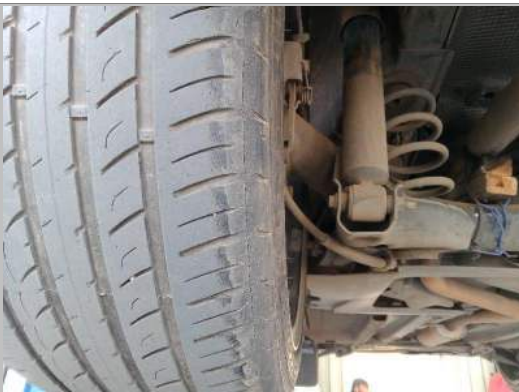
| Damage | Repair Way |
|---|---|
| Tyre Rear Left Worn | Replace |

| | Size | Load/Speed Index | Manufacture | Model | Type* | Production Date | Tread Depth (mm) |
|---|---|---|---|---|---|---|---|
| Rear Left | 255/35Z R19 | 96Y | Radar | Dimax | V | 1323 | 0 mm |

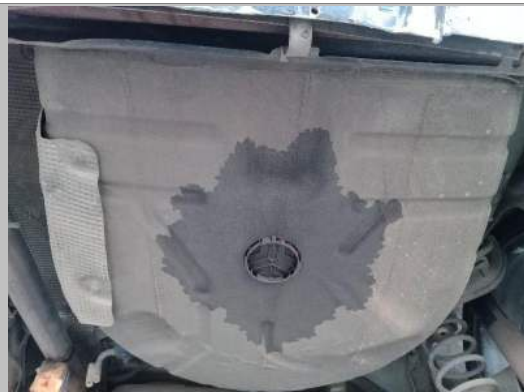
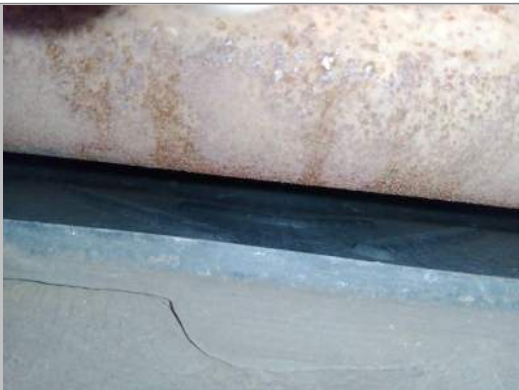
| Damage | Repair Way |
|---|---|
| Inner Boot Floor Pan and Spare Wheel Well Dented | Repair |

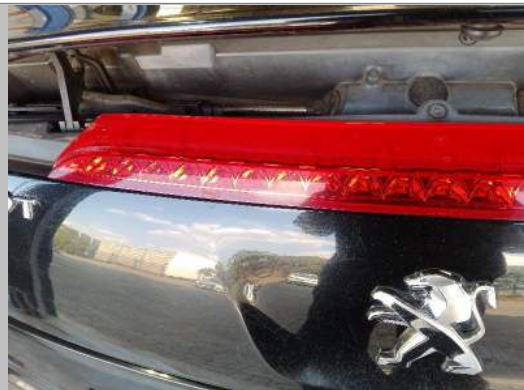
| Damage | Repair Way |
|---|---|
| Brake Light Centre Cracked | Replace |

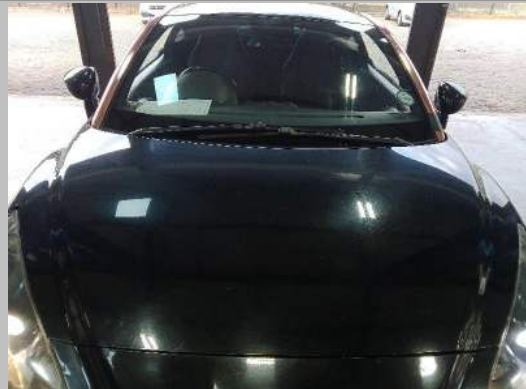
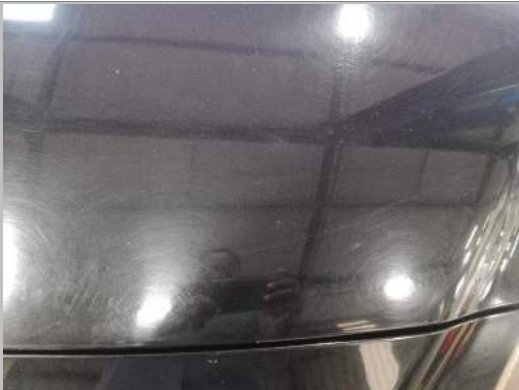
| Damage | Repair Way |
|---|---|
| Bonnet Paintwork • Scratched | Repair |

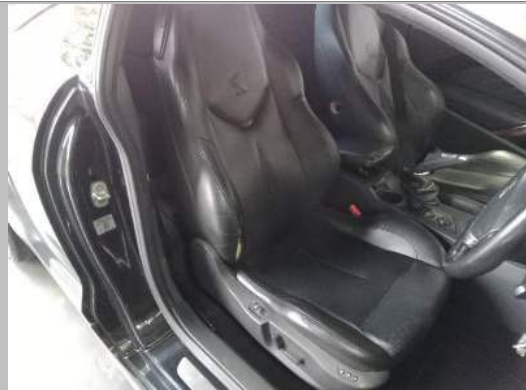
| Damage | Repair Way |
|---|---|
| Seat Front Right Damaged | Repair |

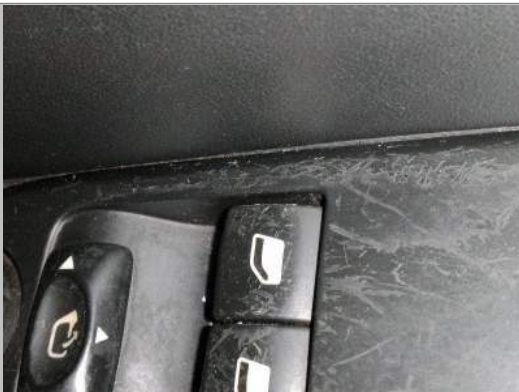
| Damage | Repair Way |
|---|---|
| Switch Electrical Window Winder front right Malfunction | Replace |
