## CONDITION REPORT

Report No: 2016476675

DATE  
01/08/2024

Vehicle Type	PASSENGER VEHICLE	Registered Owner	
Manufacturer	TOYOTA	Registration Number	FH31JSGP
Model	YARIS	Register Number	
VIN	VNKKL0D340A006115	Date Of First Licensing	
Engine Number		Last COR	
Doors	5	License Expiry Date	31/05/2021
Color	BLUE	Power / Displacement	
Year Model		Paint Finish	M - METALLIC
Km Reading	161,005 KM	Fuel	PETROL
Cab / Body Type	HATCHBACK	Transmission	MANUAL

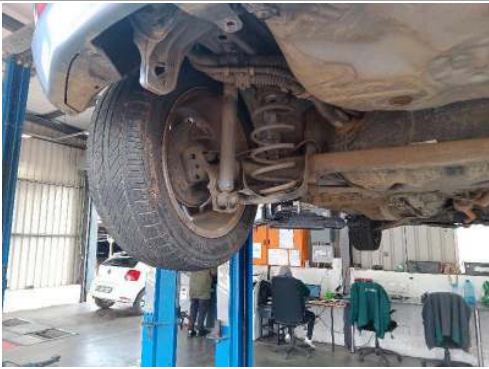
LR TYRE TREAD

Size	Load/Speed Index	Manufacture	Model	Type*	Production Date	Tread Depth (mm)
Front Left	195/50R15	82V	Dunlop	Sp sport	V	2220	4 mm
Front Right	195/50R15	82V	Dunlop	Sp sport	V	2520	4 mm
Rear Left	185/60R15	84H	Achilles	122	V	4817	3 mm
Rear Right	195/50R15	82V	Dunlop	Sp sport	V	2520	4 mm
Spare	T125/70D15	95M	Yokohama	Temporary	V	////	4 mm

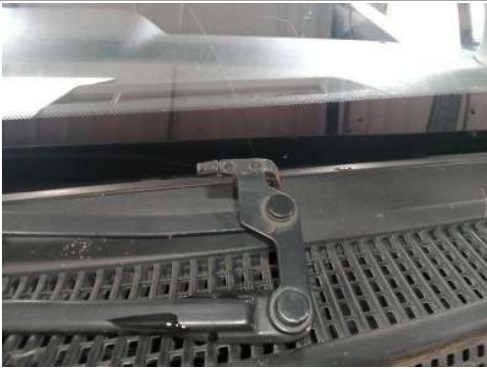
Damage	Repair Way
Engine Oil Leak	Repair
Windscreen Wiper Missing	Replace
Gear Lever Dust Boot Damaged	Repair
Front Bumper Paintwork • Overspray	Repair
Front Fender Left Paintwork • Scratched	Repair
Front Fender Right Paintwork • Pitmarks	Repair
Rear Fender Left Dented	Repair
Rear Fender Right Paintwork • Scratched	Repair
Door Front Left Dented	Repair
Door Front Right Paintwork • Pitmarks	Repair
Door Rear Left Paintwork • Scratched	Repair
Door Rear Right Paintwork • Scratched	Repair
Boot Lid / Hatch door Paintwork • Overspray	Repair
Rear bumper Paintwork • Scratched	Repair
Roof Paintwork • Pitmarks	Repair
Shock Absorber Rear Right Leak	Replace
Silencer Flange Defective	Repair
Antenna missing	Replace
