CONDITION REPORT

Report No: 2016240437

Vehicle Type	LIGHT LOAD VEHICLE	Registered Owner	MFC AUCTION HOUSE
Manufacturer	NISSAN	Registration Number	HTZ385MP
Model	NAVARA	Register Number	
VIN	VSKCVND40Z0564202	Date Of First Licensing	
Engine Number		Last COR	
Doors	4	License Expiry Date	30/09/2023
Color	WHITE	Power / Displacement	
Year Model		Paint Finish	TWO COAT UNI
Km Reading	241,942 KM	Fuel	DIESEL
Cab / Body Type	DOUBLE CAB	Transmission	AUTOMATIC

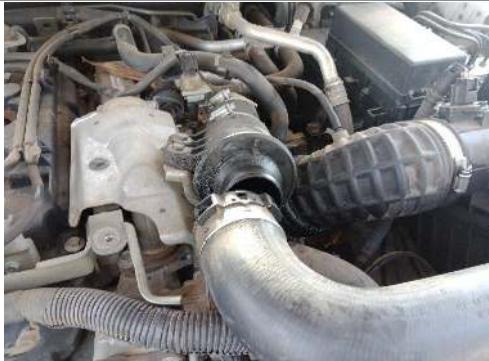
Damage	Repair Way
Engine Oil Sweat	Repair
Hoses Defective	Repair
Fan Belt Defective	Replace
Under bonnet insulation cover Damaged	Repair
Tail Light Left Broken	Replace
Seat Front Right Torn / Cut	Repair
Steering Wheel Trim Defective	Repair
Front Bumper Paintwork • Scratched	Repair
Bonnet Paintwork • Chipmarks	Repair
Front Fender Left Residual Traces of Repair	Repair
Front Fender Right Residual Traces of Repair	Repair
Rear Fender Left Residual Traces of Repair	Repair
Rear Fender Right Residual Traces of Repair	Repair
Door Front Left Paintwork • Chipmarks	Repair
Door Front Right Residual Traces of Repair	Repair
Door Rear Left Damaged	Repair
Door Rear Right Residual Traces of Repair	Repair
Tailgate Paintwork • Scratched	Repair
Rear bumper Paintwork • Scratched	Repair
Sill Panel Left Dented	Repair
Load Body Paintwork • Scratched	Repair
Windscreen Chipped	Replace
Brake disc 1. Axle left Defective	Replace
Brake disc 1. Axle right Defective	Replace

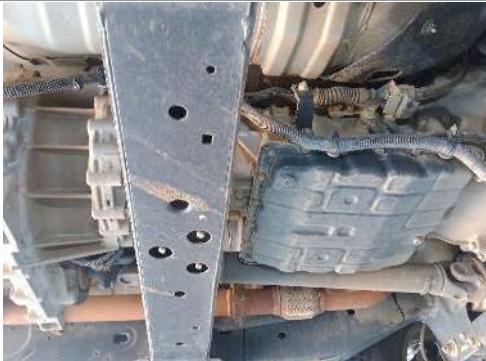
Stabilizer Mounting Front Left Defective	Repair
Engine to silencer pipe Defective	Repair
Gearbox Oil Sweat	Repair
Cab Mounting Point Rear Right Cracked	Replace
Brakes Noisy	Repair
