MFC Auction House  
M57 Pretoria Rd, Glenmarais, KEMPTON PARK  
Gauteng

| Manufacturer | OPEL | Registration Number | JH06PHGP |

## CONDITION REPORT

Report No: 2016713971

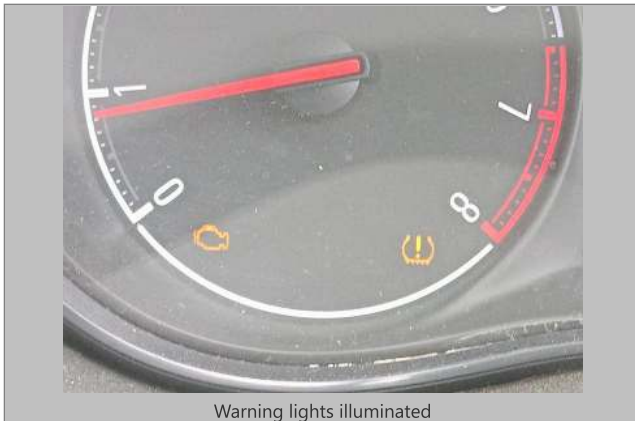
| Damage | Repair Way |
|---|---|
| Warning lights illuminated | Repair |

Warning lights illuminated

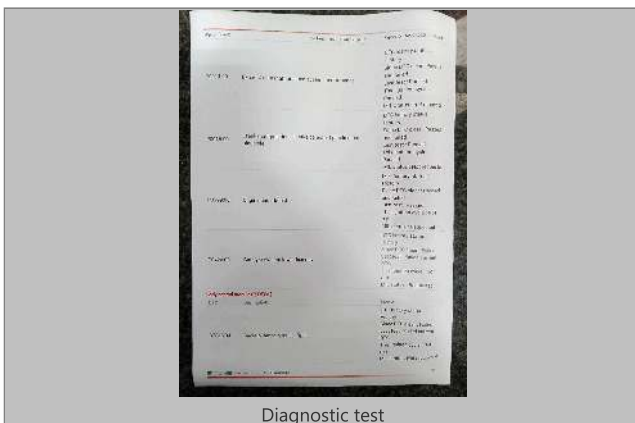
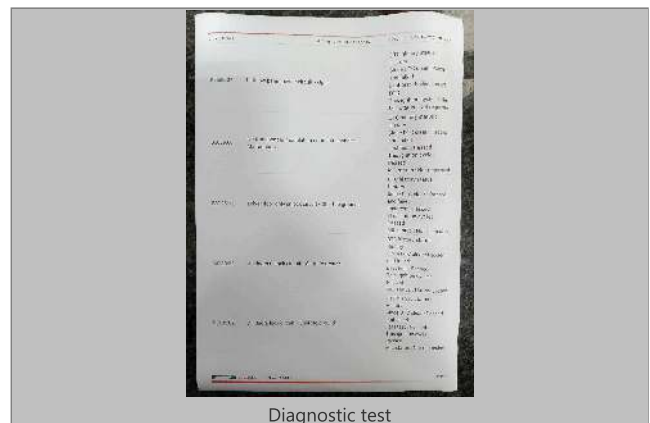
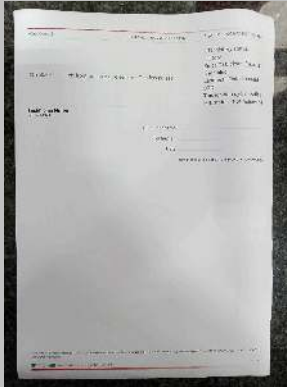
Diagnostic test

| No | System | Code | Description | Status |
|---|---|---|---|---|
| 1 | ENGINE CONTROL MODULE | P0011:00 | INTAKE CAMSHAFT POSITION SYSTEM PERFORMANCE | |

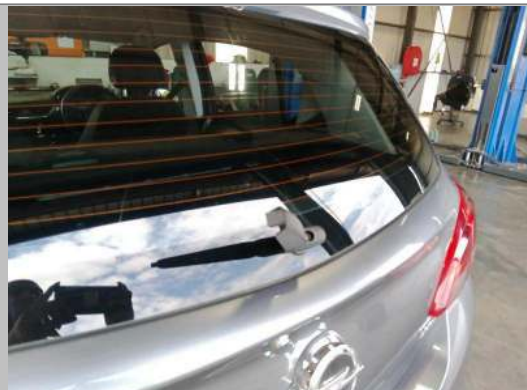
| Damage | Repair Way |
|---|---|
| Windscreen Wiper Missing | Replace |

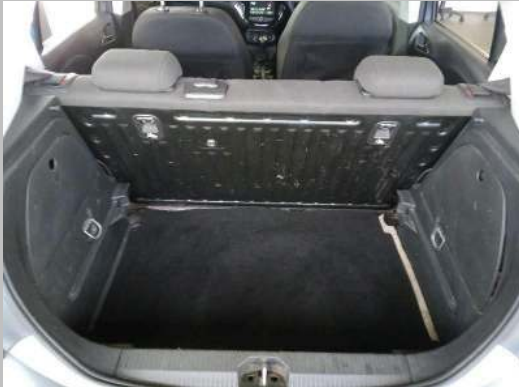
| Damage | Repair Way |
|---|---|
| Parcel Tray Missing | Replace |

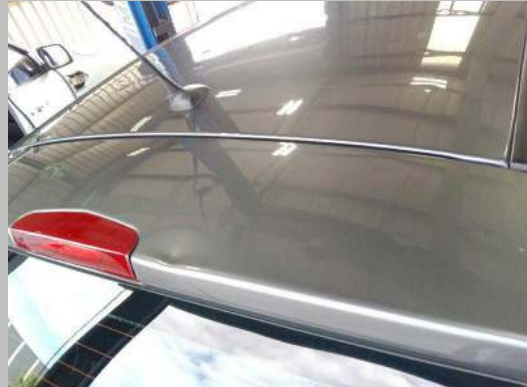
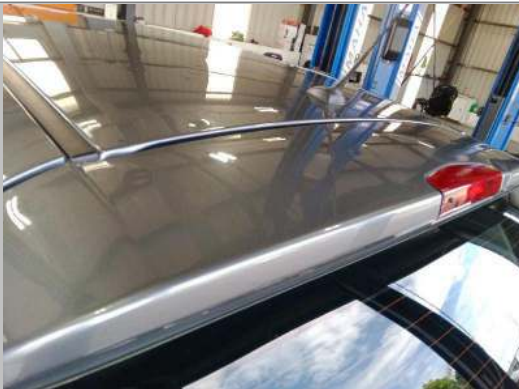
| Damage | Repair Way |
|---|---|
| Boot Lid / Hatch door Dented | Repair |

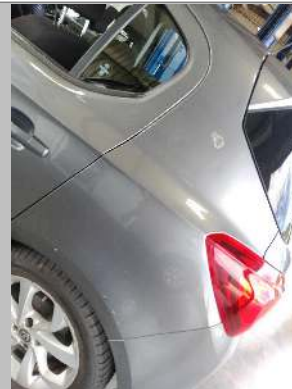
| Damage | Repair Way |
|---|---|
| Rear Fender Left Dented | Repair |

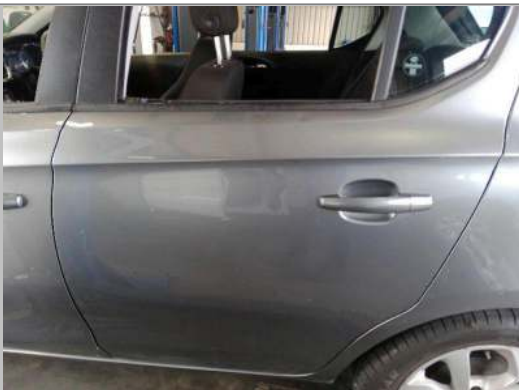
| Damage | Repair Way |
|---|---|
| Door Rear Left Dented | Repair |

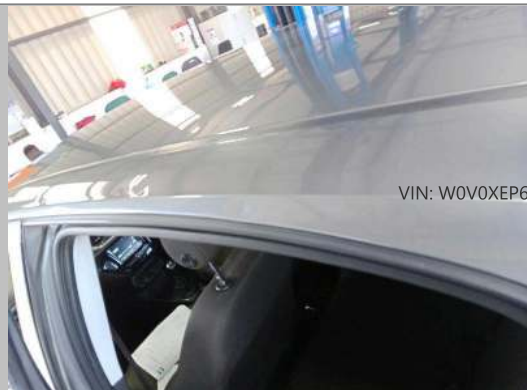
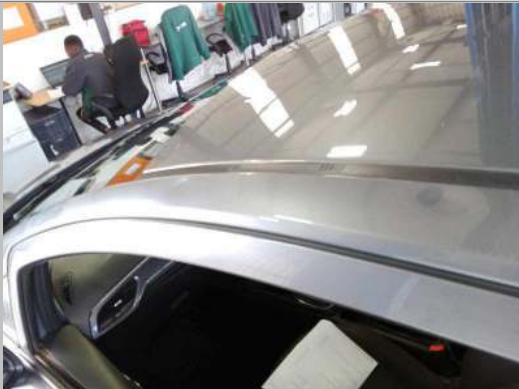
| Damage | Repair Way |
|---|---|
| A • Pillar Left Dented | Repair |

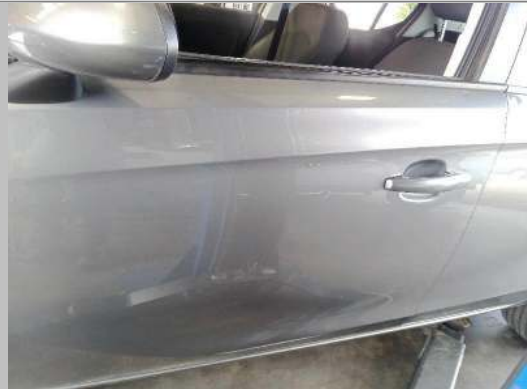
| Damage | Repair Way |
|---|---|
| Door Front Left Dented | Repair |

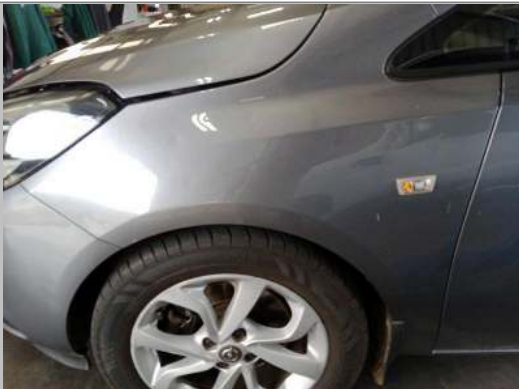
| Damage | Repair Way |
|---|---|
| Front Fender Left Dented | Repair |

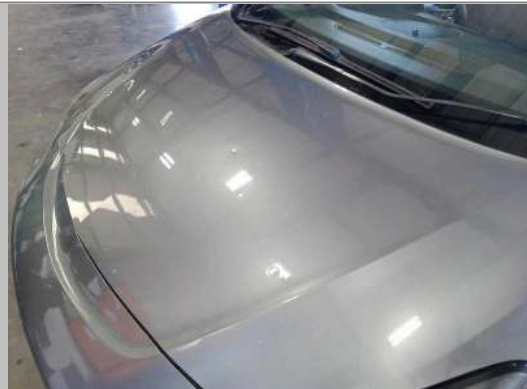
| Damage | Repair Way |
|---|---|
| Bonnet Dented | Repair |

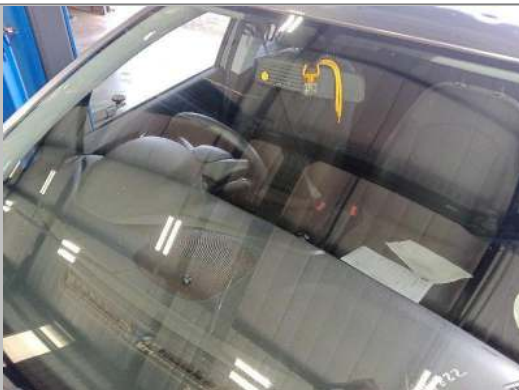
| Damage | Repair Way |
|---|---|
| Windscreen Cracked | Replace |

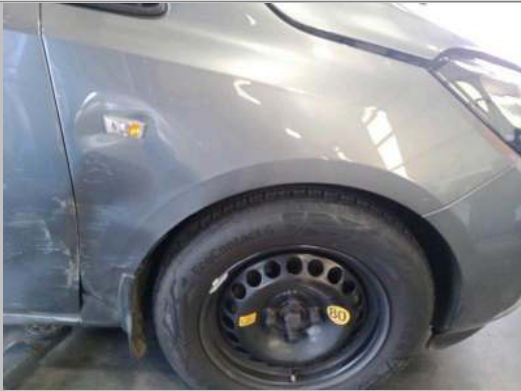
| Damage | Repair Way |
|---|---|
| Front Fender Right Damaged | Repair |

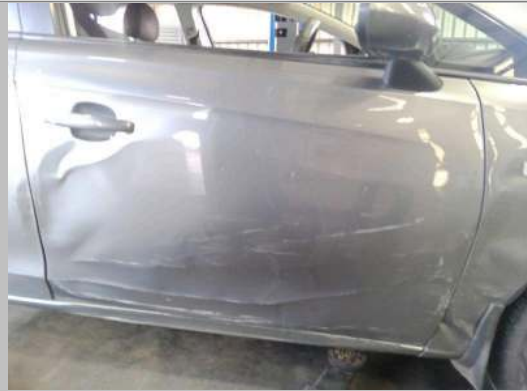
| Damage | Repair Way |
|---|---|
| Door Front Right Damaged | Repair |

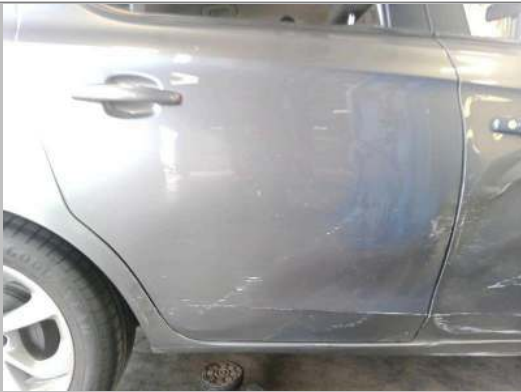
| Damage | Repair Way |
|---|---|
| Door Rear Right Damaged | Repair |

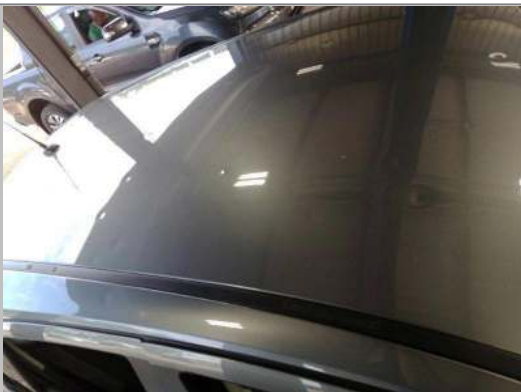
| Damage | Repair Way |
|---|---|
| Roof Dented | Repair |

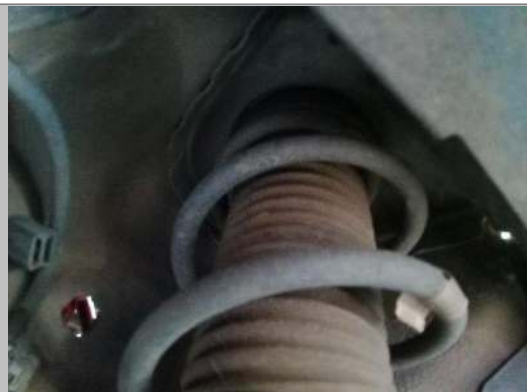
| Damage | Repair Way |
|---|---|
| Shock Absorber Mounting Front Right Loose / Excessive Play | Replace |

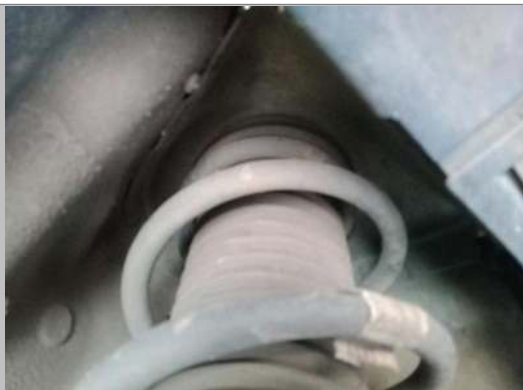
| Damage | Repair Way |
|---|---|
| Shock Absorber Mounting Front Left Loose / Excessive Play | Replace |

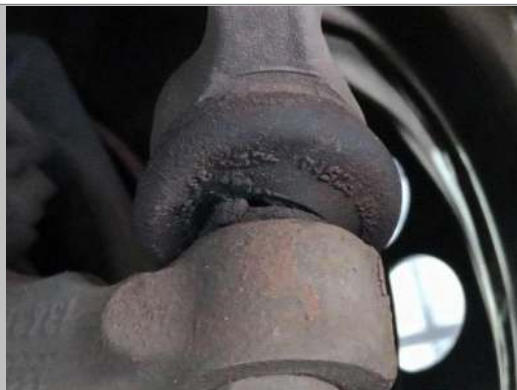
| Damage | Repair Way |
|---|---|
| Tie Rod End right Damaged | Replace |
