CONDITION REPORT

Report No: 2016368756

Vehicle Type	PASSENGER VEHICLE	Registered Owner	MFC AUCTION HOUSE
Manufacturer	AUDI	Registration Number	CF13GRGP
Model	A4	Register Number	
VIN	WAUZZZ8K6DA124505	Date Of First Licensing	
Engine Number		Last COR	
Doors	5	License Expiry Date	29/02/2024
Color	SILVER	Power / Displacement	
Year Model		Paint Finish	TWO COAT UNI
Km Reading	363,920 KM	Fuel	DIESEL
Cab / Body Type	SEDAN	Transmission	AUTOMATIC

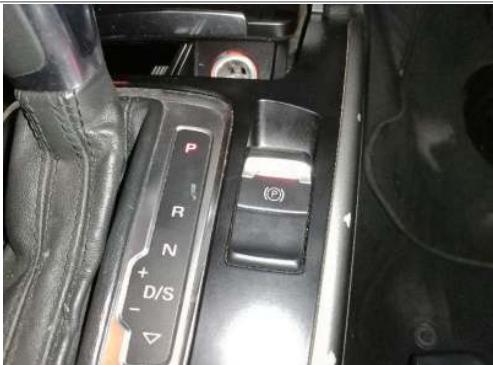
Electronic parking brake swtch

Damage	Repair Way
Windscreen Chipped	Repair
Caliper 1. Axle right Leak	Repair
Brake disc 2. Axle right Defective	Replace
Parking Brake Performance Left / Right Difference out of legal range	Repair
Control Arm Bush(es) Front Axle Left Cracked	Replace
Control Arm Bush(es) Front Axle Right Cracked	Replace
Ball Joint(s) Front Axle Right Defective	Replace
Tyre Front Left Worn	Replace
Tyre Rear Left Defective	Replace
Rim Front Left Scratched	Repair
Rim Front Right Scratched	Repair
Rim Rear Left Scratched	Repair
Rim Rear Right Scratched	Repair
Belly plates Damaged	Repair
Gearbox Mountings Defective	Repair
CV Joint(s) Boot(s) Front Left (inner/outer) Damaged	Replace
Triangle Missing	Replace
Electrical instruments and components	Vehicle electronics malfunctioning
Engine	Engine bay dirty and rust inside expansion bottle
Electrical instruments and components	Electronic parking brake switch malfunctioning
Electrical instruments and components	Oil measuring instrument faulty

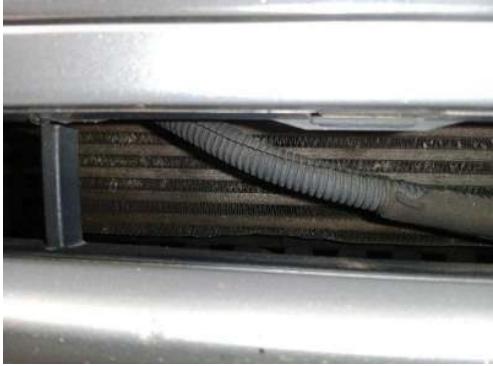
Engine	Oil cooler dented
Undercarriage	Signs of oil leak on engine splash plate
Undercarriage	Bottom of engine and gearbox fully covered
Undercarriage	Cannot pin direction of oil leak
Undercarriage	Vehicle undercarriage dirty
Brakes	Front right brake disk dust plate damaged
Interior	Vehicle interior dirty and some panels scratched
Body and Exterior	Dents and scratches on some body panels
Body and Exterior	Stone chips and spray work on some body panels
Interior	Front left bottom seat adjuster handle damaged

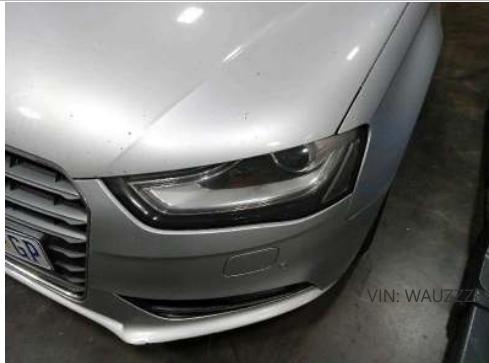
Damage	Repair Way
Engine Oil Leak	Repair
Hoses Oil Sweat	Repair
Center Console / Cubbyhole + Lid Damaged	Repair
Switch Electrical Window Winder front left Malfunction	Replace
Indicator Light Front Left Defective	Repair
Headlight Left Defective	Repair
Headlight Right Defective	Repair
Seat Front Right Damaged	Repair
Interior Mirror Missing	Replace
Sun Visor Right Broken	Replace
Door Handle Front Left Defective	Replace
Door Handle Front Right Defective	Repair
Door Handle Rear Right Defective	Repair
Door Sealing Rubber Front Right Damaged	Replace
Steering Wheel Trim Defective	Repair
Number Plate Front Dented	Repair
Side Mirror Left Paintwork • Scratched	Repair
Side Mirror Right Residual Traces of Repair	Repair
Front Bumper Damaged	Repair
Bonnet Damaged	Repair
Front Fender Left Paintwork • Scratched	Repair
Front Fender Right Paintwork • Scratched	Repair
Rear Fender Left Dented	Repair
Rear Fender Right Damaged	Repair
Door Front Left Paintwork • Scratched	Repair

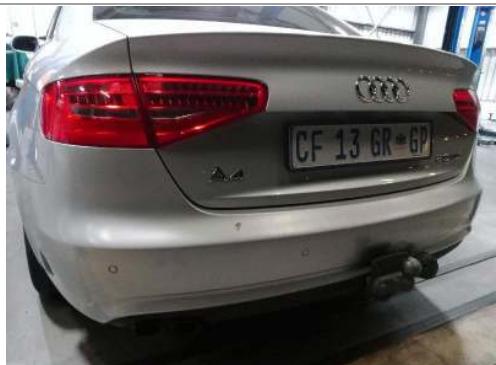
Door Front Right Paintwork • Scratched	Repair
Door Rear Right Dented	Repair
Boot Lid / Hatch door Paintwork • Scratched	Repair
Rear bumper Damaged	Repair
