MFC Auction House
M57 Pretoria Rd, Glenmarais, KEMPTON PARK
Gauteng

DEKRA MFC
M57 Pretoria Rd - 1619
KEMPTON PARK - GT
08610 33572

CONDITION REPORT

Report No: 2016346670

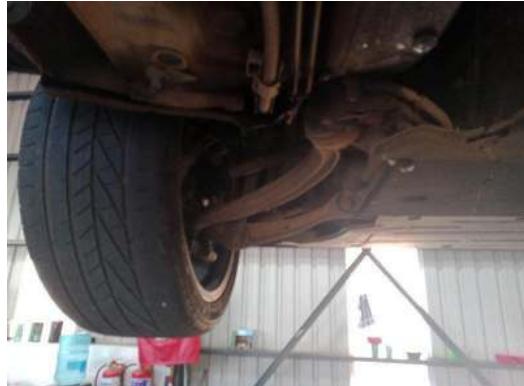
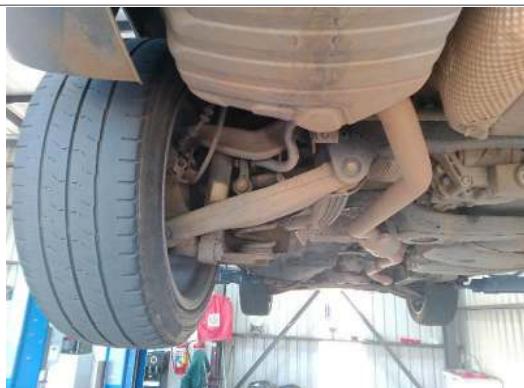
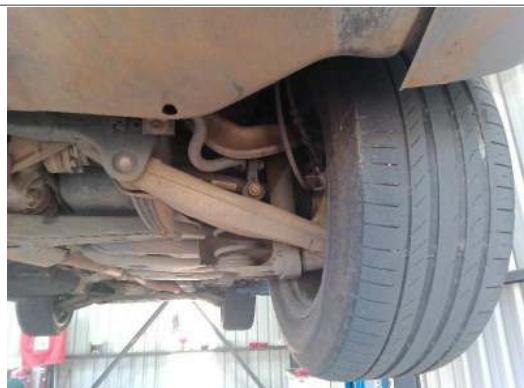
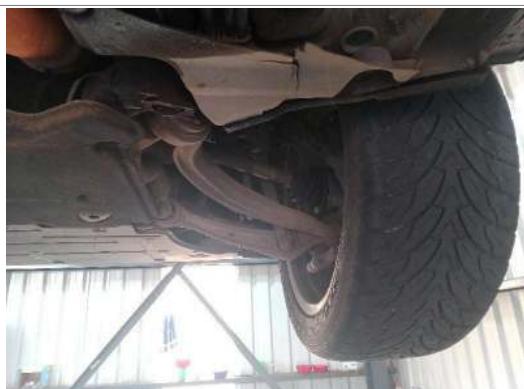
Size	Load/Speed Index	Manufacture	Model	Type*	Production Date	Tread Depth (mm)
Front Left	275/35R20	102Y	Goodyear	Excellence	V	4920	0 mm
Front Right	275/40R20	106W	Federal	Radial	V	4810	0 mm
Rear Left	245/45R20	115R	Kumho	Radial	V	4420	0 mm
Rear Right	255/55R18	109V	Continental	Contisport	V	4214	0 mm

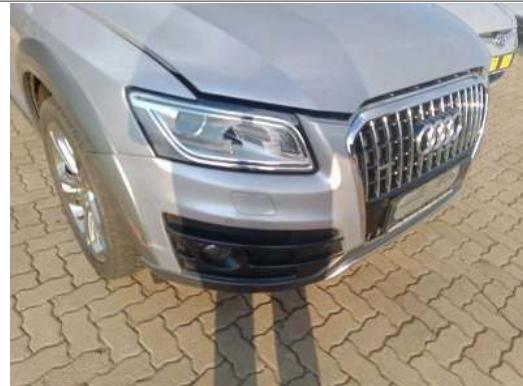
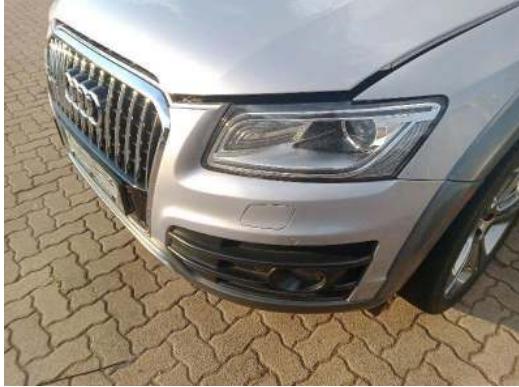
Damage	Repair Way
Central Air Vent Damaged	Repair
Carpet Front Damaged	Repair
Side Mirror Left Damaged	Repair
Side Mirror Right Damaged	Replace
Front Bumper Damaged	Repair
Bonnet Damaged	Repair
Front Fender Left Damaged	Repair
Front Fender Right Damaged	Repair
Door Front Left Damaged	Repair
Door Front Right Damaged	Repair
Door Rear Left Damaged	Repair
Rear bumper Damaged	Repair
Shock Absorber Rear Right Leak	Replace
Tyre Front Left Worn	Replace
Tyre Front Right Worn	Replace
Some interior panels damaged	Replace
Some interior panels missing	Replace
Engine management lights illuminated	Repair
Electronic handbrake malfunctioning	Repair
