## CONDITION REPORT

Report No:  
2016960881  
DATE  
28/07/2025

| Manufacturer | AUDI | Registration Number | KT09DBGP |
| Model | S3 SEDAN 2.0T FSI QUATTRO S TRONIC [2014-2014] | Register Number | |

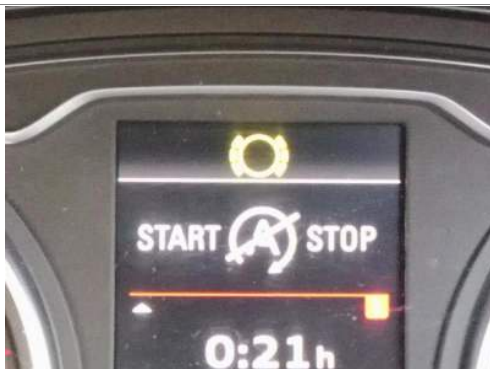
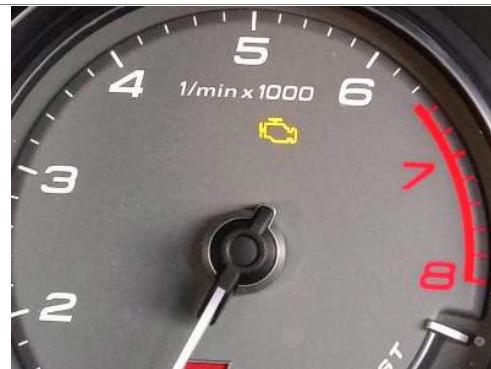
| Damage | Repair Way |
|---|---|
| Warning lights illuminated | Repair |

| No | System | Code | Description | Status |
|---|---|---|---|---|
| 1 | ENGINE CONTROL MODULE | P268100 | INTAKE MANIFOLD RUNNER BANK 1 CONTROL CIRCUIT OPEN | |

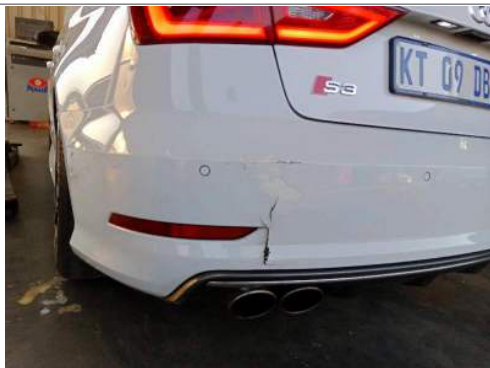
| Damage | Repair Way |
|---|---|
| Rear bumper Damaged | Repair |

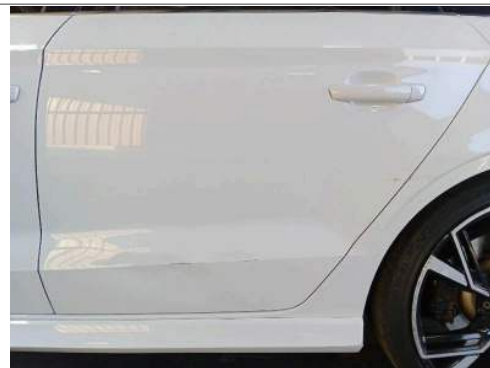
| Damage | Repair Way |
|---|---|
| Door Rear Left Damaged | Repair |

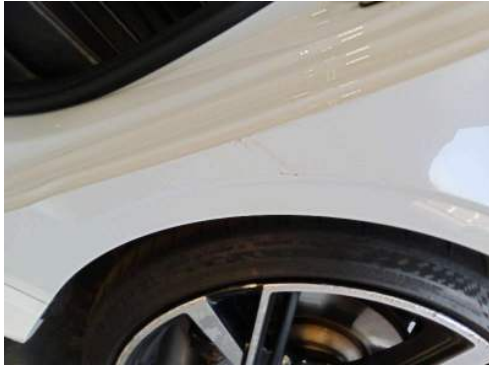
| Damage | Repair Way |
|---|---|
| C • Pillar Left Damaged | Repair |

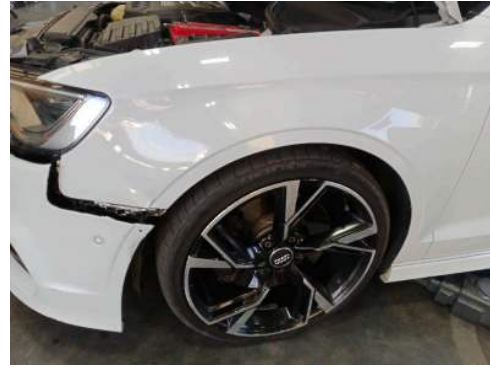
| Damage | Repair Way |
|---|---|
| Front Fender Left Dented | Repair |

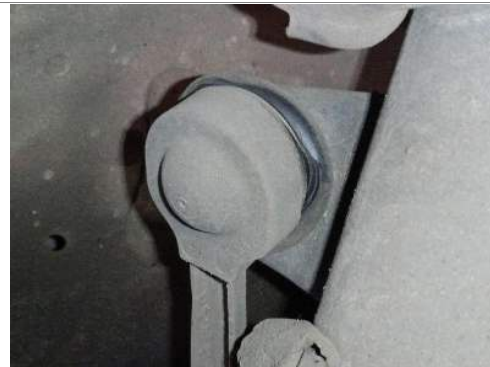
| Damage | Repair Way |
|---|---|
| Stabilizer Mounting Front Right Damaged | Replace |

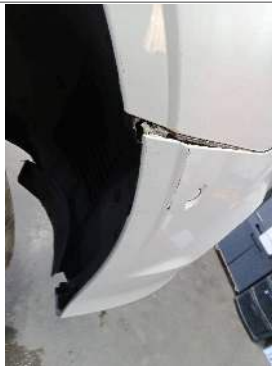
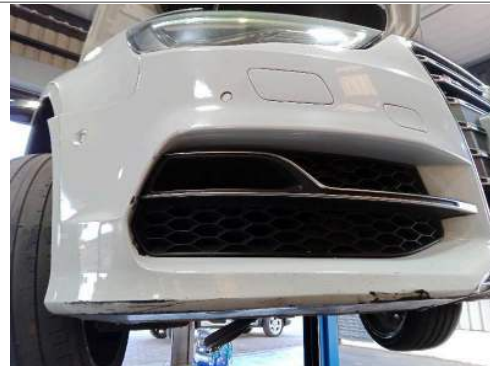
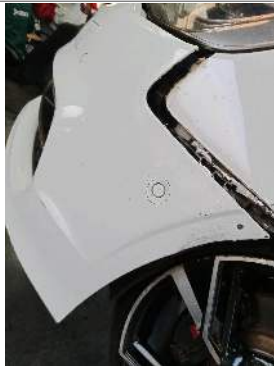
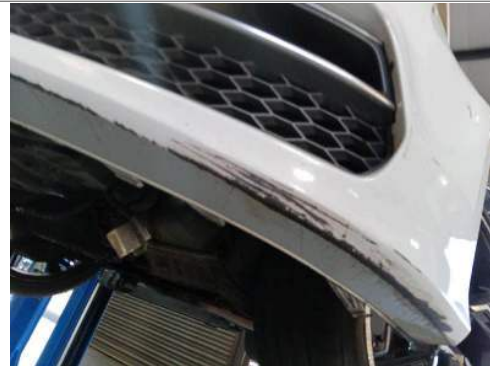
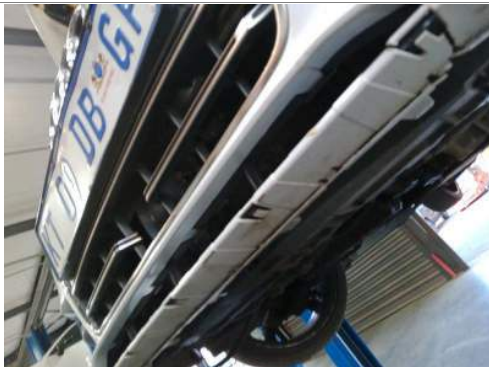
| Damage | Repair Way |
|---|---|
| Front Bumper Damaged | Repair |

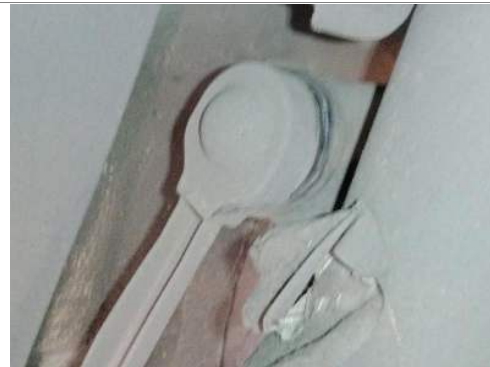
| Damage | Repair Way |
|---|---|
| Stabilizer Mounting Front Left Damaged | Replace |

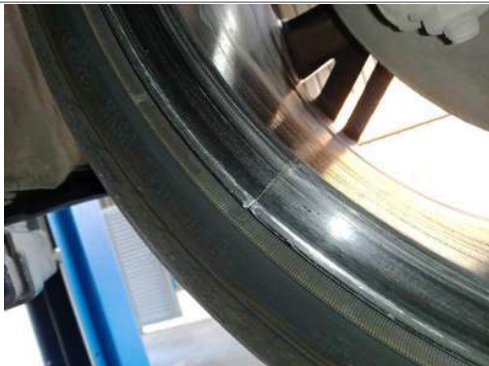
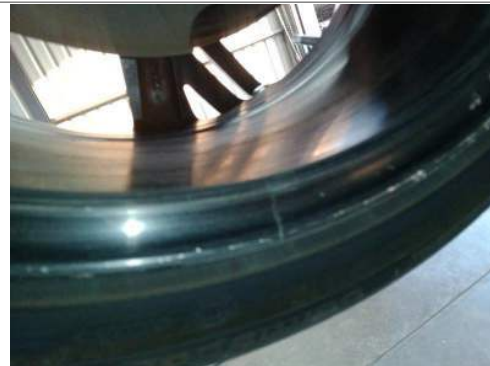
| Damage | Repair Way |
|---|---|
| Rim Front Left Cracked | Replace |

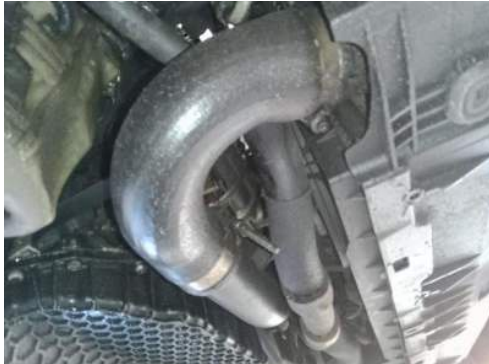
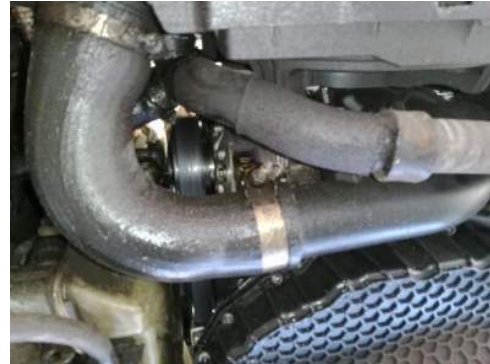
| Damage | Repair Way |
|---|---|
| Hoses Oil Leak | Repair |

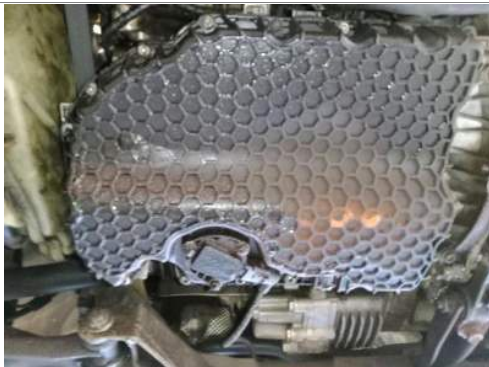
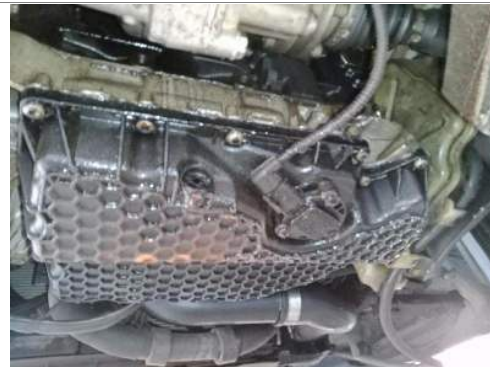
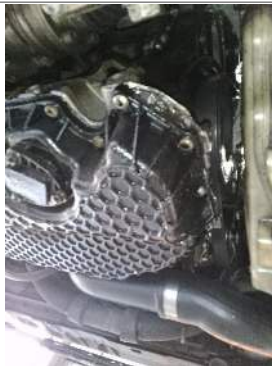
| Damage | Repair Way |
|---|---|
| Engine Oil Leak | Repair |

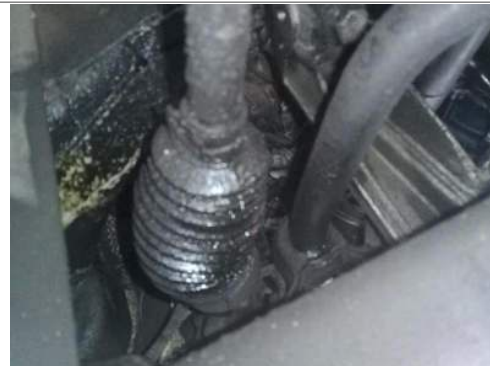
| Damage | Repair Way |
|---|---|
| Steering Rack Boot Right Leak | Repair |

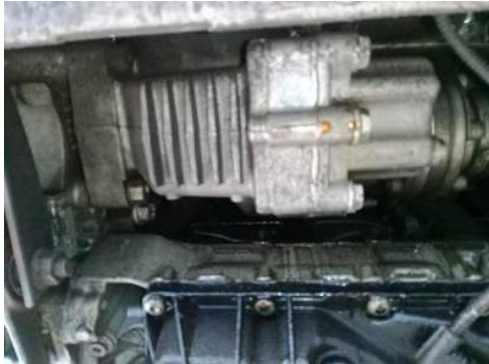
| Damage | Repair Way |
|---|---|
| Differential Oil Leak | Repair |

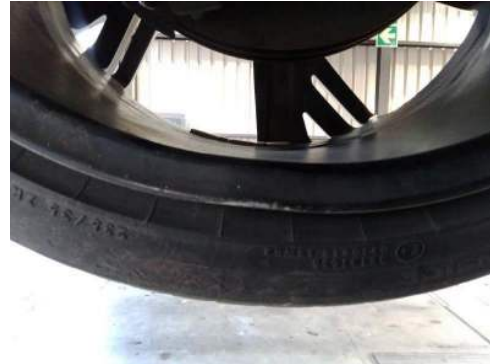
| Damage | Repair Way |
|---|---|
| Rim Rear Left Dented | Repair |

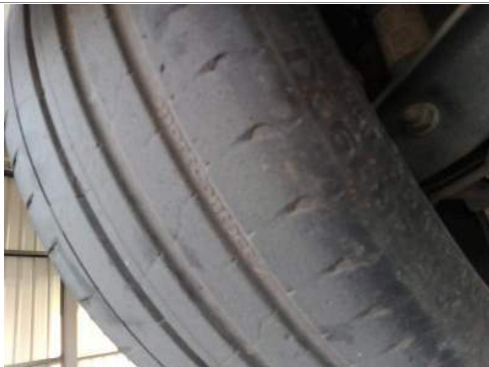
| Damage | Repair Way |
|---|---|
| Tyre Rear Left Smooth | Replace |

| | Size | Load/Speed Index | Manufacture | Model | Type* | Production Date | Tread Depth (mm) |
|---|---|---|---|---|---|---|---|
| Rear Left | 235/35R19 | 91Y | Continental | Contact | V | 2222 | 0 mm |

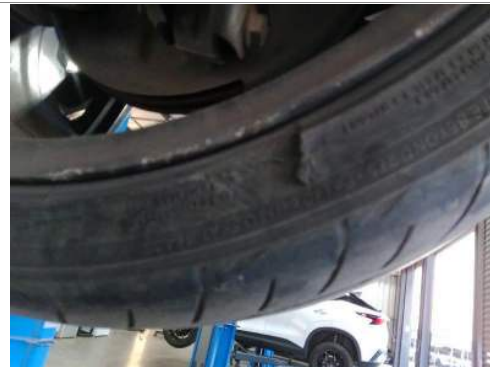
| Damage | Repair Way |
|---|---|
| Tyre Rear Right Excessive Wear & Tear | Replace |

| | Size | Load/Speed Index | Manufacture | Model | Type* | Production Date | Tread Depth (mm) |
|---|---|---|---|---|---|---|---|
| Rear Right | 235/35R19 | 91W | Yokohama | Advance | V | 0000 | 2 mm |

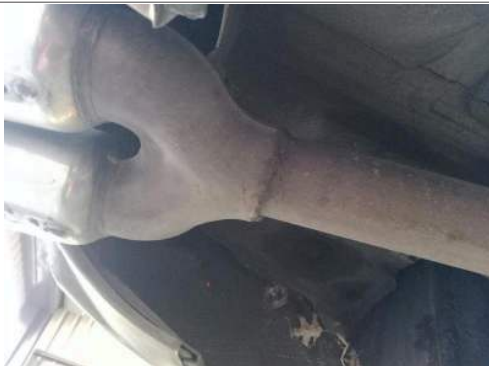
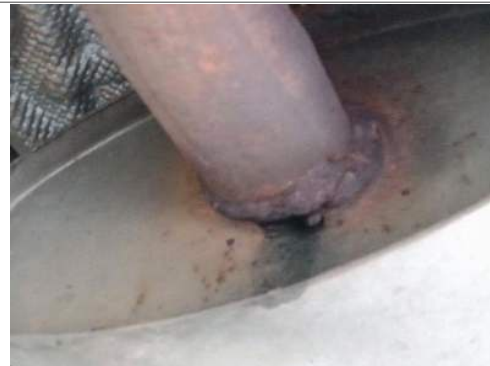
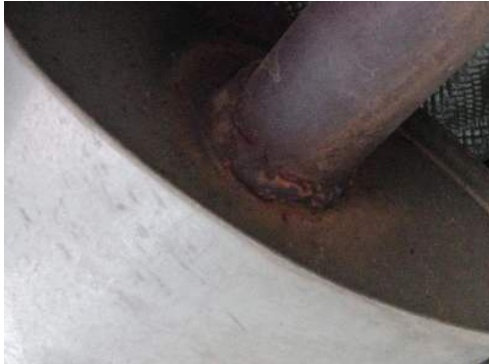
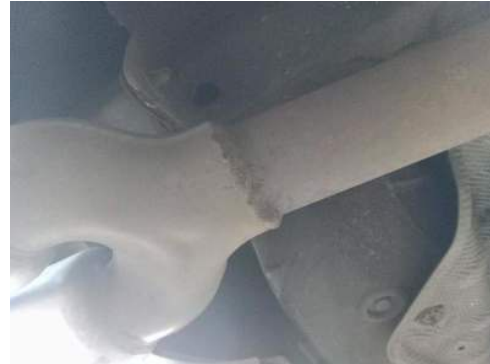
| Damage | Repair Way |
|---|---|
| Engine to silencer pipe Welded | Replace |

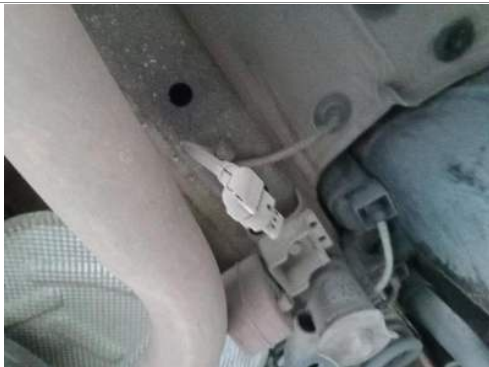
| Damage | Repair Way |
|---|---|
| Engine Wiring Damaged | Repair |
