## CONDITION REPORT

Report No:  
2016957012  
DATE  
24/07/2025

| Manufacturer | AUDI | Registration Number | DV39TLGP |
| Model | A3 SPORTBACK 1.4T FSI S 5-DR [2014-2017] | Register Number | |

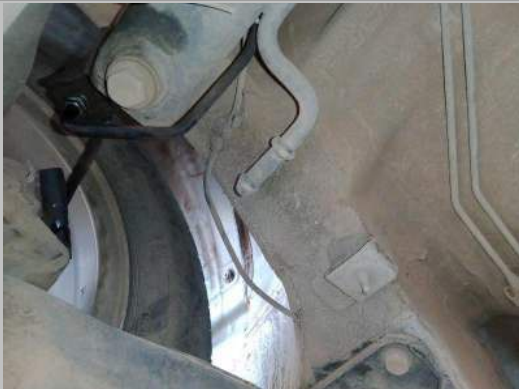
| Damage | Repair Way |
|---|---|
| Brakes | Front left brake wear sensor damaged |

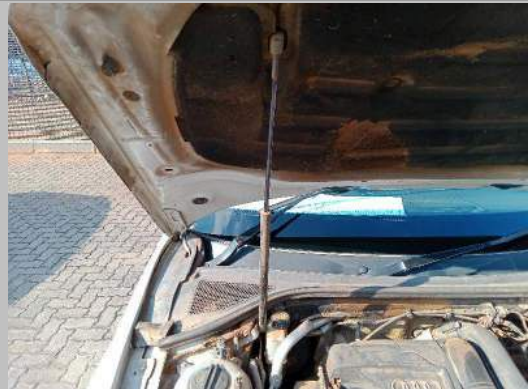
| Damage | Repair Way |
|---|---|
| Bonnet cable Defective | Repair |

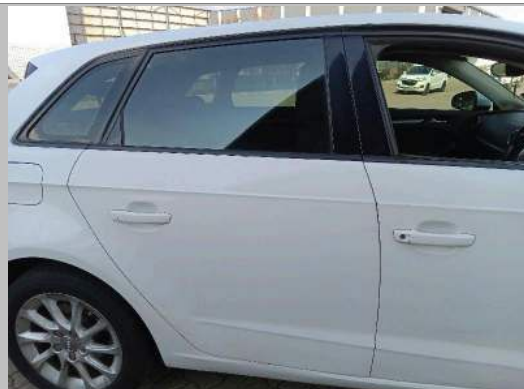
| Damage | Repair Way |
|---|---|
| Door Front Right Residual Traces of Repair | Repair |

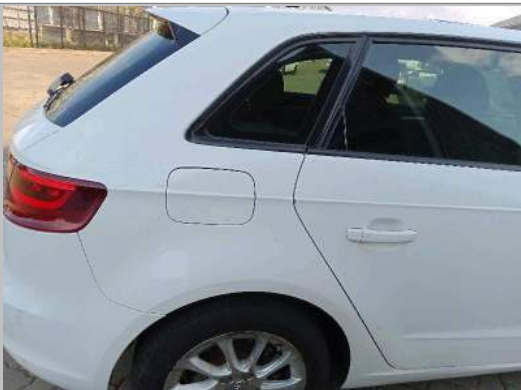
| Damage | Repair Way |
|---|---|
| Door Rear Right Residual Traces of Repair | Repair |

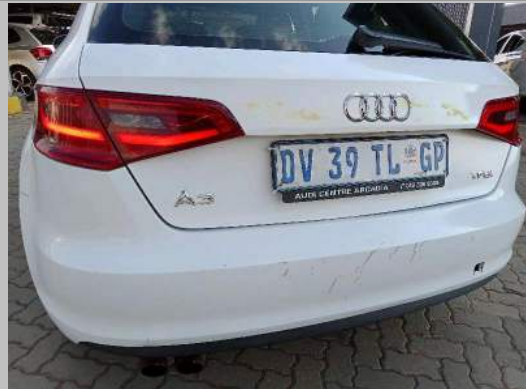
| Damage | Repair Way |
|---|---|
| Rear bumper Damaged | Repair |

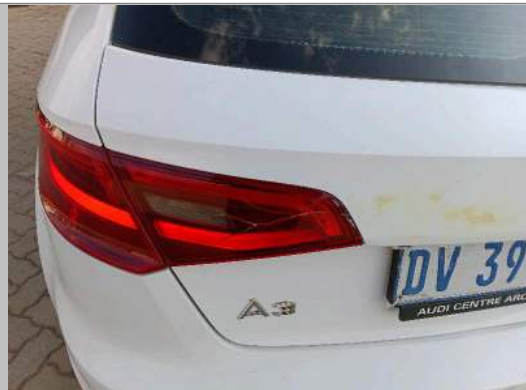
| Damage | Repair Way |
|---|---|
| Tail Light Right Broken | Replace |

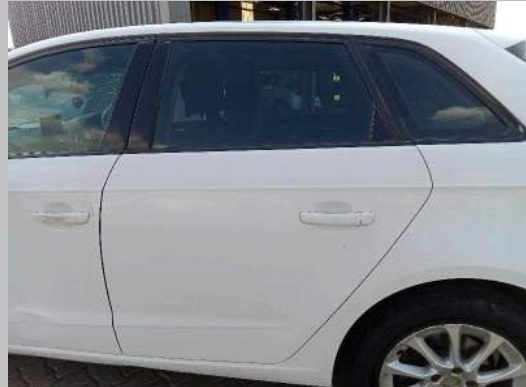
| Damage | Repair Way |
|---|---|
| Rear Fender Left Residual Traces of Repair | Repair |

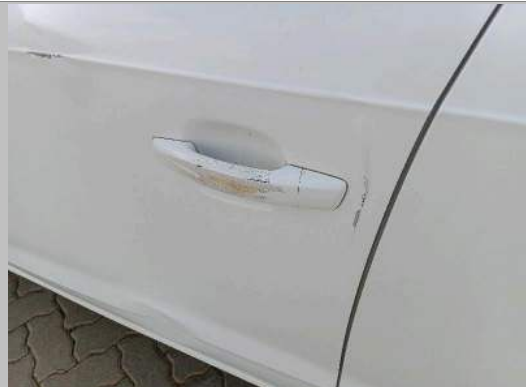
| Damage | Repair Way |
|---|---|
| Door Front Left Damaged | Repair |

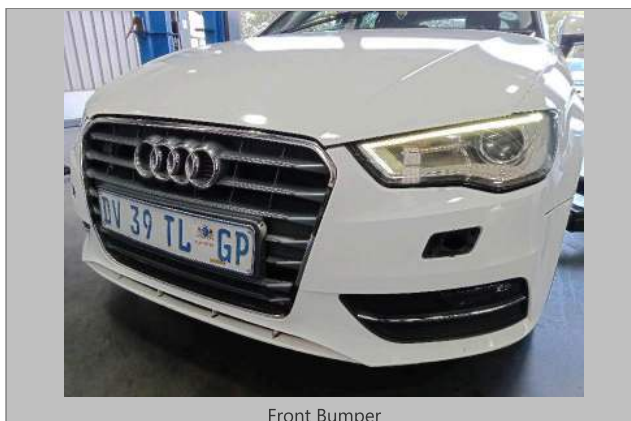
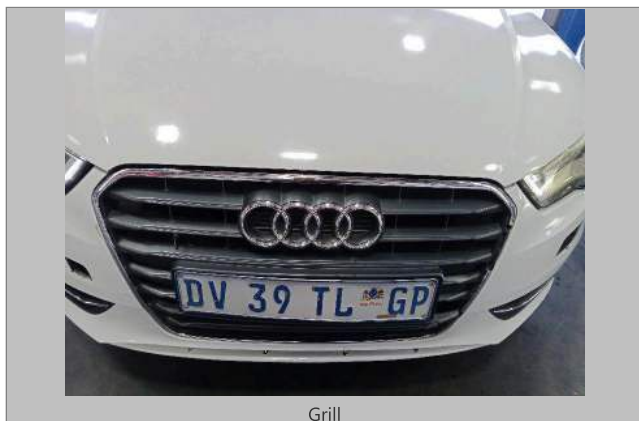
| Damage | Repair Way |
|---|---|
| Front Bumper Damaged | Repair |

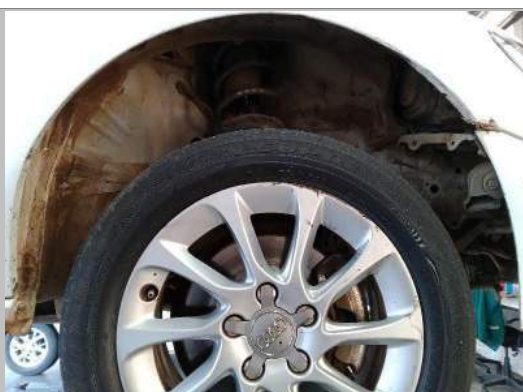
| Damage | Repair Way |
|---|---|
| Rim Front Right Scratched | Repair |

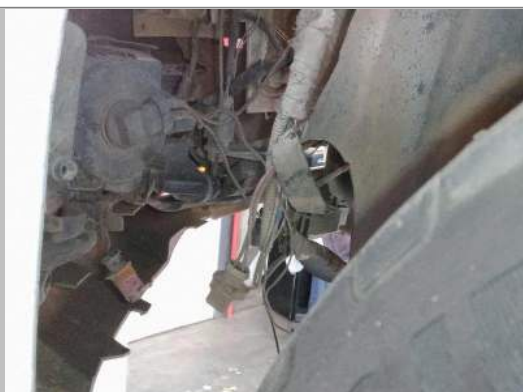
| Damage | Repair Way |
|---|---|
| Control Arm Bush(es) Front Axle Right Cracked | Replace |

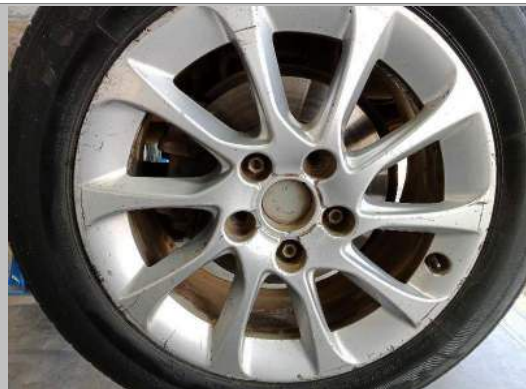
| Damage | Repair Way |
|---|---|
| Rim Rear Left Scratched | Repair |

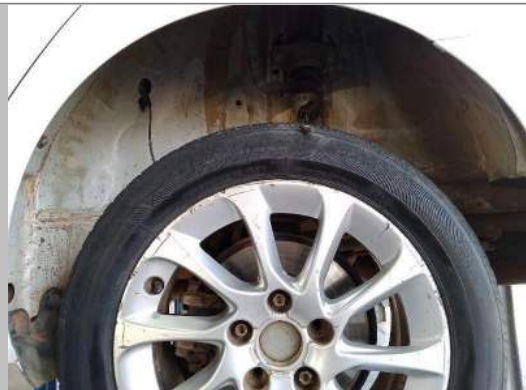
| Damage | Repair Way |
|---|---|
| Tyre Rear Left Damaged | Replace |

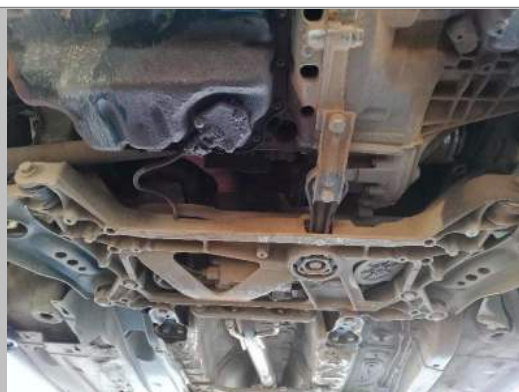
| Damage | Repair Way |
|---|---|
| Gearbox Oil Leak | Repair |

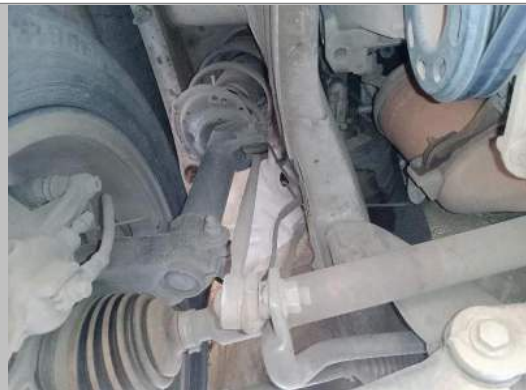
| Damage | Repair Way |
|---|---|
| Stabilizer Mounting Front Left Damaged | Replace |

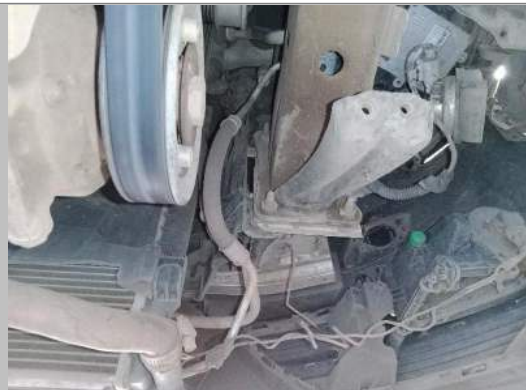
| Damage | Repair Way |
|---|---|
| Hoses Defective | Replace |

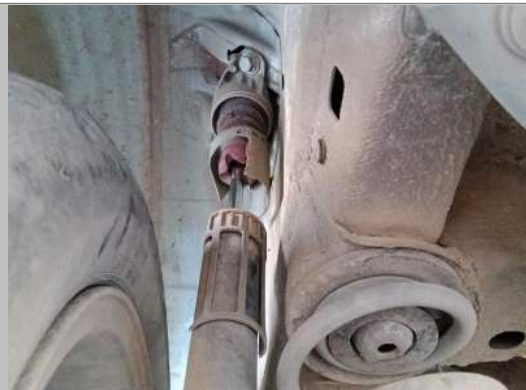
| Damage | Repair Way |
|---|---|
| Tyre Rear Right Damaged | Replace |
