## CONDITION REPORT

Report No:  
2017304202  
DATE  
28/09/2026

| Manufacturer | BMW | Registration Number | LG66DXGP |
| Model | 118I HATCH 5-DR AT [2011-2016] | Register Number | |

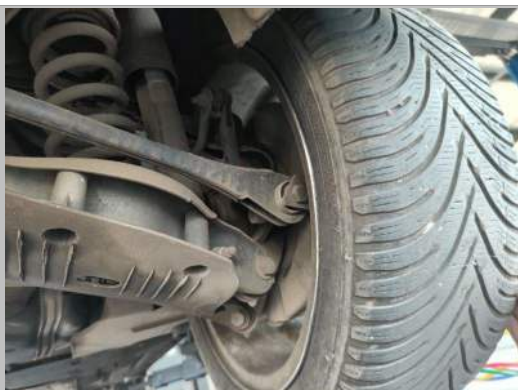
RR TYRE TREAD

| | Size | Load/Speed Index | Manufacture | Model | Type* | Production Date | Tread Depth (mm) |
|---|---|---|---|---|---|---|---|
| Rear Right | 225/45R17 | 94H | Kleber | Krisalp | V | 3819 | 1 mm |

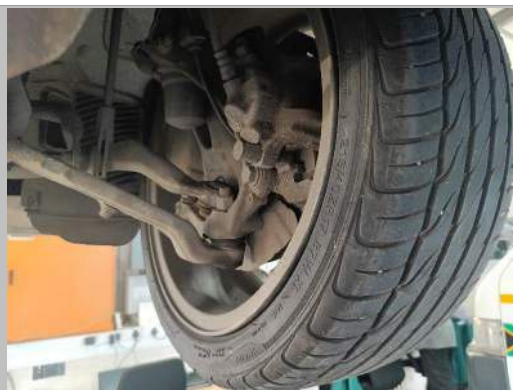
RF TYRE TREAD

| | Size | Load/Speed Index | Manufacture | Model | Type* | Production Date | Tread Depth (mm) |
|---|---|---|---|---|---|---|---|
| Front Left | 215/40R17 | 87W | Continental | Contact | V | 0123 | 2 mm |

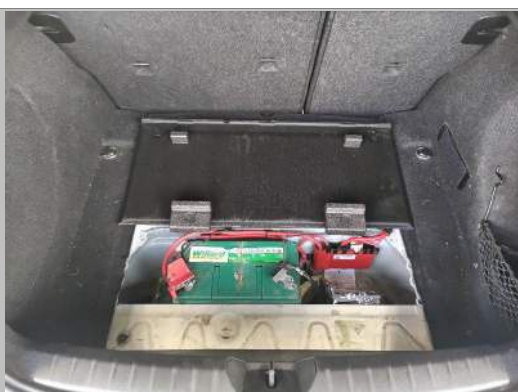
No sparewheel

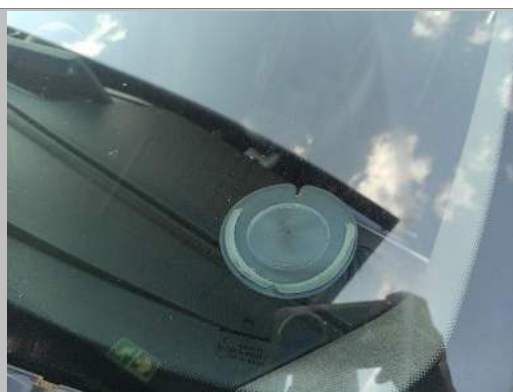
No license disc

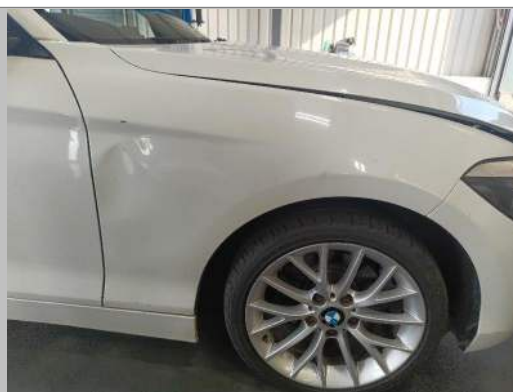
| Damage | Repair Way |
|---|---|
| Front Fender Right Dented | Repair |

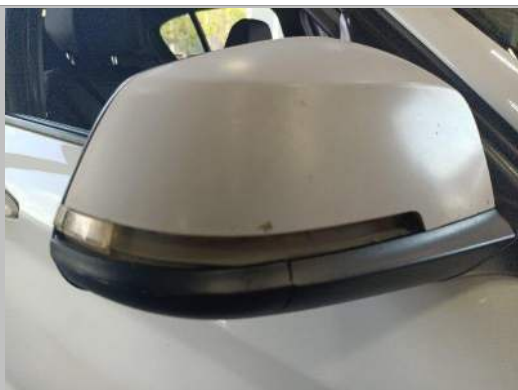
| Damage | Repair Way |
|---|---|
| Indicator Light Front Right Missing | Replace |

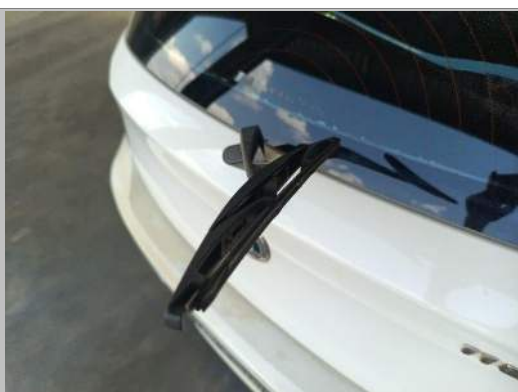
| Damage | Repair Way |
|---|---|
| Windscreen Wiper Worn | Replace |

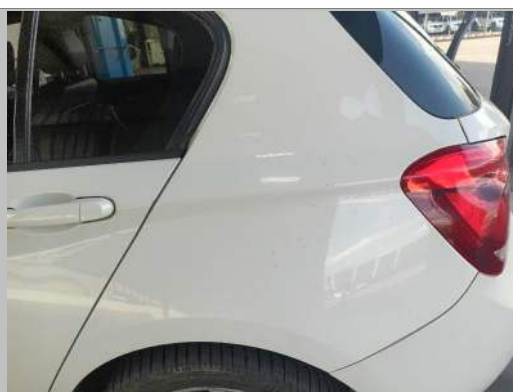
| Damage | Repair Way |
|---|---|
| Rear Fender Left Paintwork • Chipmarks | Repair |

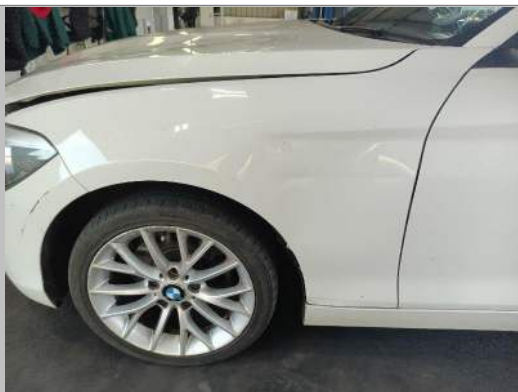
| Damage | Repair Way |
|---|---|
| Front Fender Left Dented | Repair |

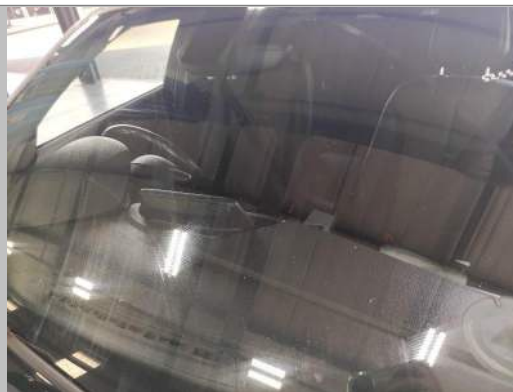
| Damage | Repair Way |
|---|---|
| Windscreen Chipped | Replace |

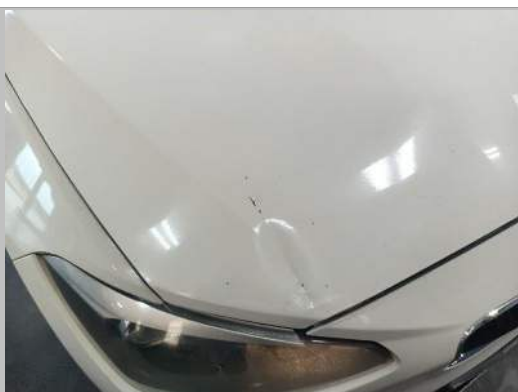
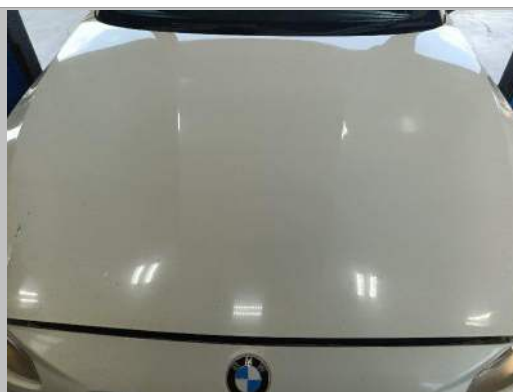
| Damage | Repair Way |
|---|---|
| Bonnet Dented | Repair |
| Bonnet does not close | Report |

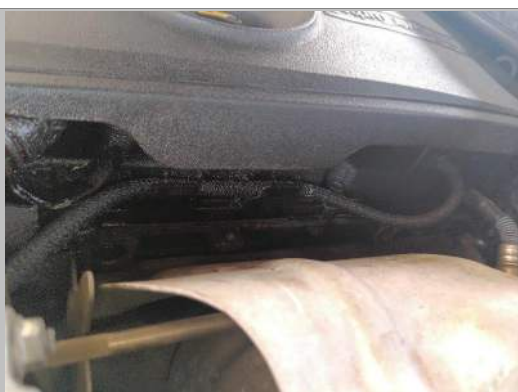
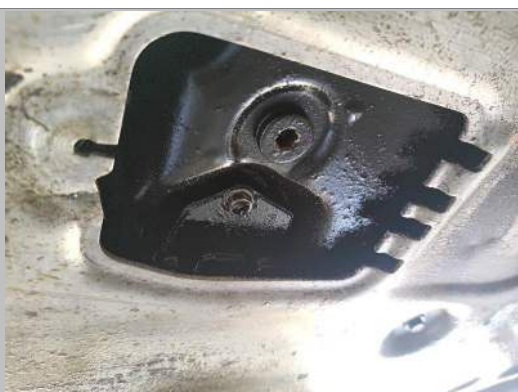
| Damage | Repair Way |
|---|---|
| Engine Oil Leak | Repair |

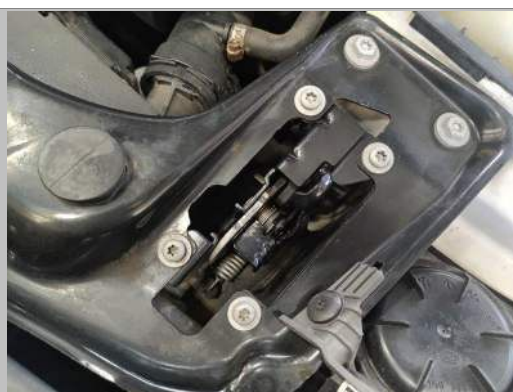
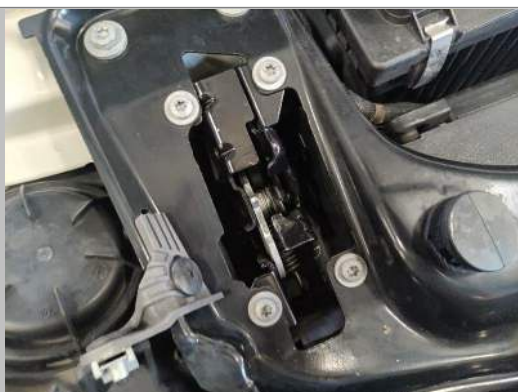
| Damage | Repair Way |
|---|---|
| Bonnet safety caps Damaged | Replace |

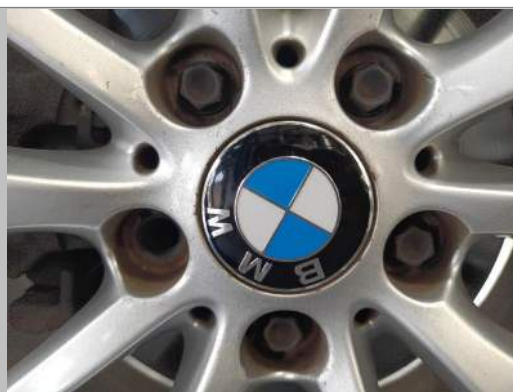
| Damage | Repair Way |
|---|---|
| Bolt(s) / Nut(s) Front Wheel Right Missing | Replace |

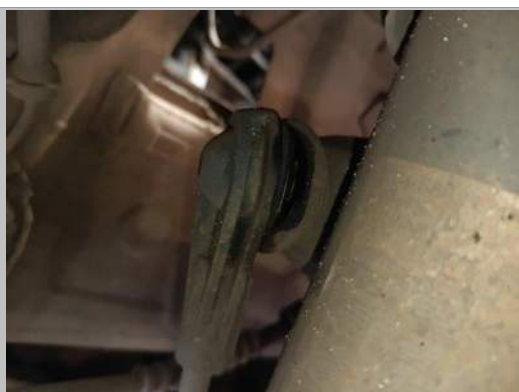
| Damage | Repair Way |
|---|---|
| Stabilizer Mounting Front Right Damaged | Replace |

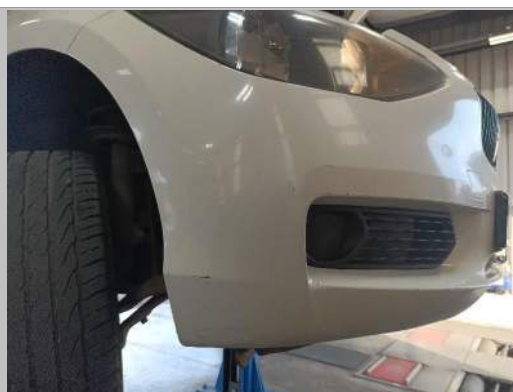
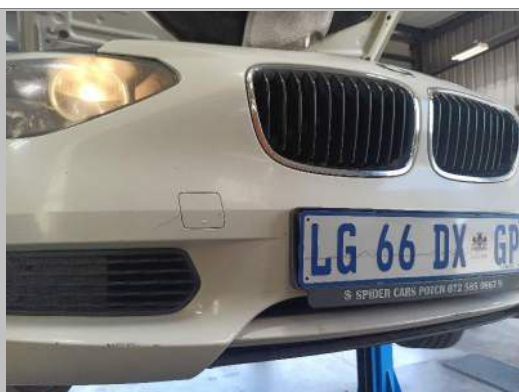
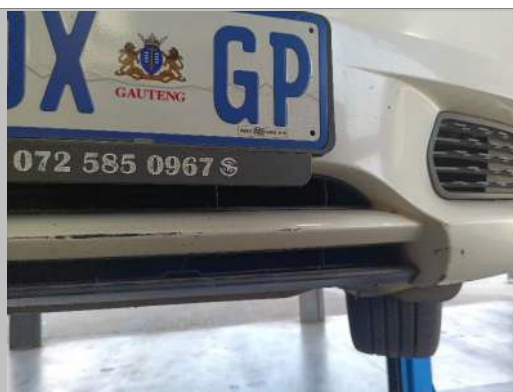
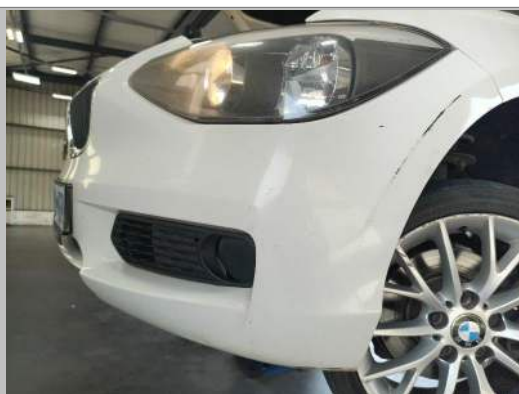
| Damage | Repair Way |
|---|---|
| Front Bumper Paintwork • Scratched | Repair |

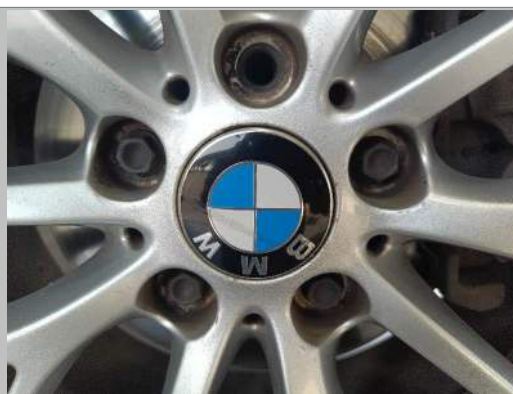
| Damage | Repair Way |
|---|---|
| Bolt(s) / Nut(s) Front Wheel Left Missing | Replace |

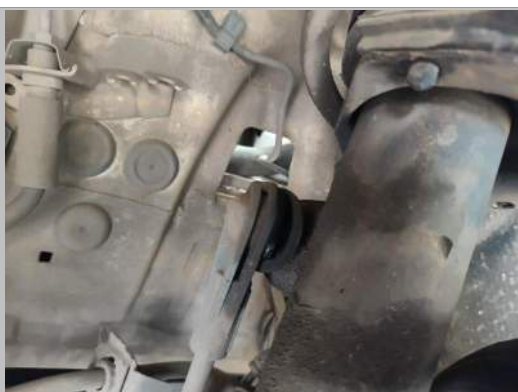
| Damage | Repair Way |
|---|---|
| Stabilizer Mounting Front Left Damaged | Replace |

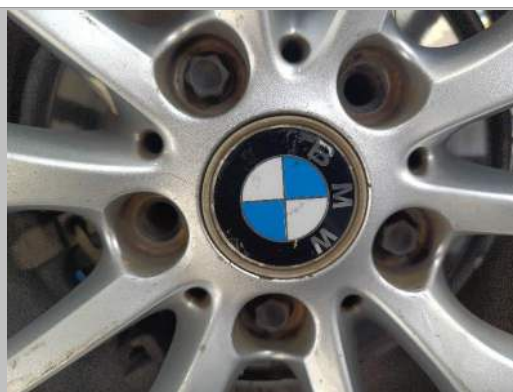
| Damage | Repair Way |
|---|---|
| Bolt(s) / Nut(s) Rear Wheel Left Missing | Replace |

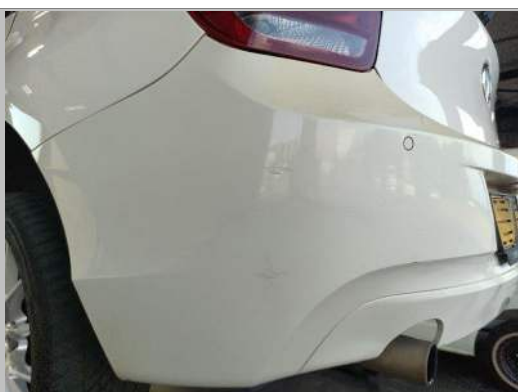
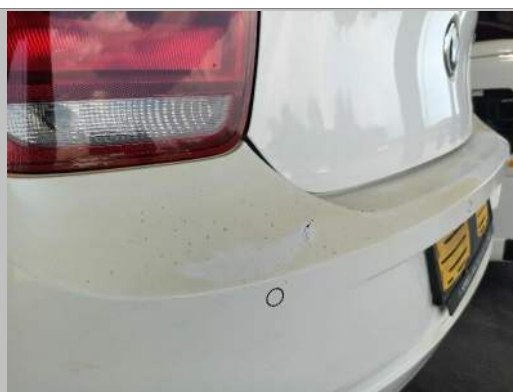
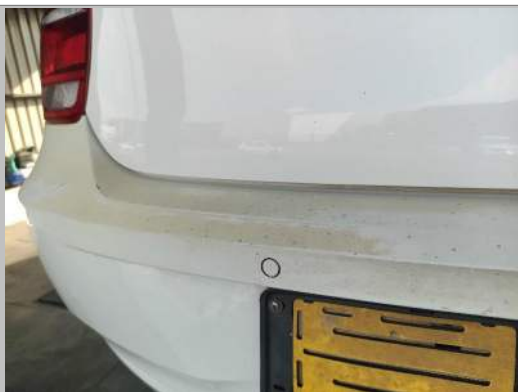
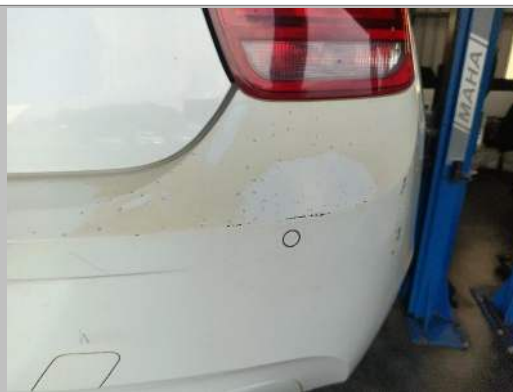
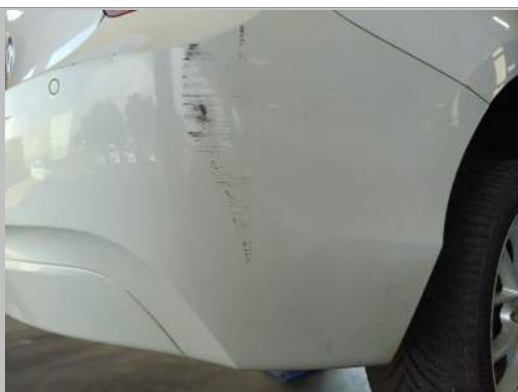
| Damage | Repair Way |
|---|---|
| Rear bumper Residual Traces of Repair | Repair |

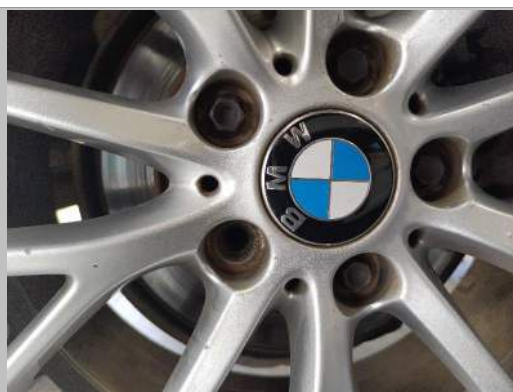
| Damage | Repair Way |
|---|---|
| Bolt(s) / Nut(s) Rear Wheel Right Missing | Replace |

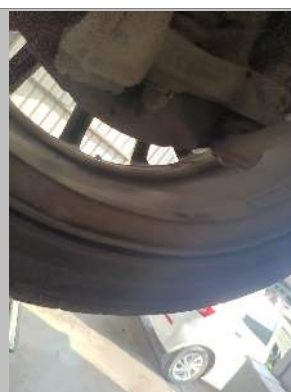
| Damage | Repair Way |
|---|---|
| Rim Front Left Deformed | Repair |

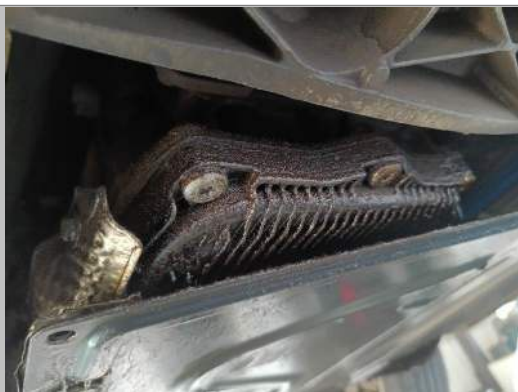
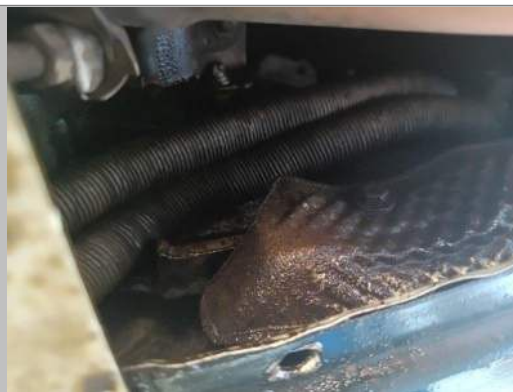
| Damage | Repair Way |
|---|---|
| Gearbox Oil Leak | Repair |

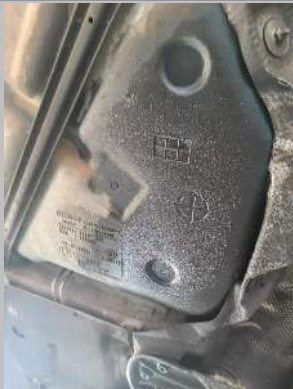
| Damage | Repair Way |
|---|---|
| Fuel Tank Sweat | Repair |

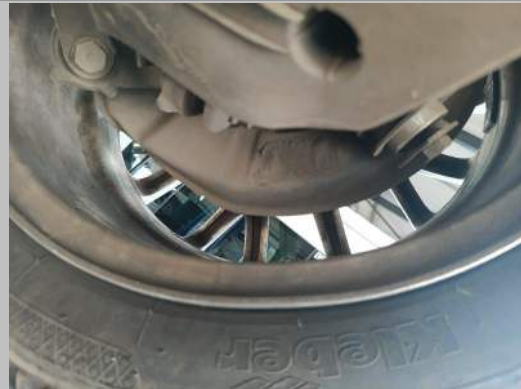
| Damage | Repair Way |
|---|---|
| Rim Rear Right Deformed | Repair |

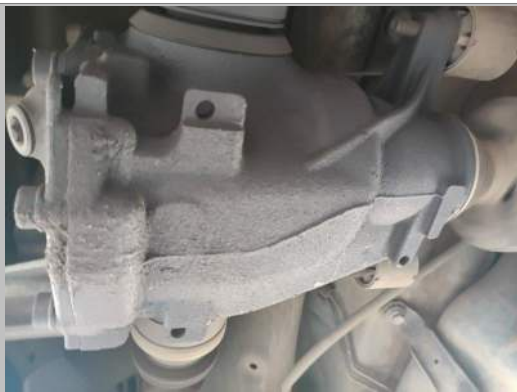
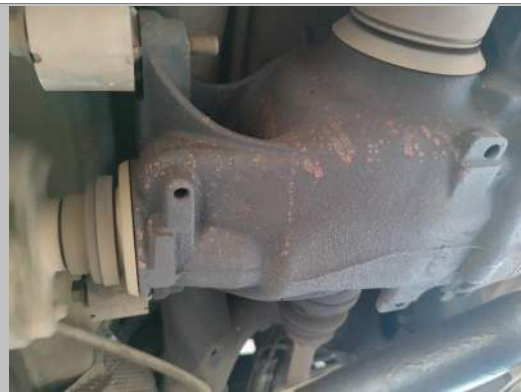
| Damage | Repair Way |
|---|---|
| Differential Oil Sweat | Repair |

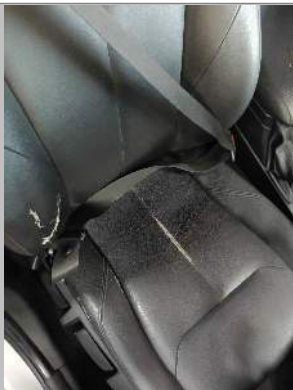
| Damage | Repair Way |
|---|---|
| Seat Front Right Torn / Cut | Repair |
