## CONDITION REPORT

Report No: 2016839316

DATE  
11/04/2025

| Manufacturer | BMW | Registration Number | FZ89XHGP |

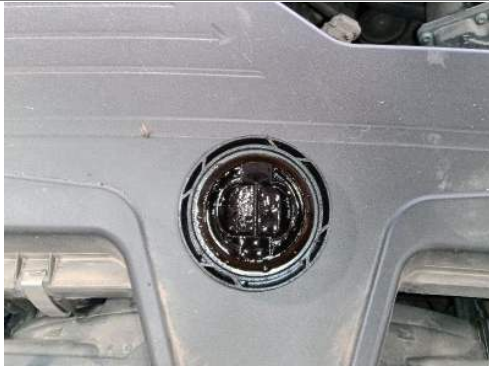
Oil cap

| Damage | Repair Way |
|---|---|
| Electrical instruments and components | Oil level could not be checked |

| No | System | Code | Description | Status |
|---|---|---|---|---|
| 1 | DME(ENGINE-DIGITAL MOTOR ELECTRONICS) | 1C4002 | OIL LEVEL:TOO LOW | |

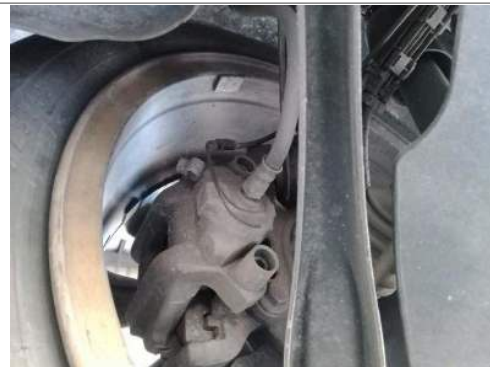
Rear right brake wear sensor w

| Damage | Repair Way |
|---|---|
| Brakes | Rear right brake wear sensor wiring damaged |

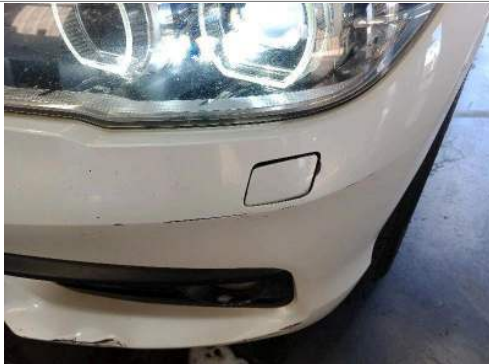
| Damage | Repair Way |
|---|---|
| Electrical instruments and components | Front left headlight washer damaged |

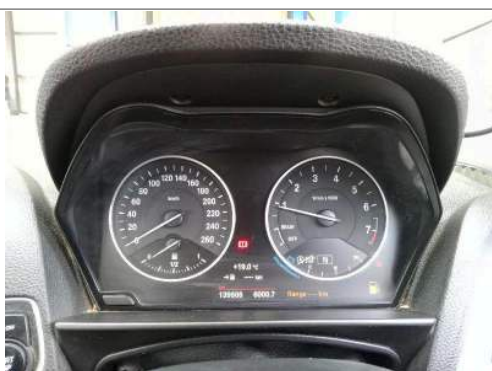
DASHBOARD (W/ ENGINE RUNNING)

| Damage | Repair Way |
|---|---|
| Warning light illuminated on dashboard | Repair |

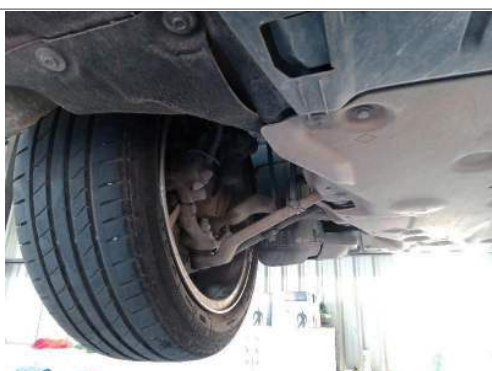
LF TYRE TREAD

| | Size | Load/Speed Index | Manufacture | Model | Type* | Production Date | Tread Depth (mm) |
|---|---|---|---|---|---|---|---|
| Front Left | 225/45 R17 | 91W | Dunlop | Sp-Sport | V | 0823 | 5 mm |

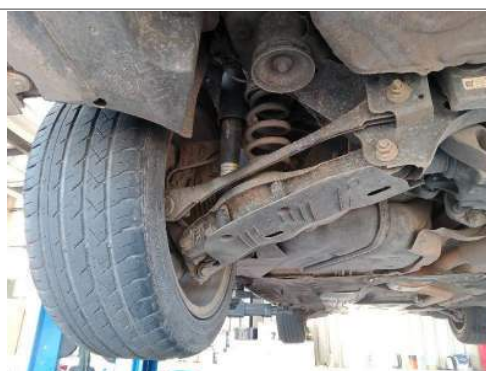
LR TYRE TREAD

| | Size | Load/Speed Index | Manufacture | Model | Type* | Production Date | Tread Depth (mm) |
|---|---|---|---|---|---|---|---|
| Rear Left | 225/45 R17 | 94W | Grenlader | Radial | V | 3019 | 0 mm |

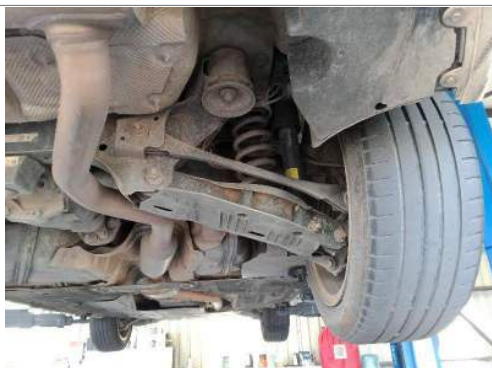
RR TYRE TREAD

| | Size | Load/Speed Index | Manufacture | Model | Type* | Production Date | Tread Depth (mm) |
|---|---|---|---|---|---|---|---|
| Rear Right | 225/45 R17 | 91W | Dunlop | Sp-Sport | V | 2519 | 2 mm |

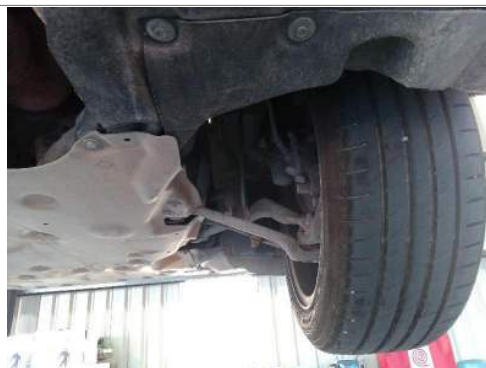
RF TYRE TREAD

| | Size | Load/Speed Index | Manufacture | Model | Type* | Production Date | Tread Depth (mm) |
|---|---|---|---|---|---|---|---|
| Front Right | 225/45 R17 | 91W | Dunlop | Sp-Sport | V | 0823 | 5 mm |

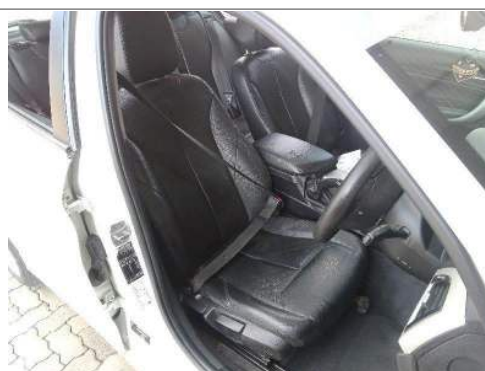
| Damage | Repair Way |
|---|---|
| Seat Front Right Damaged | Repair |

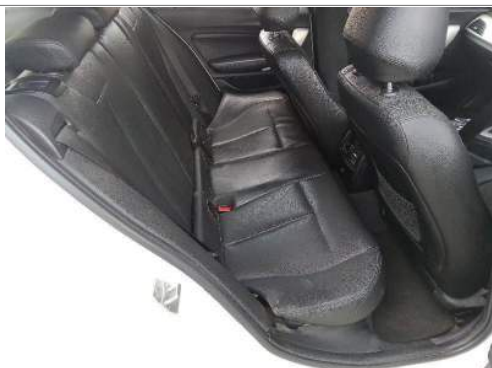
| Damage | Repair Way |
|---|---|
| Seat Rear Damaged | Repair |

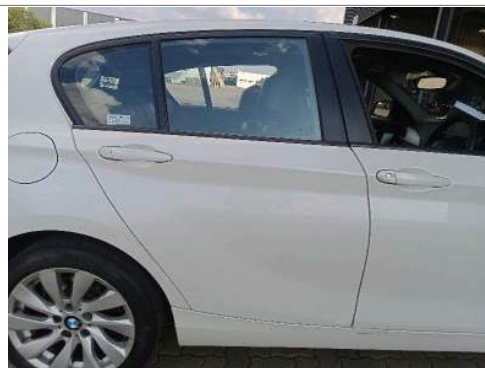
| Damage | Repair Way |
|---|---|
| Door Rear Right Damaged | Repair |

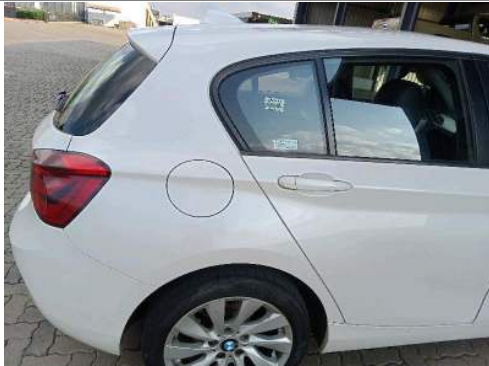
| Damage | Repair Way |
|---|---|
| Rear Fender Right Paintwork • Scratched | Repair |

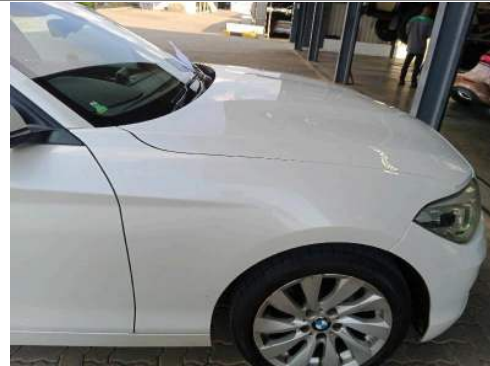
| Damage | Repair Way |
|---|---|
| Front Fender Right Paintwork • Scratched | Repair |

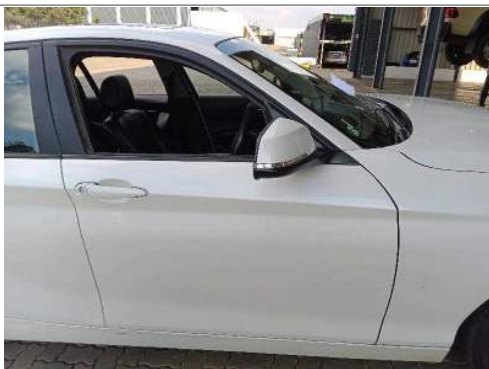
| Damage | Repair Way |
|---|---|
| Door Front Right Dented | Repair |

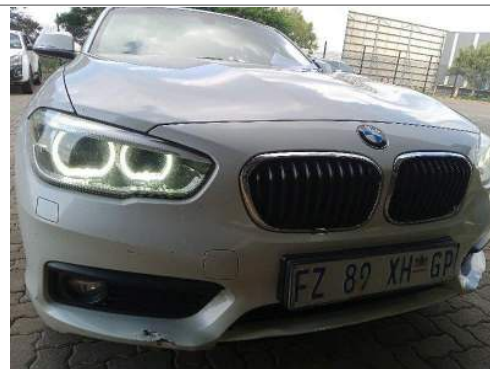
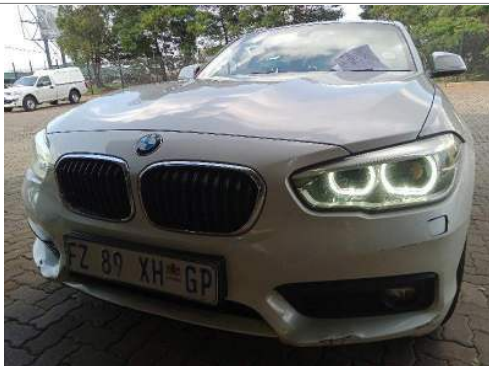
| Damage | Repair Way |
|---|---|
| Front Bumper Damaged | Repair |

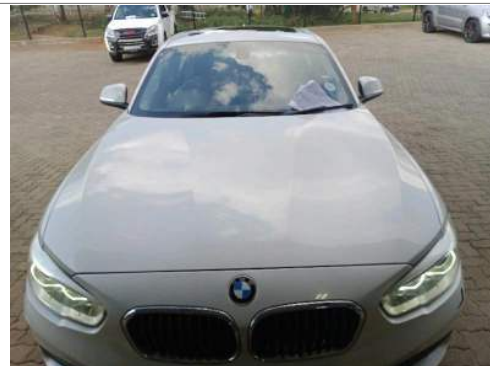
| Damage | Repair Way |
|---|---|
| Bonnet Paintwork • Scratched | Repair |

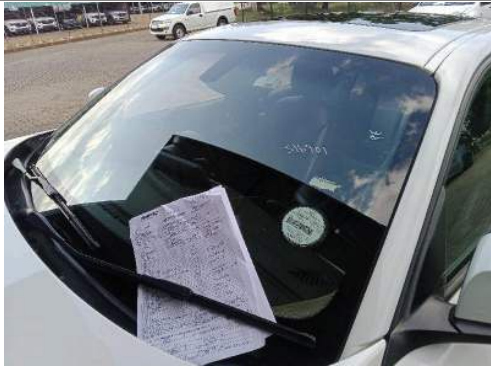
| Damage | Repair Way |
|---|---|
| Windscreen Cracked | Replace |

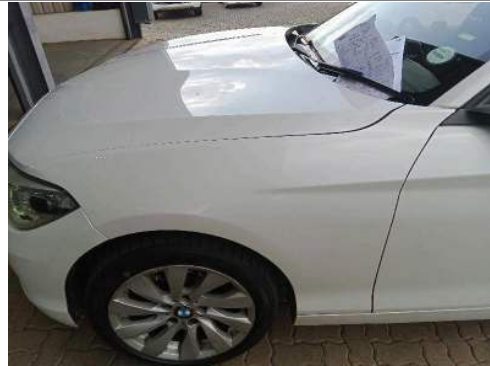
| Damage | Repair Way |
|---|---|
| Front Fender Left Residual Traces of Repair | Repair |

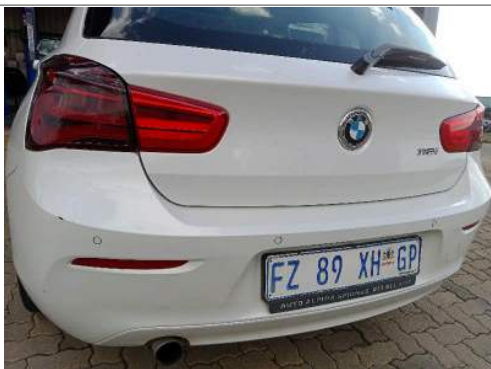
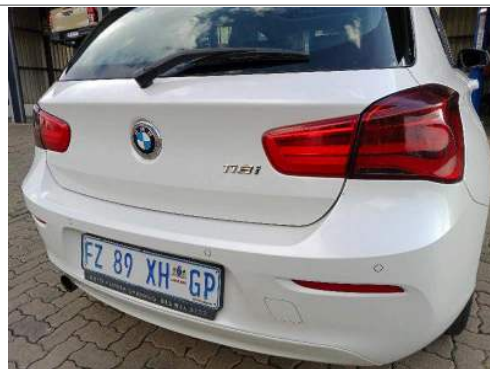
| Damage | Repair Way |
|---|---|
| Rear bumper Paintwork • Scratched | Repair |

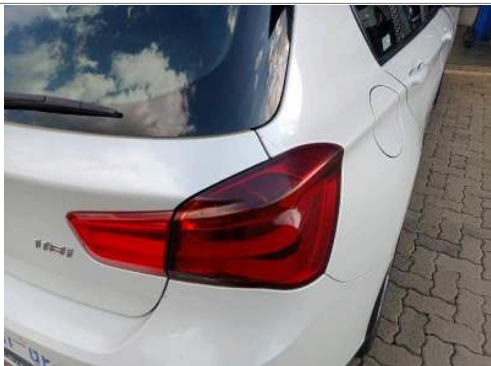
| Damage | Repair Way |
|---|---|
| Tail Light Right Defective | Repair |

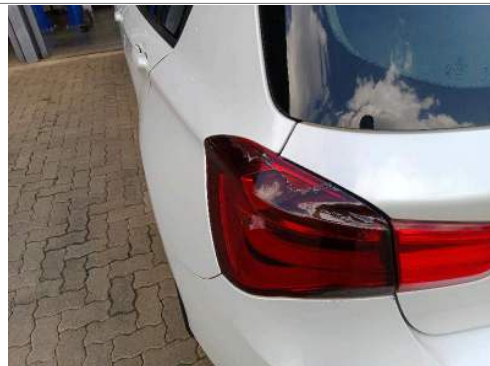
| Damage | Repair Way |
|---|---|
| Tail Light Left Defective | Repair |

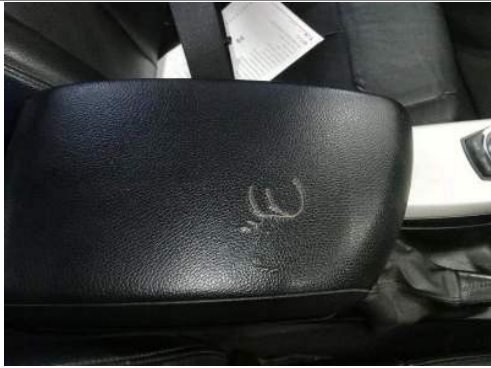
| Damage | Repair Way |
|---|---|
| Center Console / Cubbyhole + Lid Defective | Repair |

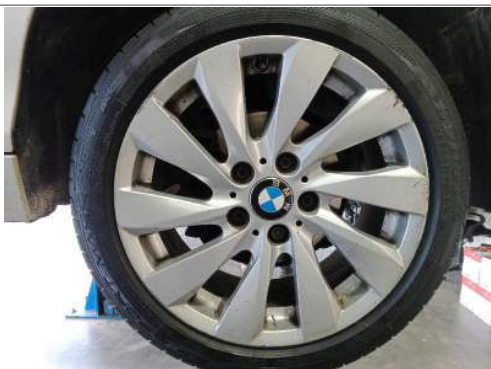
| Damage | Repair Way |
|---|---|
| Rim Front Right Scratched | Repair |

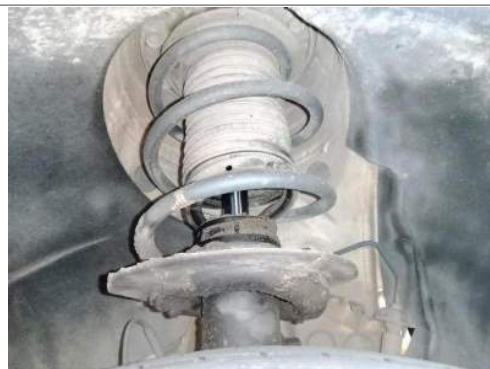
| Damage | Repair Way |
|---|---|
| Shock Absorber Front Right Leak | Replace |

| Damage | Repair Way |
|---|---|
| Front right shock absorber weak | Replace |

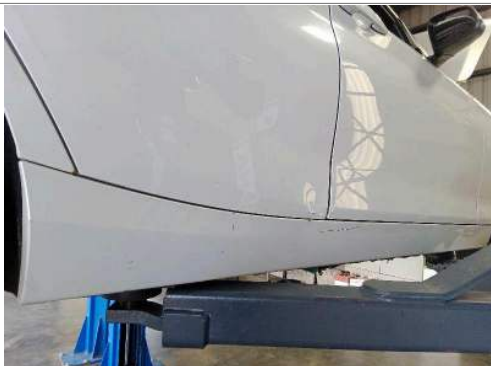
| Damage | Repair Way |
|---|---|
| Rocker Panel Right Damaged | Repair |

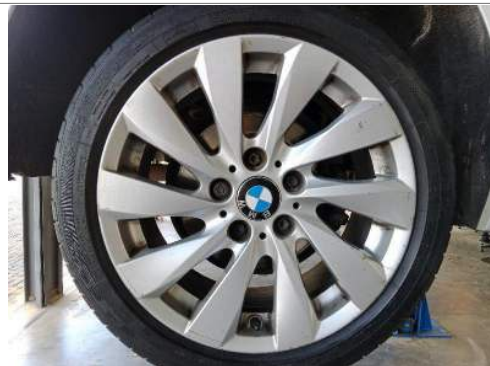
| Damage | Repair Way |
|---|---|
| Rim Rear Right Scratched | Repair |

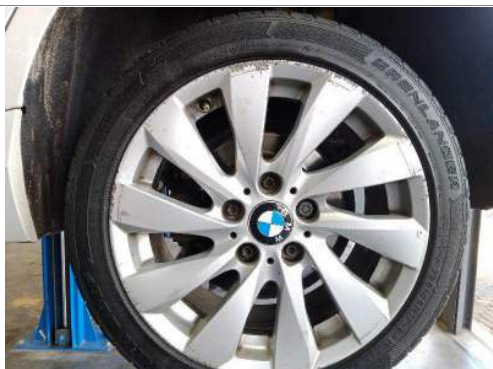
| Damage | Repair Way |
|---|---|
| Rim Rear Left Scratched | Repair |

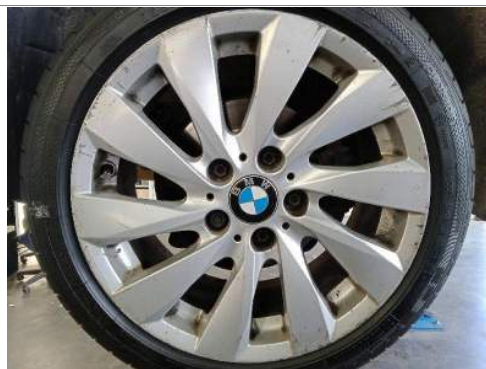
| Damage | Repair Way |
|---|---|
| Rim Front Left Scratched | Repair |

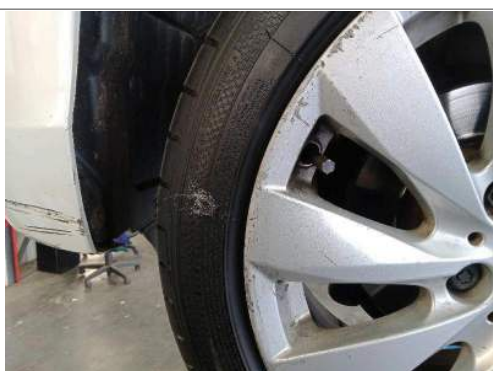
| Damage | Repair Way |
|---|---|
| Tyre Front Left Damaged | Replace |

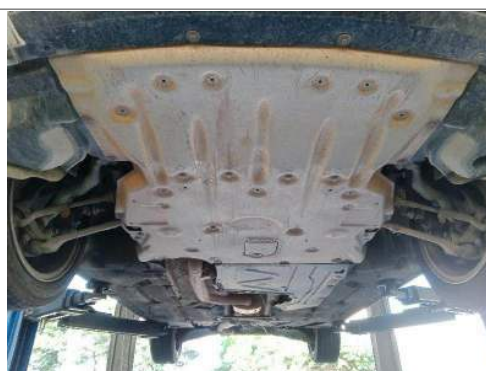
| Damage | Repair Way |
|---|---|
| Belly plates Damaged | Repair |

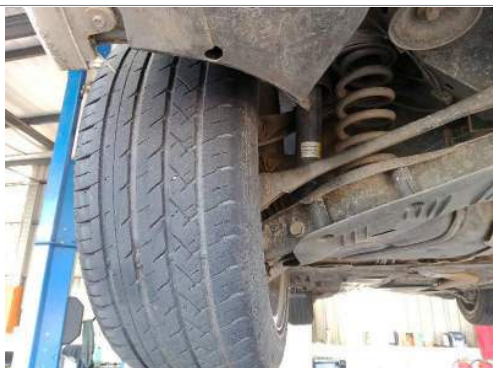
| Damage | Repair Way |
|---|---|
| Tyre Rear Left Worn | Replace |

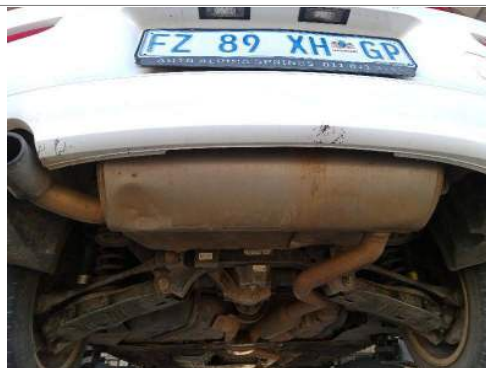
| Damage | Repair Way |
|---|---|
| Silencer Damaged | Replace |

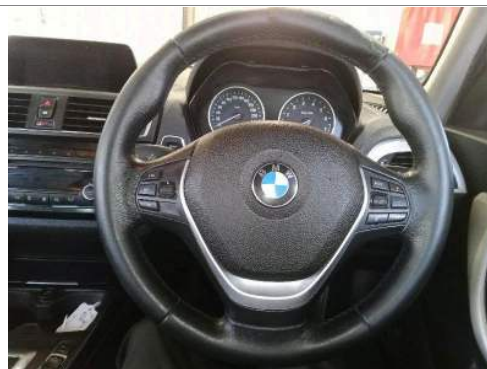
| Damage | Repair Way |
|---|---|
| Steering Wheel Trim Defective | Repair |
