CONDITION REPORT

Report No:
2016959304
DATE
26/07/2025

MFC Auction House
M57 Pretoria Rd, Glenmarais, KEMPTON PARK
Gauteng

Vehicle Type	PASSENGER VEHICLE	Registered Owner	MFC
Manufacturer	BMW	Registration Number	CZ21WYGP
Model	320I AT [2012-2016]	Register Number	
VIN	WBA3B16060NS53148	Date Of First Licensing	
Engine Number		Last COR	
Doors	4	License Expiry Date	31/10/2025
Color	SILVER	Power / Displacement	
Year Model	2014	Paint Finish	TWO COAT UNI
Km Reading	195,272 KM	Fuel	PETROL
Cab / Body Type	SEDAN	Transmission	AUTOMATIC

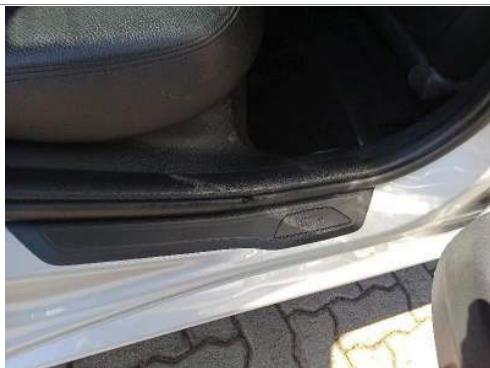
Damage	Repair Way
Engine Oil Leak	Repair
Engine Wiring Defective	Repair
Caps Broken	Replace
Under bonnet insulation cover Damaged	Replace
Tail Light Right Damaged	Replace
Fog Light Front Right Cracked	Replace
Headlight Left Damaged	Replace
Seat Rear Damaged	Replace
Seat Belt Rear Right Defective	Replace
Door Sealing Rubber Rear Right Torn / Cut	Repair
Front Bumper Damaged	Repair
Grill Damaged	Replace
Bonnet Damaged	Repair
Front Fender Left Residual Traces of Repair	Repair
Front Fender Right Dented	Repair
Rear Fender Left Dented	Repair
Rear Fender Right Damaged	Repair
Front Fender Left / Inner Tray Damaged	Repair
Door Front Right Damaged	Repair
Door Rear Left Residual Traces of Repair	Repair
Door Rear Right Damaged	Repair
Boot Lid / Hatch door Damaged	Repair
Rear bumper Damaged	Repair
Fuel Flap Defective	Repair
Rocker Panel Left Damaged	Repair
Rocker Panel Right Paintwork • Scratched	Repair
Roof Paintwork • Scratched	Repair

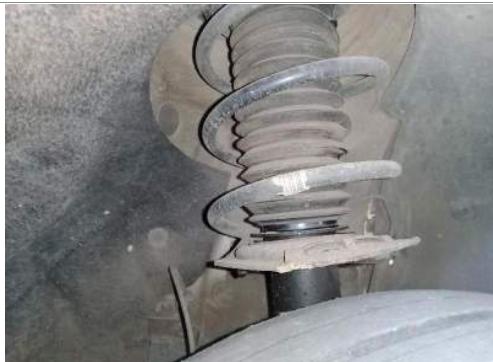
Shock Absorber Front Right Leak	Replace
Stabilizer Mounting Front Right Damaged	Replace
Tyre Front Right Damaged	Replace
Tyre Rear Left Worn	Replace
Tyre Rear Right Damaged	Replace
Engine to silencer pipe Damaged	Repair
Belly plates Defective	Repair
Gearbox Oil Leak	Repair
Fuel Lines Defective	Repair
Engine Noise Excessive	Repair
Body and Exterior	Boot does not open
Front right shock absorber weak	Replace
Body and Exterior	Dents and scratches on some body panels
Body and Exterior	Some body panels misaligned
Body and Exterior	Signs of impact damage to rear of vehicle
Undercarriage	Front right jacking point bracket missing
Body and Exterior	Poor residual traces of repair on some body panels
Undercarriage	Bottom of engine fully covered
Body and Exterior	Stone chips and spray work on some body panels
Axle and suspension	Front suspension noisy

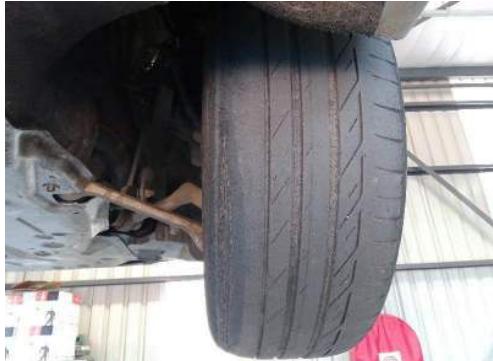
Tyre Front Right

Size	Load/Speed Index	Manufacture	Model	Type*	Production Date	Tread Depth (mm)
Front Left	225/50 R17	94W	Bridgestone	Potenza	V	2121	1 mm
Front Right	225/50 R17	94W	Bridgestone	Turanza	V	4021	0 mm
Rear Left	225/50 R17	94W	Bridgestone	Potenza	V	4417	0 mm
Rear Right	225/50 R17	94W	Bridgestone	Turanza	V	2619	0 mm
