## CONDITION REPORT

Report No:  
2017304186  
DATE  
28/09/2026

| Manufacturer | BMW | Registration Number | JM73CPGP |
| Model | 320i GT 5-DR AT [2013-2016] | Register Number | |

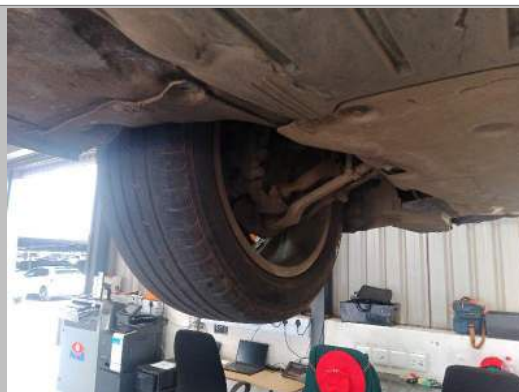
LF TYRE TREAD

| | Size | Load/Speed Index | Manufacture | Model | Type* | Production Date | Tread Depth (mm) |
|---|---|---|---|---|---|---|---|
| Front Left | 235/50R18 | 97V | Yokohama | C drive | V | 2919 | 3 mm |

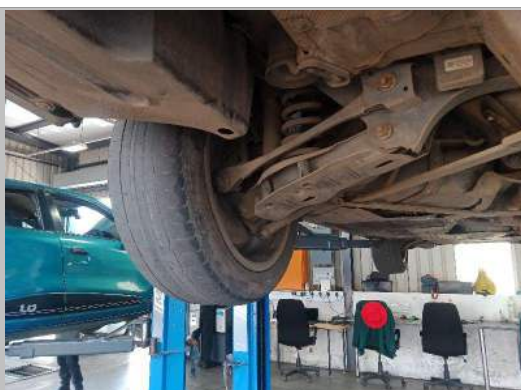
LR TYRE TREAD

| | Size | Load/Speed Index | Manufacture | Model | Type* | Production Date | Tread Depth (mm) |
|---|---|---|---|---|---|---|---|
| Rear Left | 225/50R18 | 95W | Bridgestone | Turanza | V | 2820 | 0 mm |

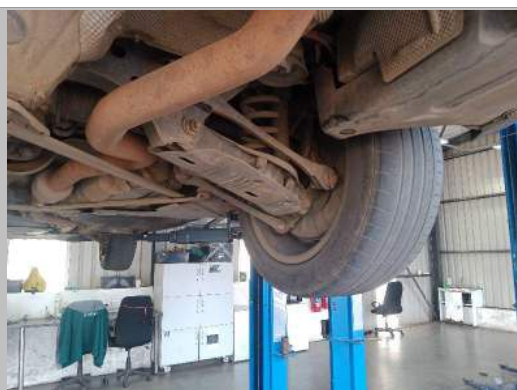
RR TYRE TREAD

| | Size | Load/Speed Index | Manufacture | Model | Type* | Production Date | Tread Depth (mm) |
|---|---|---|---|---|---|---|---|
| Rear Right | 235/50R18 | 101V | Continental | Contact | V | 5017 | 1 mm |

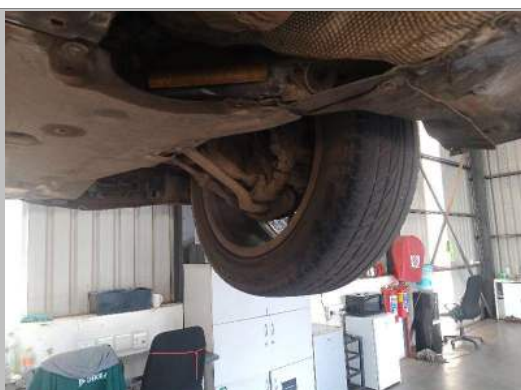
RF TYRE TREAD

| | Size | Load/Speed Index | Manufacture | Model | Type* | Production Date | Tread Depth (mm) |
|---|---|---|---|---|---|---|---|
| Front Right | 235/50R18 | 101W | Lanvigator | Catch power | V | 2519 | 2 mm |

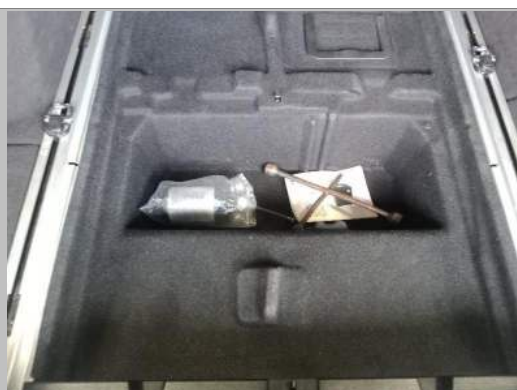
No spare wheel

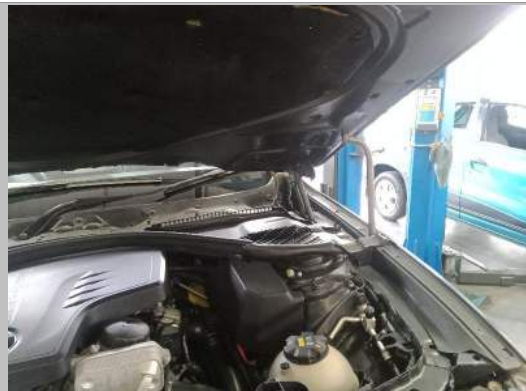
| Bonnet stay and shocks Defective | Replace |

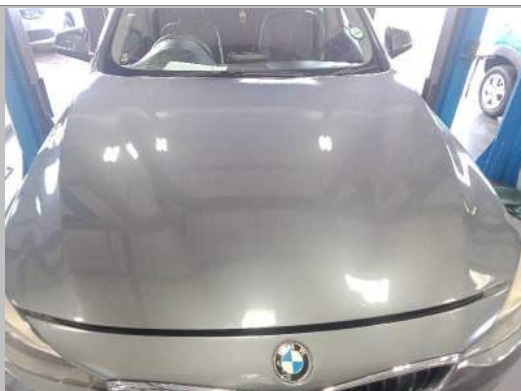
| Bonnet Residual Traces of Repair | Repair |

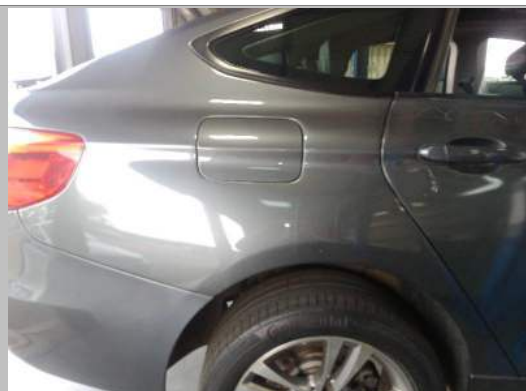
| Rear Fender Right Paintwork • Scratched | Repair |

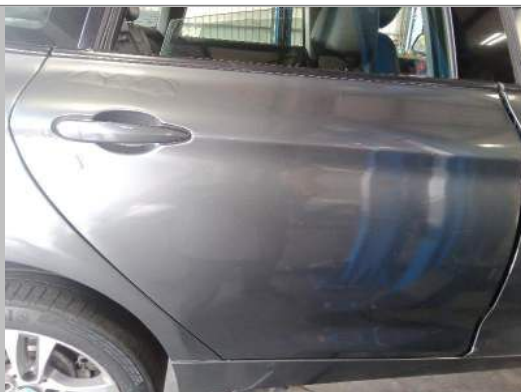
| Door Rear Right Residual Traces of Repair | Repair |

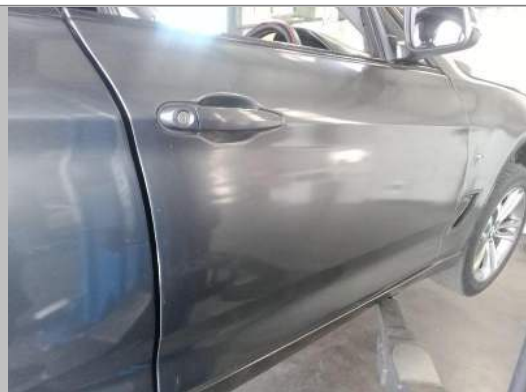
| Door Front Right Residual Traces of Repair | Repair |

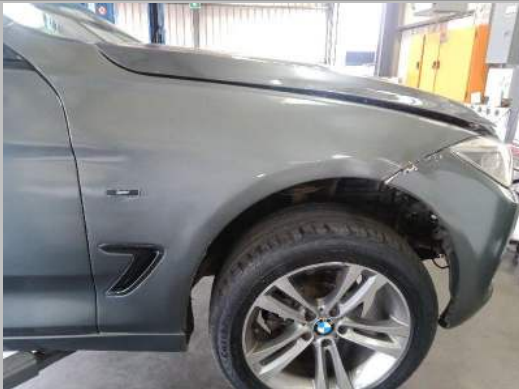
| Front Fender Right Residual Traces of Repair | Repair |

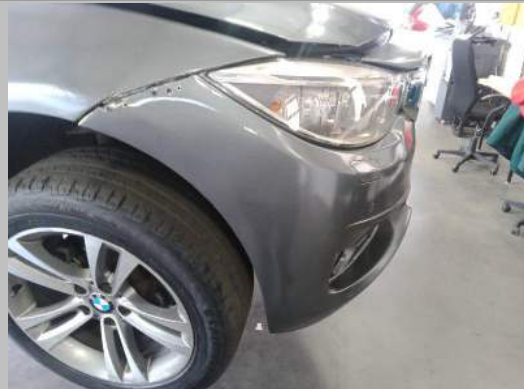
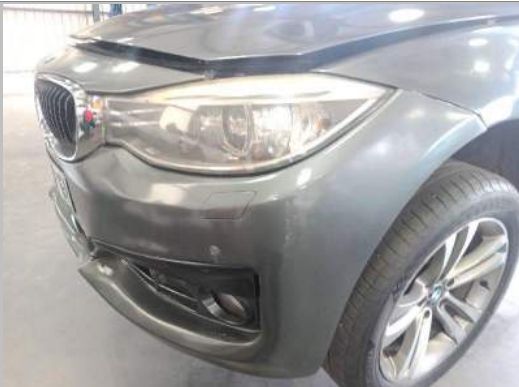
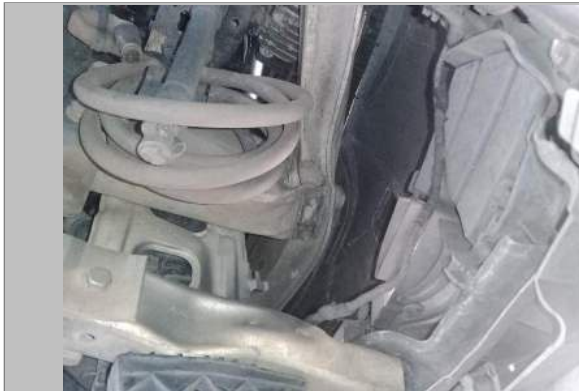
| Front Bumper Damaged | Repair |

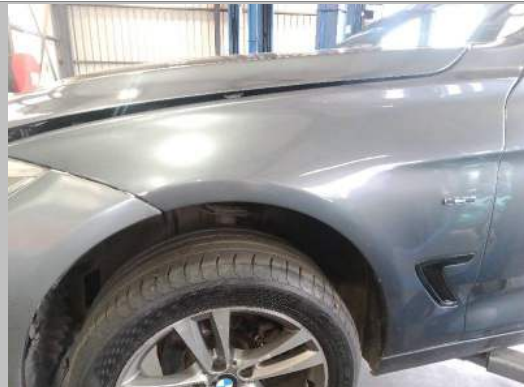
| Front Fender Left Residual Traces of Repair | Repair |

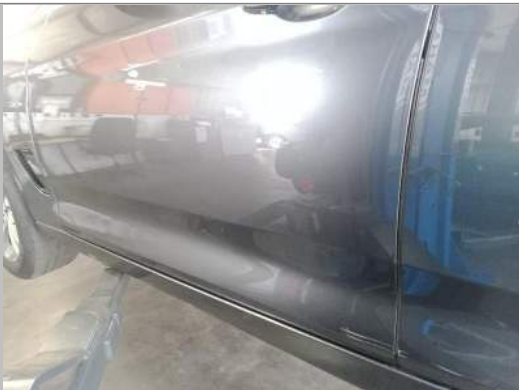
| Door Front Left Paintwork • Scratched | Repair |

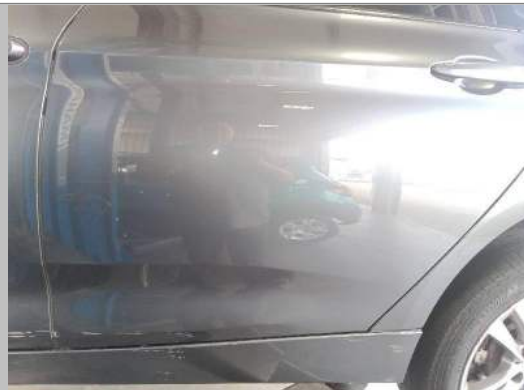
| Door Rear Left Paintwork • Scratched | Repair |

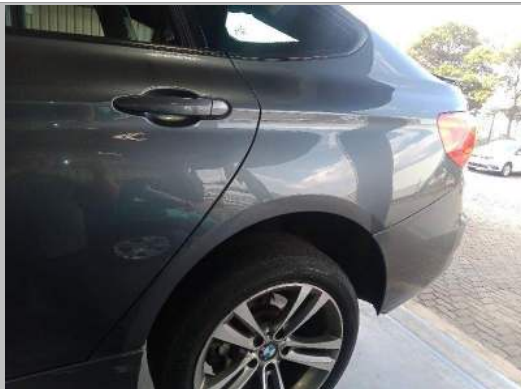
| Rear Fender Left Dented | Repair |

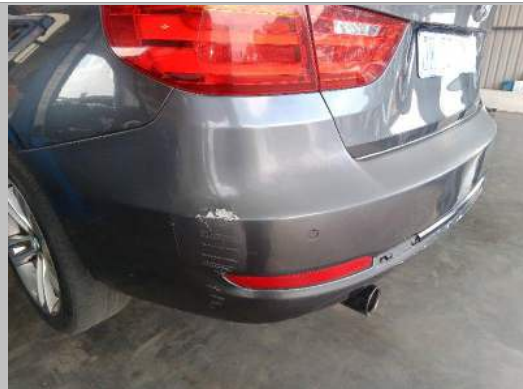
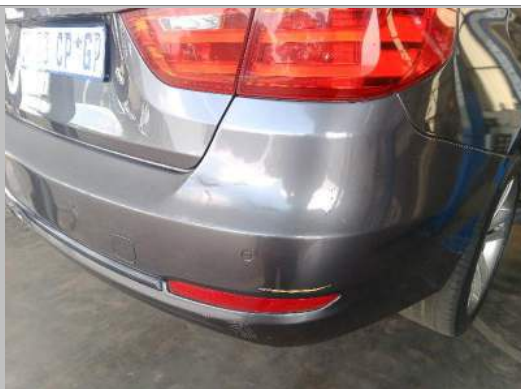
| Rear bumper Damaged | Repair |

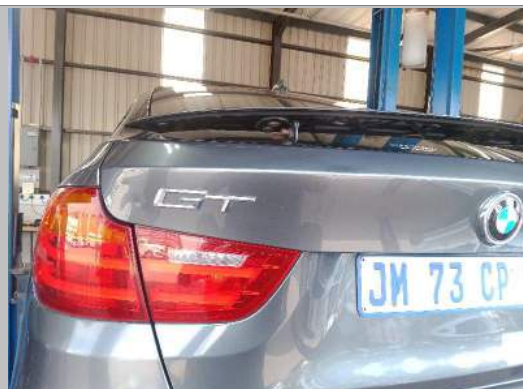
| Boot Lid / Hatch door Dented | Repair |

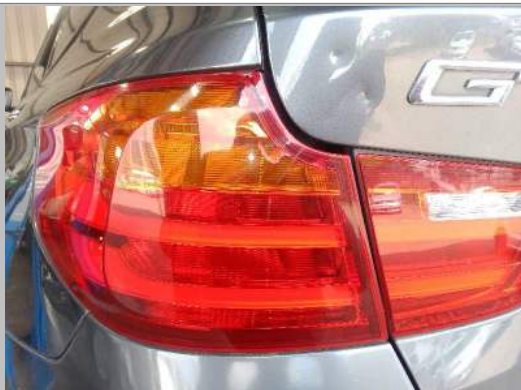
| Tail Light Left Cracked | Repair |

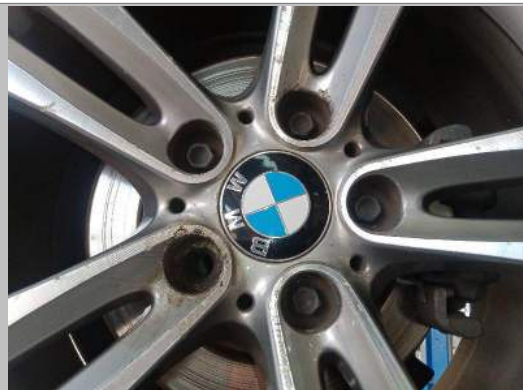
| Bolt(s) / Nut(s) Rear Wheel Right Missing | Replace |

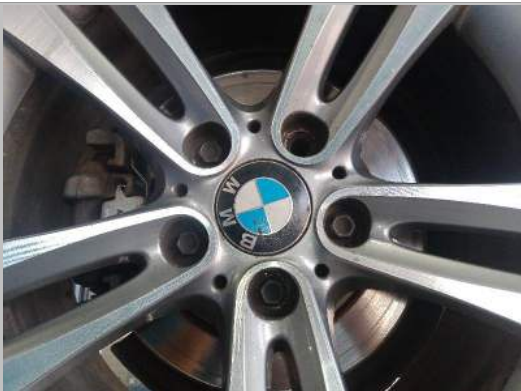
| Bolt(s) / Nut(s) Rear Wheel Left Missing | Replace |

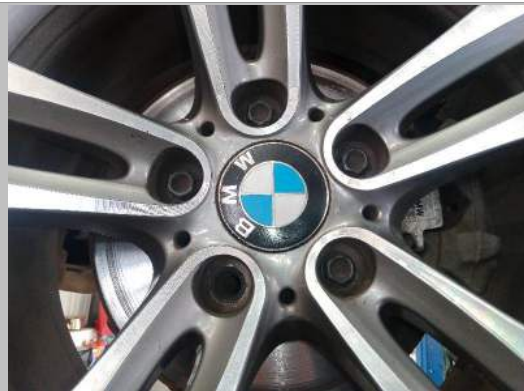
| Bolt(s) / Nut(s) Front Wheel Left Missing | Replace |

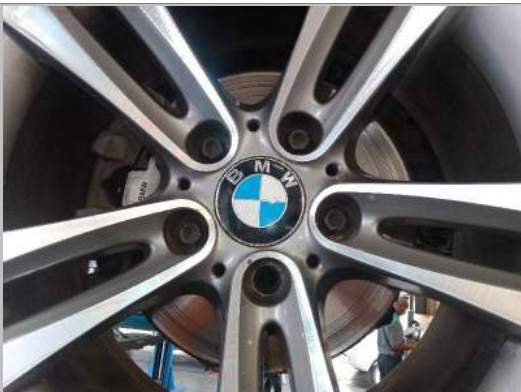
| Bolt(s) / Nut(s) Front Wheel Right Missing | Replace |

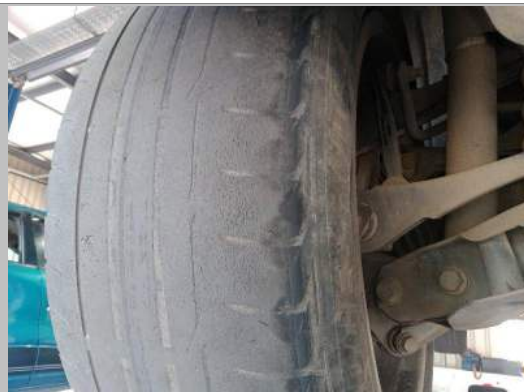
| Tyre Rear Left Smooth | Replace |

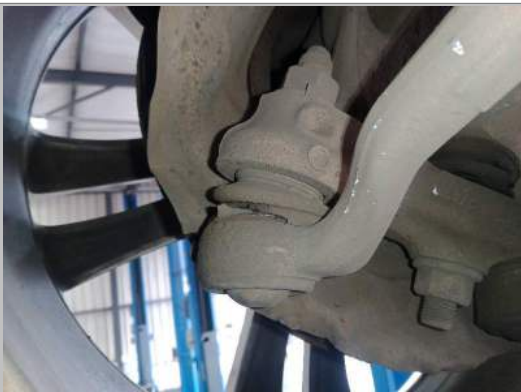
| Tie Rod End right Damaged | Replace |

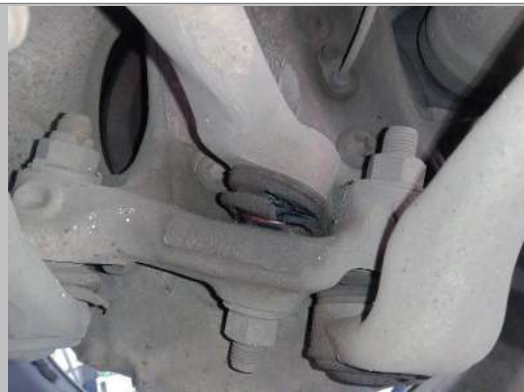
| Control Arm Bush(es) Front Axle Right Damaged | Replace |
