MFC Auction House
M57 Pretoria Rd, Glenmarais, KEMPTON PARK
Gauteng

DEKRA MFC
M57 Pretoria Rd - 1619
KEMPTON PARK - GT
08610 33572

VEHICLE INSPECTION

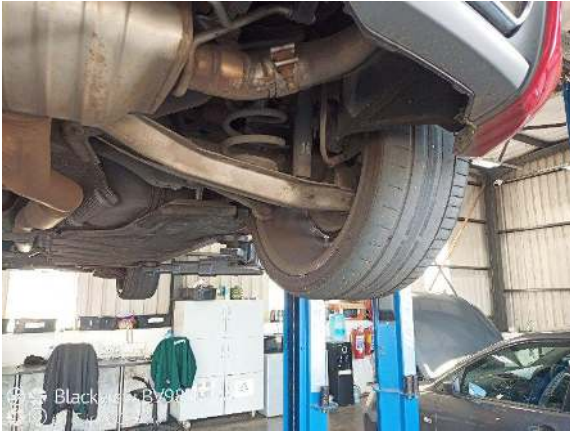
RR TYRE TREAD

Size	Load/Speed Index	Manufacture	Model	Type*	Production Date	Tread Depth (mm)
Front Left	235/35R19	91W	Mazzini	Eco607	V	4320	1 mm
Front Right	235/35R19	91Y	Continental	Contact	V	1921	0 mm
Rear Left	235/35R19	91Y	Yokohama	Advan sport	V	4816	2 mm
Rear Right	235/35R19	91Y	Continental	Contact	V	0819	0 mm

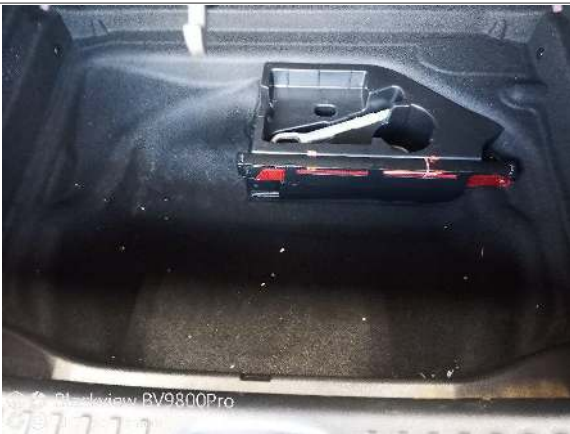
No spare wheel

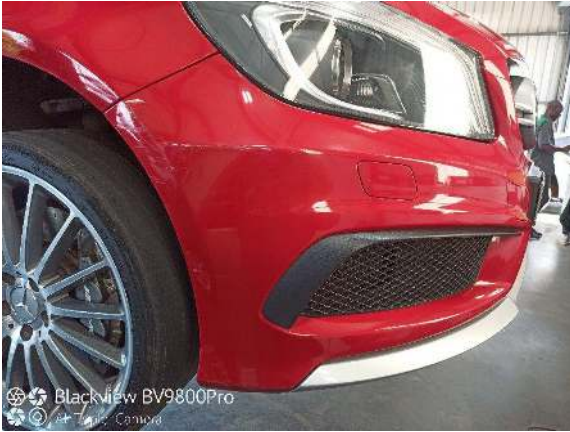
Damage	Repair Way
Front Bumper Paintwork • Scratched	Repair
Front Fender Right Paintwork • Scratched	Repair
Door Front Left Paintwork • Chipmarks	Repair
Door Front Right Paintwork • Chipmarks	Repair
Rear bumper Paintwork • Scratched	Repair
Windscreen Cracked	Replace
Tyre Front Right Damaged	Replace
Tyre Rear Right Smooth	Replace
No license dice	Replace
Engine management lights illuminated	Repair
