MFC Auction House
M57 Pretoria Rd, Glenmarais, KEMPTON PARK
Gauteng

DEKRA MFC
M57 Pretoria Rd - 1619
KEMPTON PARK - GT
08610 33572

CONDITION REPORT

Report No: 2016237217

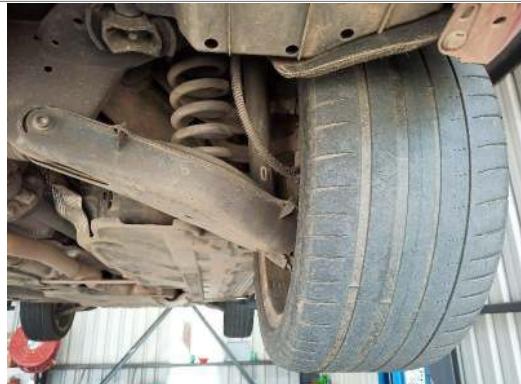
RR TYRE TREAD

Size	Load/Speed Index	Manufacture	Model	Type*	Production Date	Tread Depth (mm)
Front Left	225/40R18	92W	Hilo	Radial	V	0321	3 mm
Front Right	225/45R18	95Y	Continental	Contisport	V	0219	0 mm
Rear Left	255/35R18	94W	Lanigator	Radial	V	3921	3 mm
Rear Right	255/35R18	94Y	Michelin	Radial	V	1218	1 mm

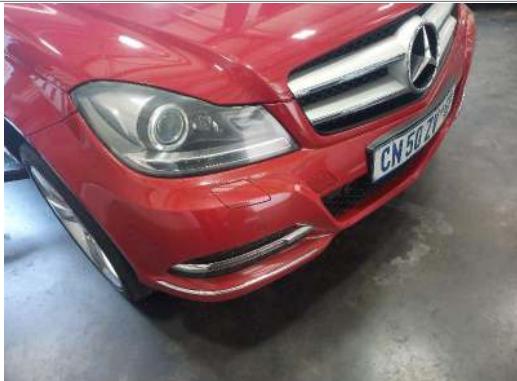
Damage	Repair Way
Tail Light Left Defective	Replace
Dim Light Left Defective	Replace
Sun Roof Switch Defective	Repair
Sun Roof Defective	Repair
Seat Front Left Damaged	Repair
Seat Front Right Damaged	Repair
Number Plate Front Deformed	Repair
Number Plate Rear Defective	Repair
Front Bumper Damaged	Repair
Bonnet Damaged	Repair
A • Pillar Left Damaged	Repair
Front Fender Left Damaged	Repair
Front Fender Right Damaged	Repair
Rear Fender Left Damaged	Repair
Rear Fender Right Damaged	Repair
Door Front Left Damaged	Repair
Door Front Right Damaged	Repair
Boot Lid / Hatch door Damaged	Repair
Rear bumper Damaged	Repair
Stabilizer Mounting Front Left Damaged	Replace
Stabilizer Mounting Front Right Damaged	Replace
Tyre Front Right Worn	Replace
