MFC Auction House
M57 Pretoria Rd, Glenmarais, KEMPTON PARK
Gauteng

Vehicle Type	PASSENGER VEHICLE	Registered Owner	
Manufacturer	MERCEDES-BENZ	Registration Number	FRM352L
Model	C180	Register Number	
VIN	WDD2050762R533972	Date Of First Licensing	
Engine Number		Last COR	
Doors	4	License Expiry Date	
Color	SILVER	Power / Displacement	
Year Model		Paint Finish	TWO COAT METALLIC
Km Reading	132,170 KM	Fuel	PETROL
Cab / Body Type	SEDAN	Transmission	AUTOMATIC

VEHICLE INSPECTION

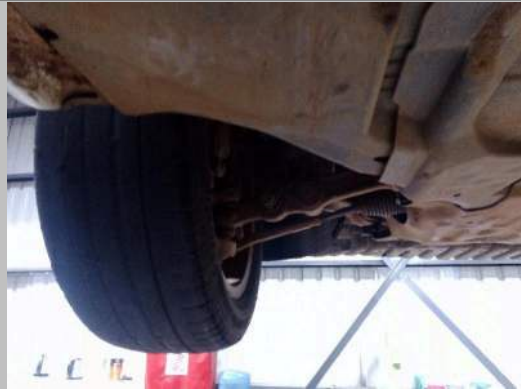
LF TYRE TREAD

Size	Load/Speed Index	Manufacture	Model	Type*	Production Date	Tread Depth (mm)
Front Left	225/50R17	94W	Bridgestone	Radial	V	3922	0 mm
Front Right	225/50R17	94W	Bridgestone	Radial	V	3922	0 mm
Rear Left	225/50R17	94W	Bridgestone	Radial	V	4422	2 mm
Rear Right	225/50R17	94W	Bridgestone	Radial	V	4422	2 mm

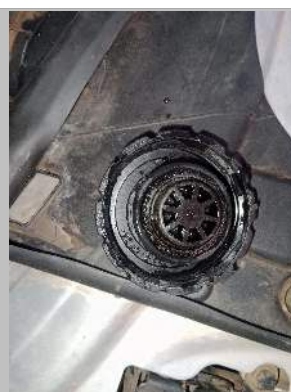
Damage	Repair Way
Caps Damaged	Replace
Expansion Bottle Damaged	Replace
Center Console / Cubbyhole + Lid Damaged	Repair
Engine Management Lights Set	Repair
Seat Front Left Worn	Repair
Seat Front Right Damaged	Repair
Front Bumper Damaged	Repair
Bonnet Damaged	Repair
Door Front Left Damaged	Repair
Rear bumper Damaged	Repair
Windscreen Damaged	Replace
Brake disc 1. Axle left Worn	Replace
Brake disc 1. Axle right Worn	Replace
Brake disc 2. Axle left Worn	Replace
Brake disc 2. Axle right Worn	Repair
Tyre Front Left Worn	Replace
Tyre Front Right Worn	Replace

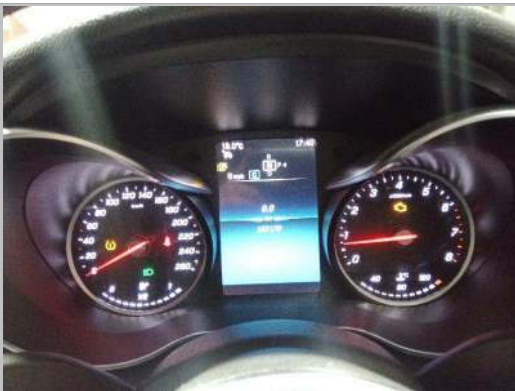
Engine Management Lights

No	System	Code	Description	Status
1	ECM	P012B28	THE PRESSURE SENSOR UPSTREAM OF THE TURBOCHARGER H
