CONDITION REPORT

Report No:
2016962636
DATE
30/07/2025

MFC Auction House
M57 Pretoria Rd, Glenmarais, KEMPTON PARK
Gauteng

Vehicle Type	PASSENGER VEHICLE	Registered Owner	
Manufacturer	MERCEDES-BENZ	Registration Number	JZ11GGGP
Model	VITO	Register Number	
VIN	WDF44770323599001	Date Of First Licensing	
Engine Number		Last COR	
Doors	5	License Expiry Date	31/05/2026
Color	SILVER	Power / Displacement	
Year Model		Paint Finish	TWO COAT METALLIC
Km Reading	154,720 KM	Fuel	DIESEL
Cab / Body Type	STATION WAGON	Transmission	AUTOMATIC

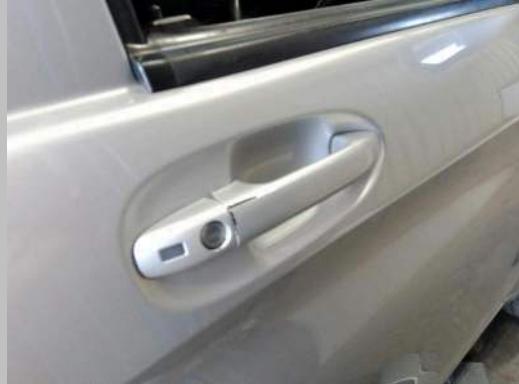
Damage	Repair Way
Engine Oil Leak	Repair
Central Air Vent Damaged	Replace
Windscreen Wiper Damaged	Replace
Seat Front Right Torn / Cut	Repair
Seat Rear Damaged	Repair
Seat Belt Rear Middle Damaged	Repair
Door Handle Front Right Damaged	Repair
Carpet Rear Damaged	Repair
Side Mirror Left Damaged	Repair
Side Mirror Right Damaged	Repair
Front Bumper Damaged	Repair
Bonnet Damaged	Repair
Front Fender Left Damaged	Repair
Front Fender Right Damaged	Repair
Rear Fender Left Damaged	Repair
Rear Fender Right Damaged	Repair
Door Front Left Damaged	Repair
Door Front Right Damaged	Repair
Door Rear Left Damaged	Repair
Door Rear Right Damaged	Repair
Boot Lid / Hatch door Damaged	Repair
Rear bumper Damaged	Repair
Windscreen Damaged	Replace
Brake disc 1. Axle left Worn	Replace
Brake disc 1. Axle right Worn	Replace
Brake disc 2. Axle left Worn	Replace
Brake disc 2. Axle right Worn	Replace
Brake Pad/Shoe 2. Axle left Worn	Replace
Brake Pad/Shoe 2. Axle right Worn	Replace

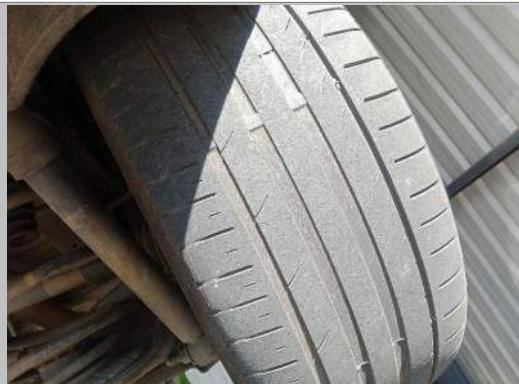
Rebound Rubber Rear Axle Left Damaged	Replace
Control Arm Bush(es) Front Axle Left Welded	Replace
Control Arm Bush(es) Front Axle Right Worn	Replace
Tyre Front Right Worn	Replace
Tyre Rear Left Excessive Wear & Tear	Replace
Tyre Rear Right Worn	Replace
Spare Tyre Damaged	Replace
Rim Front Left Cracked	Replace
Rim Front Right Damaged	Replace
Rim Rear Left Deformed	Repair
Rim Rear Right Cracked	Replace
Rim Spare Wheel Damaged	Replace
Belly plates Damaged	Replace
Center Prop Shaft Rubber(s) Loose / Excessive Play	Repair
Rear tyres size differs	Replace

Size	Load/Speed Index	Manufacture	Model	Type*	Production Date	Tread Depth (mm)
Front Left	245/45R19	102Y	Continental	EcoContact	V	2523	2 mm
Front Right	245/45ZR19	102Y	Tracmax	Radial	V	5123	0 mm
Rear Left	205/65R16C	103H	Michelin	Agilis 51	V	0819	3 mm
Rear Right	245/45ZR16	102Y	Tracmax	Radial	V	5123	0 mm
Spare	245/45ZR19	102Y			V	5123	0 mm

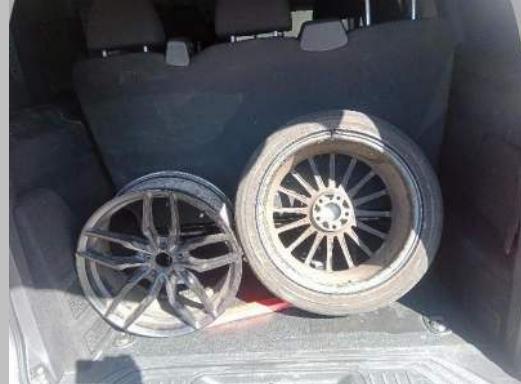
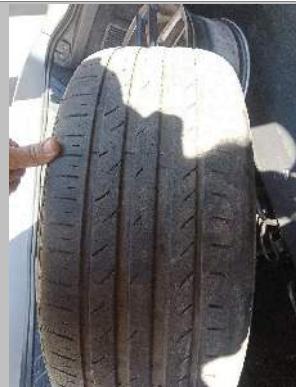
Spare Tyre

Tyres and Rims: Spare tire making model not visible. spare wheel fitted to left rear.
