MFC Auction House
M57 Pretoria Rd, Glenmarais, KEMPTON PARK
Gauteng

DEKRA MFC
M57 Pretoria Rd - 1619
KEMPTON PARK - GT
08610 33572

VEHICLE INSPECTION

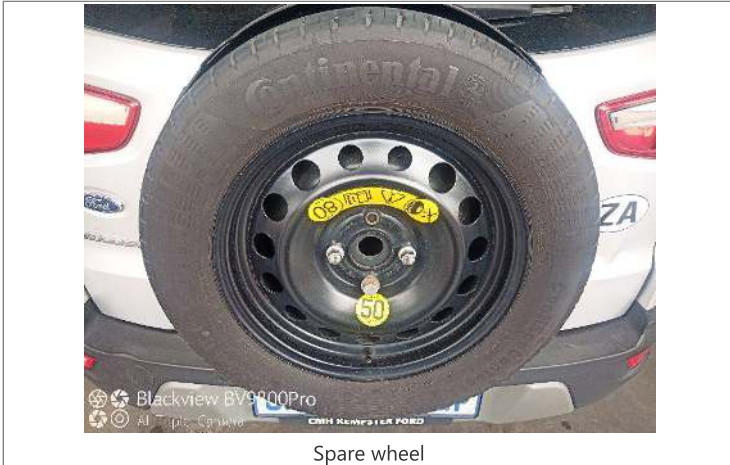
Damage	Repair Way
Under bonnet insulation cover Defective	Repair
Front Bumper Paintwork • Discoloured	Repair
Bonnet Paintwork • Scratched	Repair
Front Fender Left Corrosion	Repair
Rear Fender Left Paintwork • Scratched	Repair
Door Front Left Paintwork • Scratched	Repair
Door Front Right Paintwork • Scratched	Repair
Door Rear Right Paintwork • Scratched	Repair
Boot Lid / Hatch door Dented	Repair
Rear bumper Paintwork • Scratched	Repair
Windscreen Chipped	Repair
Control Arm(s) Front Axle Left Defective	Replace
Tyre Front Right Smooth	Replace
Gearbox Mountings Damaged	Replace
CV Joint(s) Boot(s) Front Left (inner/outer) Defective	Repair
Spare wheel cover missing	Replace
Airbag light on	Repair

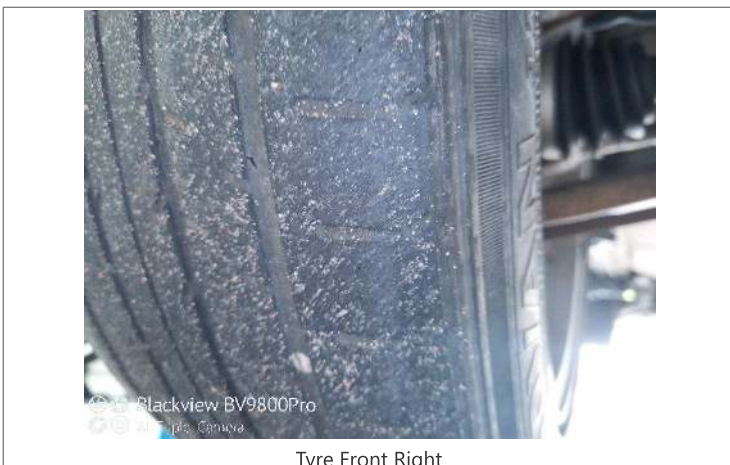
Tyre Front Right

Size	Load/Speed Index	Manufacture	Model	Type*	Production Date	Tread Depth (mm)
Front Left	205/50R17	93W	Dunlop	Sp sport	V	3621	3 mm
Front Right	205/50R17	89V	Yokohama	Advan	V	3215	0 mm
Rear Left	205/50R17	93W	Gt radial	Champiro	V	1921	2 mm
Rear Right	205/50R17	89V	Apollo	Alnac	V	2821	1 mm
Spare	205/60R16	92H	Continental	Contact	V	3019	5 mm
