| Manufacturer | FORD | Registration Number | KDL218NW |
| Model | FOCUS 1.5 ECOBOOST TREND 5-DR POWERSHIFT [2015-2018] | Register Number | |

## CONDITION REPORT

Report No: 2016670339

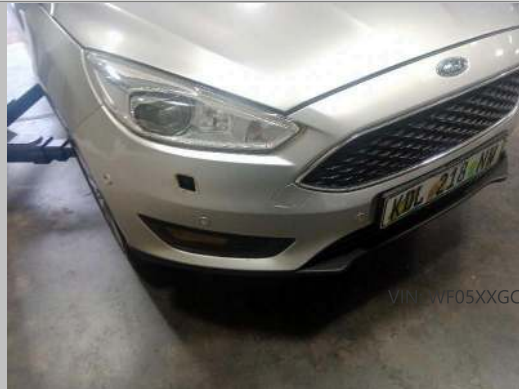
| Damage | Repair Way |
|---|---|
| Front Bumper Damaged | Repair |

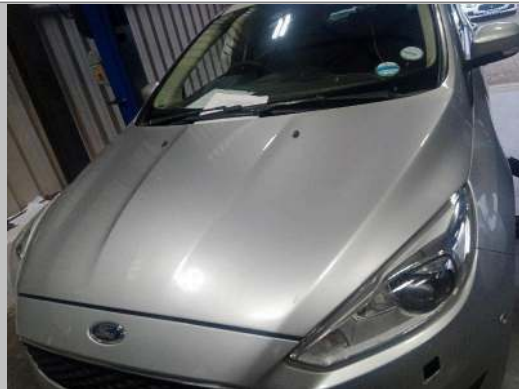
| Damage | Repair Way |
|---|---|
| Bonnet Damaged | Repair |

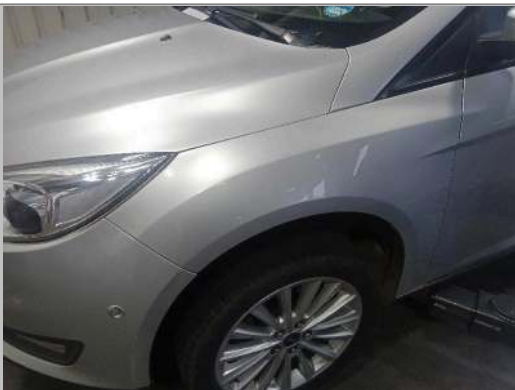
| Damage | Repair Way |
|---|---|
| Front Fender Left Damaged | Repair |

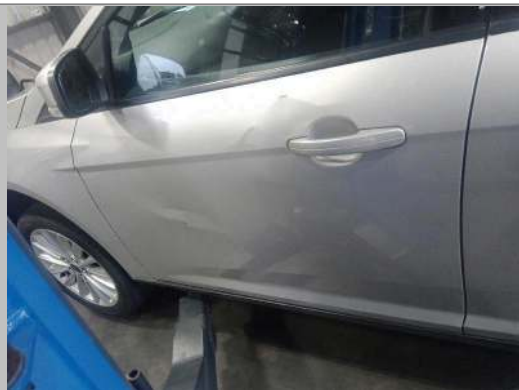
| Damage | Repair Way |
|---|---|
| Door Front Left Damaged | Repair |

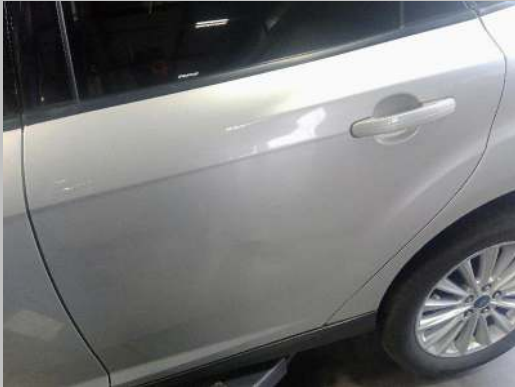
| Damage | Repair Way |
|---|---|
| Door Rear Left Damaged | Repair |

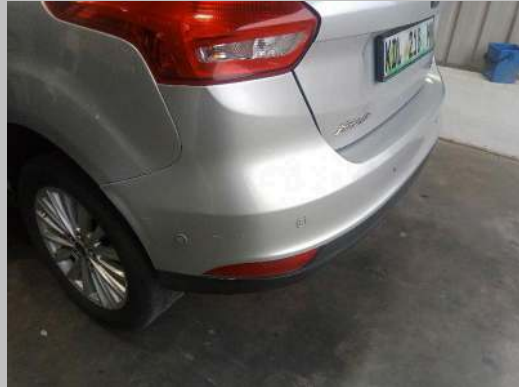
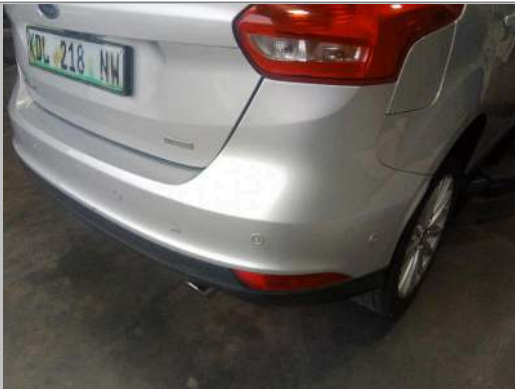
| Damage | Repair Way |
|---|---|
| Rear bumper Damaged | Repair |

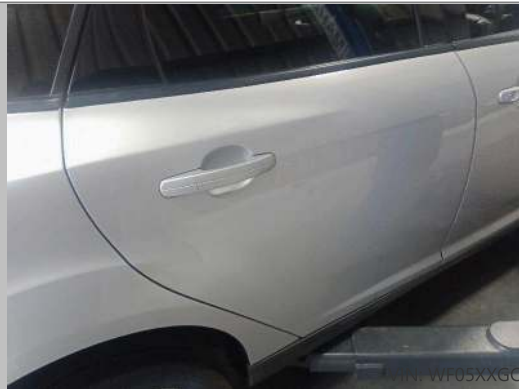
| Damage | Repair Way |
|---|---|
| Door Rear Right Damaged | Repair |

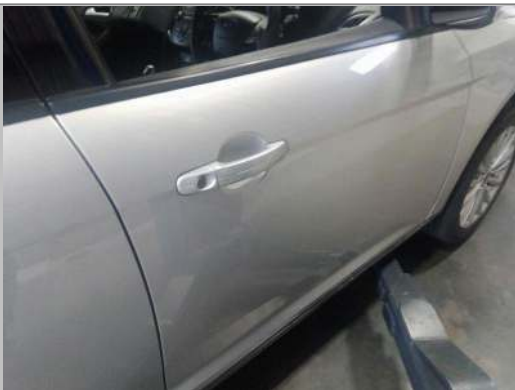
| Damage | Repair Way |
|---|---|
| Door Front Right Damaged | Repair |

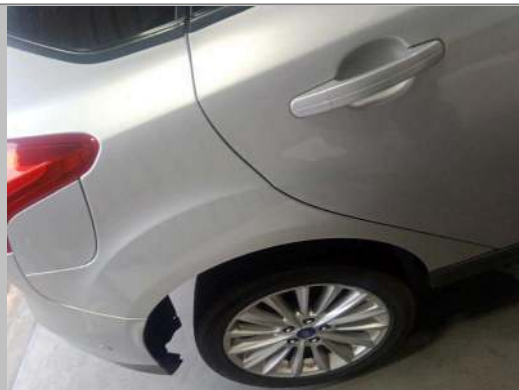
| Damage | Repair Way |
|---|---|
| Rear Fender Right Damaged | Replace |

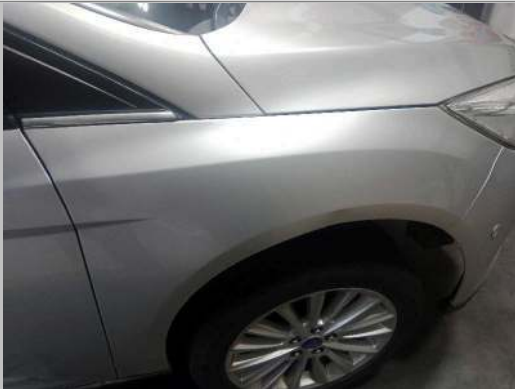
| Damage | Repair Way |
|---|---|
| Front Fender Right Damaged | Repair |

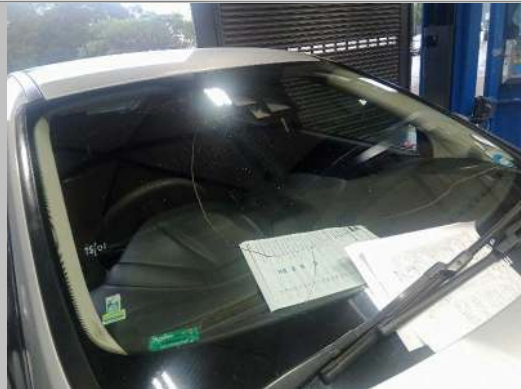
| Damage | Repair Way |
|---|---|
| Windscreen Damaged | Repair |

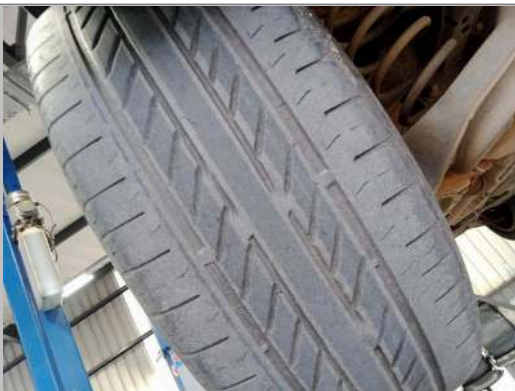
| Damage | Repair Way |
|---|---|
| Tyre Rear Left Worn | Replace |

| | Size | Load/Speed Index | Manufacture | Model | Type* | Production Date | Tread Depth (mm) |
|---|---|---|---|---|---|---|---|
| Rear Left | 225/55R17 | 101Y | Continental | Contipremium | V | 0416 | 0 mm |

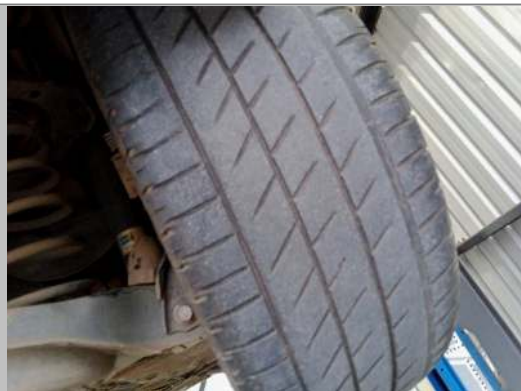
| Damage | Repair Way |
|---|---|
| Tyre Rear Right Worn | Replace |

| | Size | Load/Speed Index | Manufacture | Model | Type* | Production Date | Tread Depth (mm) |
|---|---|---|---|---|---|---|---|
| Rear Right | 235/45R17 | 97W | Cachland | Radial | V | 4821 | 0 mm |

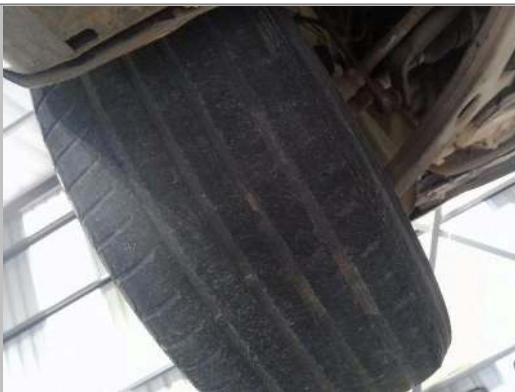
| Damage | Repair Way |
|---|---|
| Tyre Front Left Worn | Replace |

| | Size | Load/Speed Index | Manufacture | Model | Type* | Production Date | Tread Depth (mm) |
|---|---|---|---|---|---|---|---|
| Front Left | 215/50R17 | 91V | Hankook | Radial | V | 1813 | 0 mm |

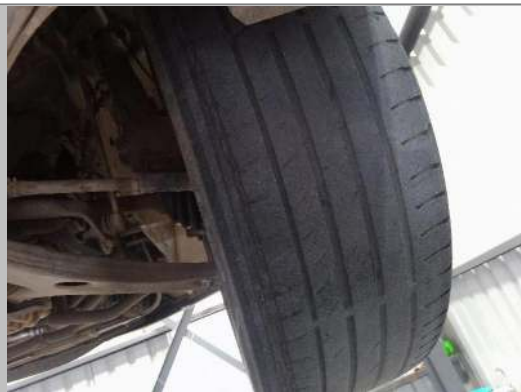
| Damage | Repair Way |
|---|---|
| Tyre Front Right Worn | Replace |

| | Size | Load/Speed Index | Manufacture | Model | Type* | Production Date | Tread Depth (mm) |
|---|---|---|---|---|---|---|---|
| Front Right | 225/50R17 | 98W | Nexen | Radial | V | 4120 | 0 mm |

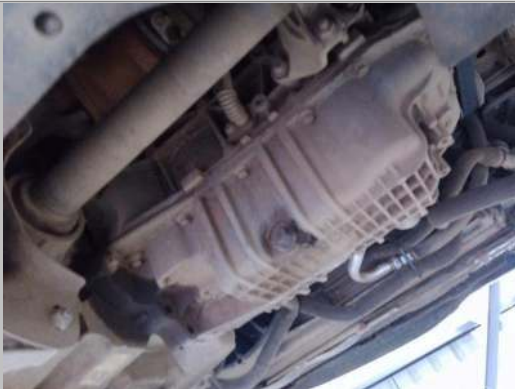
| Damage | Repair Way |
|---|---|
| Engine Oil Sweat | Repair |

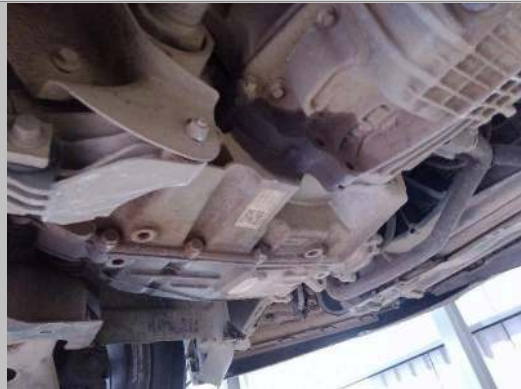
| Damage | Repair Way |
|---|---|
| Gearbox Oil Sweat | Repair |

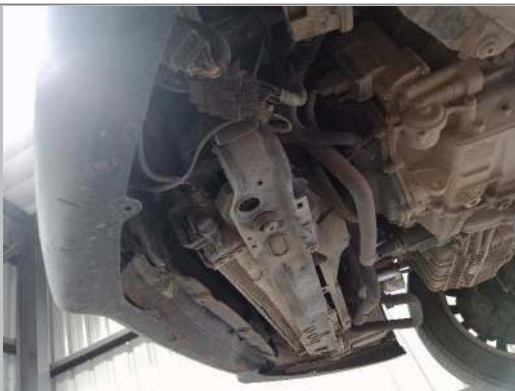
| Damage | Repair Way |
|---|---|
| Radiator Cradle Damaged | Replace |

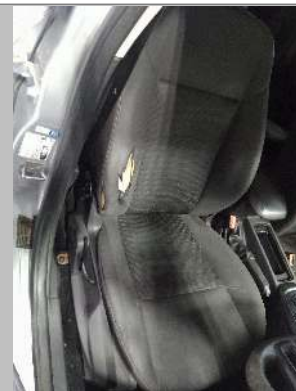
| Damage | Repair Way |
|---|---|
| Seat Front Right Damaged | Repair |

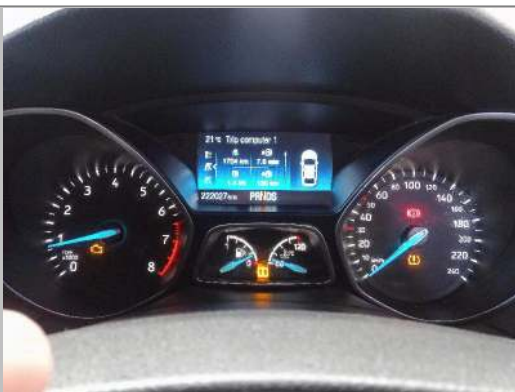
| Damage | Repair Way |
|---|---|
| Engine Management Lights Set | Repair |

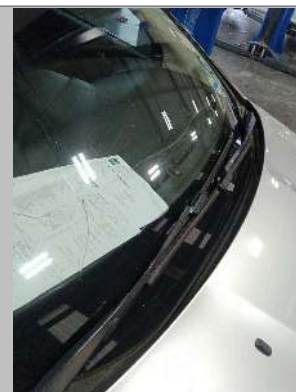
| Damage | Repair Way |
|---|---|
| Windscreen Wiper Worn | Replace |
