## CONDITION REPORT

Report No: 2016866839

| Manufacturer | FORD | Registration Number | JB40BLGP |
| Model | KUGA 2.0 ECOBOOST TITANIUM AWD AT [2014-2016] | Register Number | |

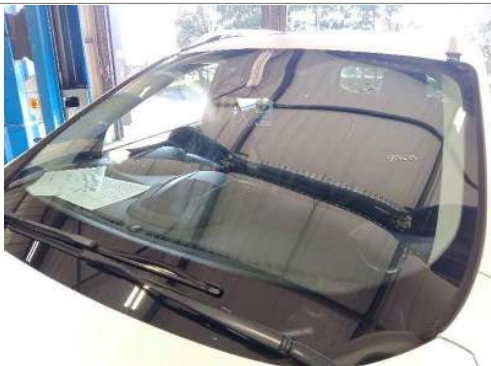
| Damage | Repair Way |
|---|---|
| Body and Exterior | Vehicle license disk missing |

No license disc

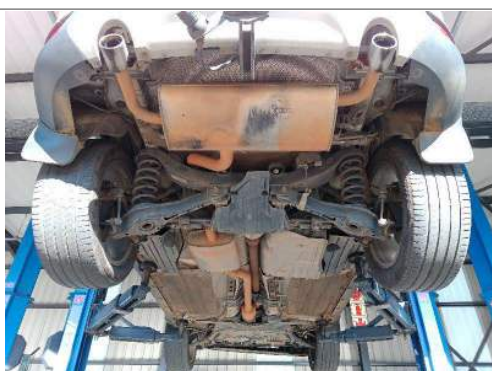
Rear chassis

| Damage | Repair Way |
|---|---|
| Body and Exterior | Traces of repair work done on rear of vehicle. |

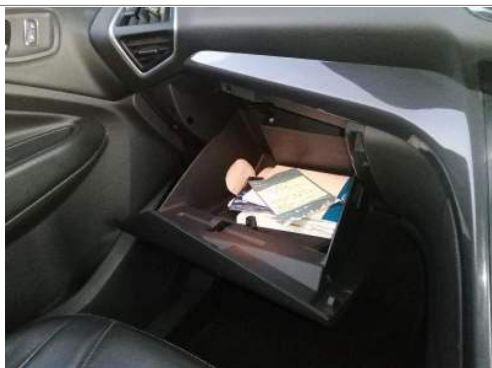
| Damage | Repair Way |
|---|---|
| Center Console / Cubbyhole + Lid Defective | Repair |

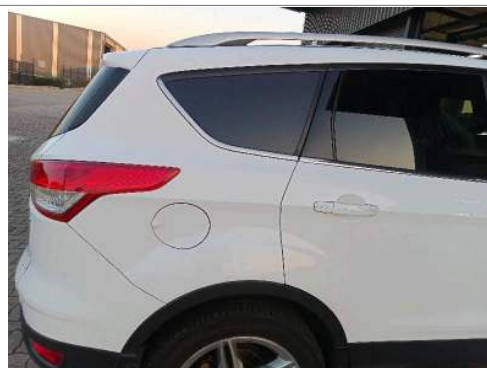
| Damage | Repair Way |
|---|---|
| Rear Fender Right Paintwork • Scratched | Repair |

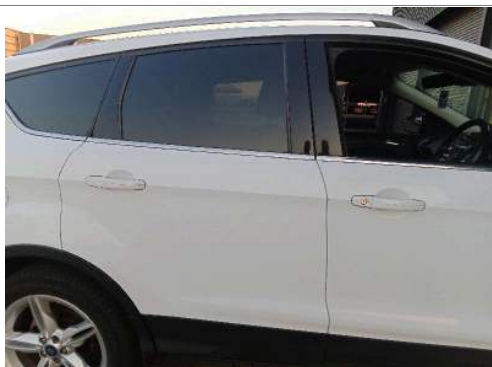
| Damage | Repair Way |
|---|---|
| Door Rear Right Paintwork • Scratched | Repair |

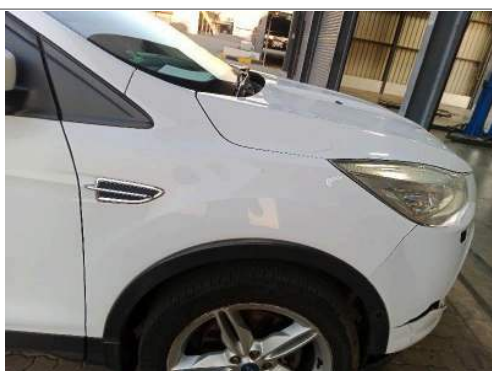
| Damage | Repair Way |
|---|---|
| Front Fender Right Paintwork • Scratched | Repair |

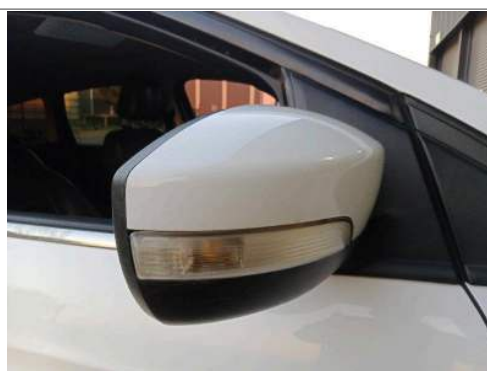
| Damage | Repair Way |
|---|---|
| Indicator Light Front Right Broken | Repair |

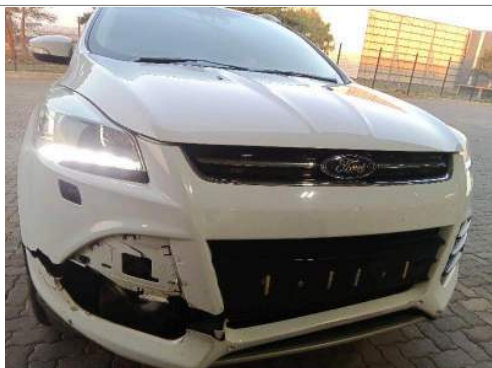
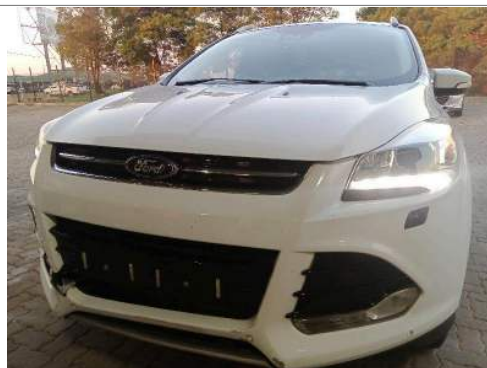
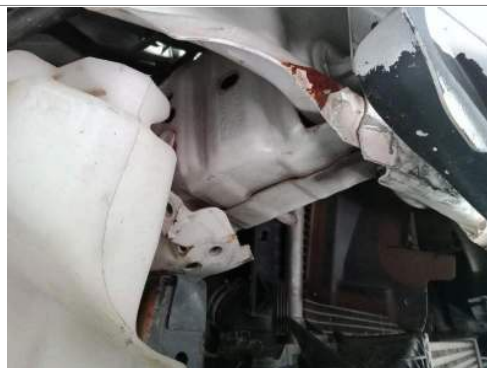
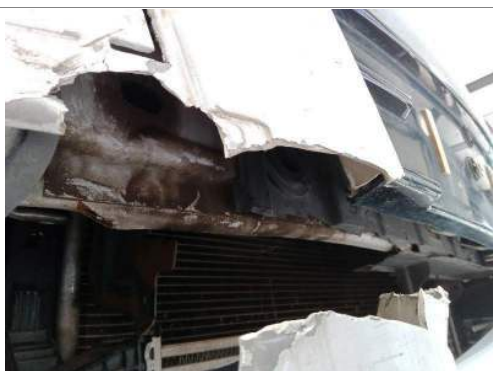
| Damage | Repair Way |
|---|---|
| Front Bumper Damaged | Repair |

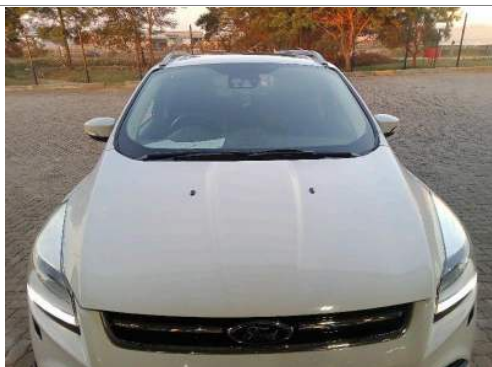
| Damage | Repair Way |
|---|---|
| Bonnet Paintwork • Scratched | Repair |

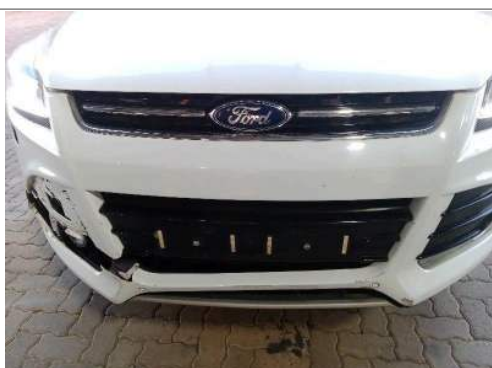
| Damage | Repair Way |
|---|---|
| Number Plate Front Missing | Replace |

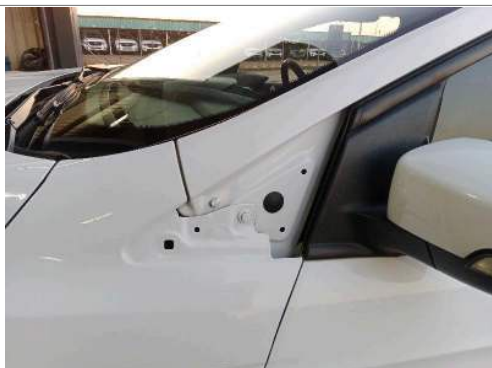
| Damage | Repair Way |
|---|---|
| Front Fender Left Dented | Repair |

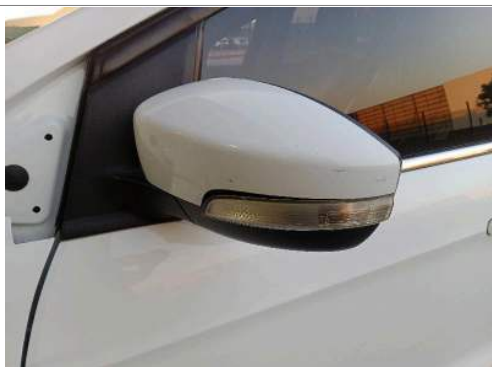
| Damage | Repair Way |
|---|---|
| Indicator Light Front Left Damaged | Repair |

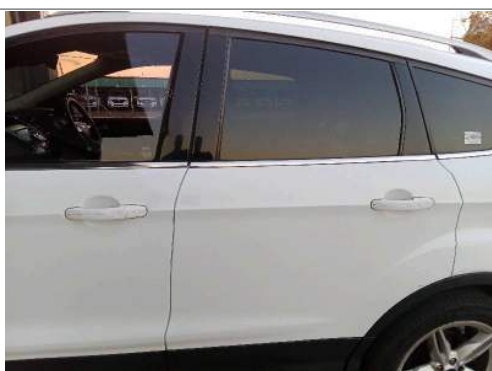
| Damage | Repair Way |
|---|---|
| Door Rear Left Paintwork • Scratched | Repair |

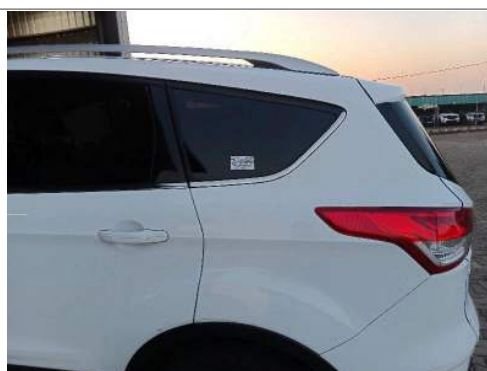
| Damage | Repair Way |
|---|---|
| Rear Fender Left Paintwork • Scratched | Repair |

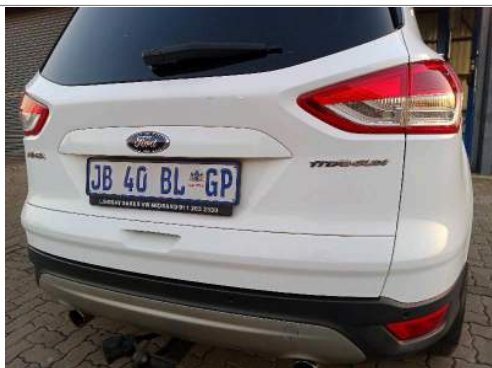
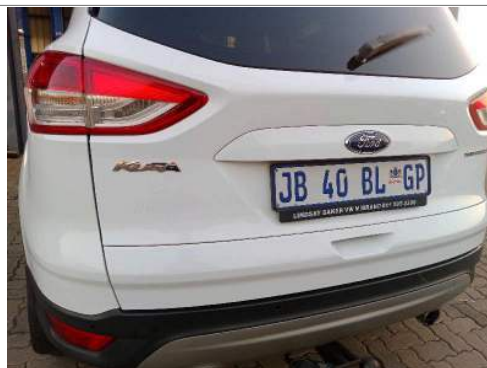
| Damage | Repair Way |
|---|---|
| Rear bumper Paintwork • Scratched | Repair |

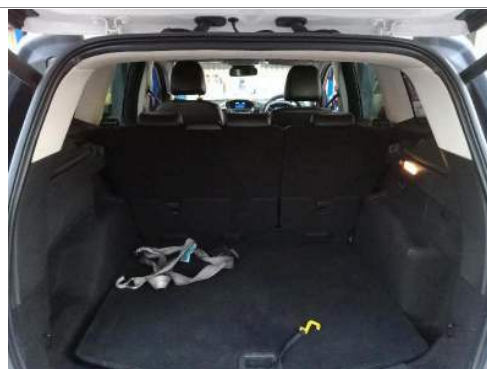
| Damage | Repair Way |
|---|---|
| Parcel Tray Missing | Replace |

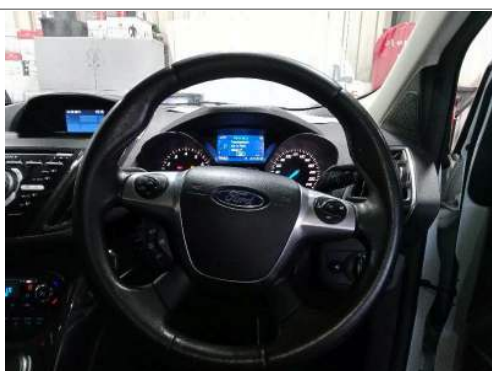
| Damage | Repair Way |
|---|---|
| Steering Wheel Trim Defective | Repair |

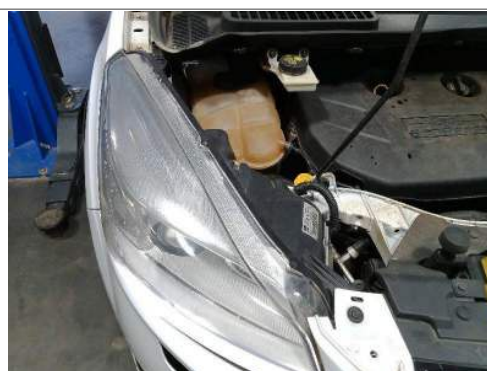
| Damage | Repair Way |
|---|---|
| Headlight Right Damaged | Replace |

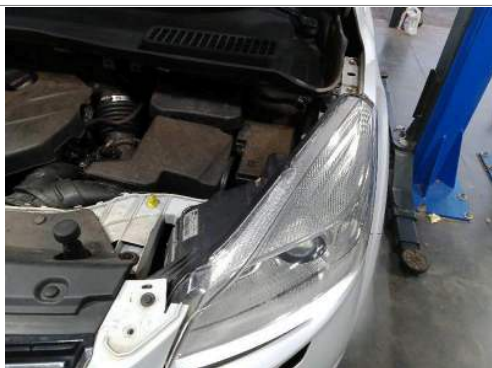
| Damage | Repair Way |
|---|---|
| Headlight Left Damaged | Replace |

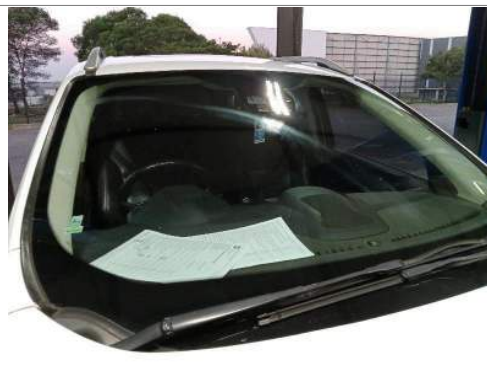
| Damage | Repair Way |
|---|---|
| Windscreen Cracked | Replace |

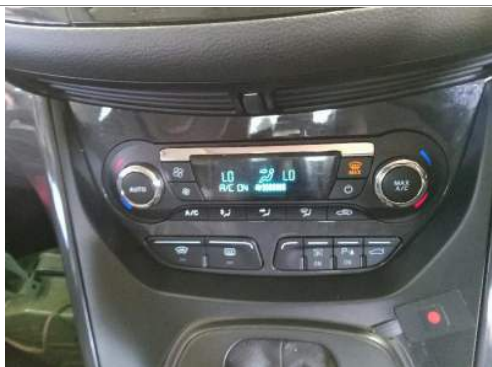
| Damage | Repair Way |
|---|---|
| Air Conditioner Insufficient | Replace |

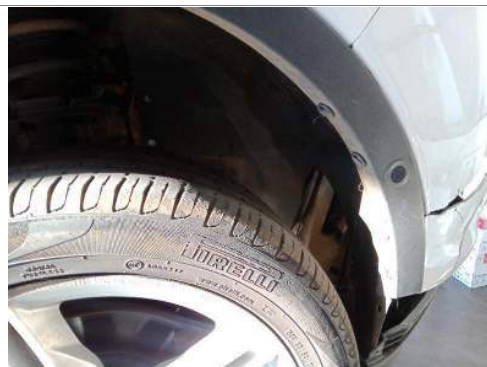
| Damage | Repair Way |
|---|---|
| Front Fender Right / Inner Tray Damaged | Replace |

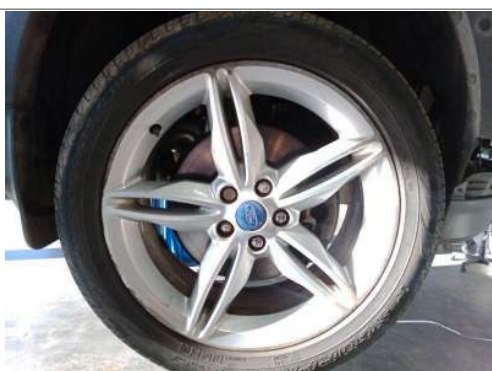
| Damage | Repair Way |
|---|---|
| Rim Front Right Scratched | Repair |

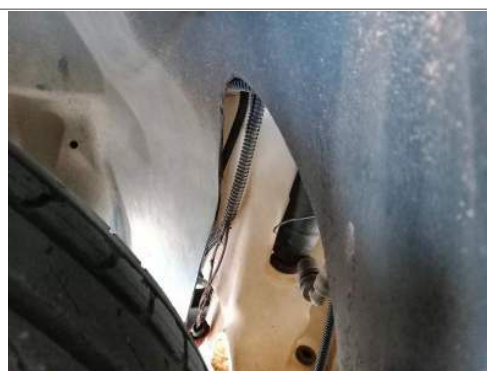
| Damage | Repair Way |
|---|---|
| Engine Wiring Damaged | Repair |

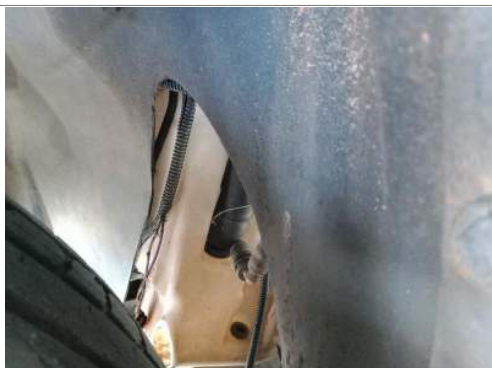
| Damage | Repair Way |
|---|---|
| Windscreen Washer Damaged | Replace |

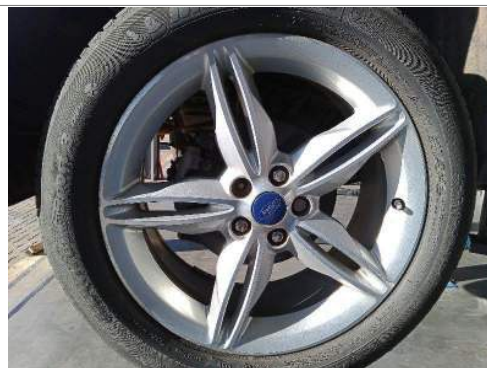
| Damage | Repair Way |
|---|---|
| Bolt(s) / Nut(s) Rear Wheel Right Missing | Replace |

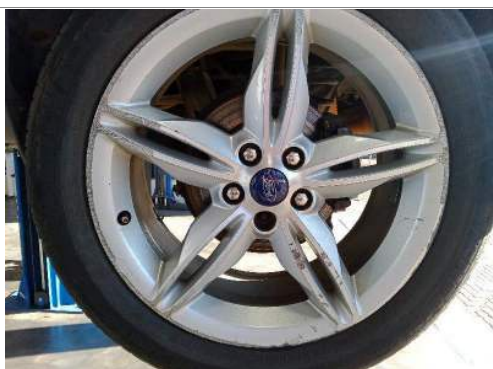
| Damage | Repair Way |
|---|---|
| Bolt(s) / Nut(s) Rear Wheel Left Missing | Replace |

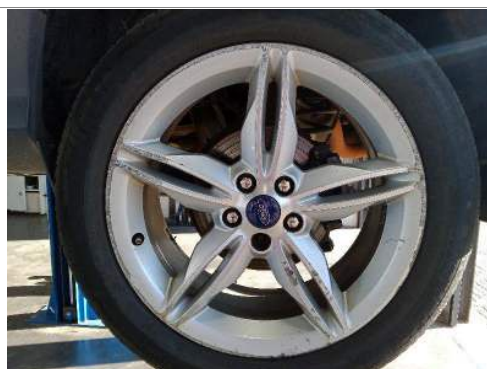
| Damage | Repair Way |
|---|---|
| Rim Rear Left Damaged | Repair |

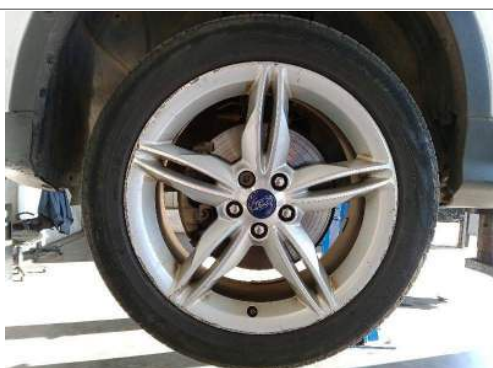
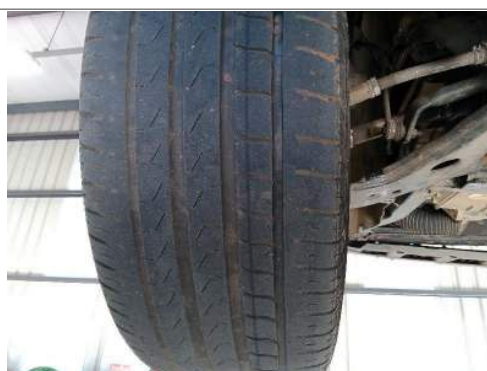
| Damage | Repair Way |
|---|---|
| Tyre Front Left Damaged | Replace |

| | Size | Load/Speed Index | Manufacture | Model | Type* | Production Date | Tread Depth (mm) |
|---|---|---|---|---|---|---|---|
| Front Left | 255/45 R19 | 100V | Pirelli | Scorpion | V | 1618 | 0 mm |

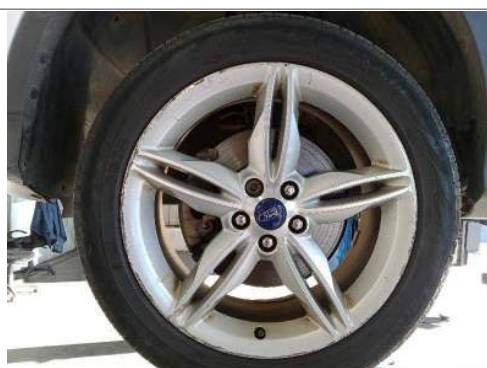
| Damage | Repair Way |
|---|---|
| Rim Front Left Scratched | Repair |

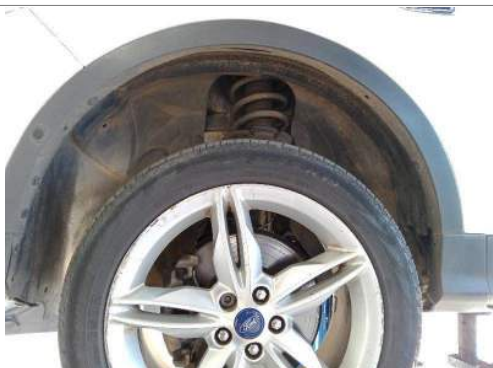
| Damage | Repair Way |
|---|---|
| Front Fender Left / Inner Tray Damaged | Repair |

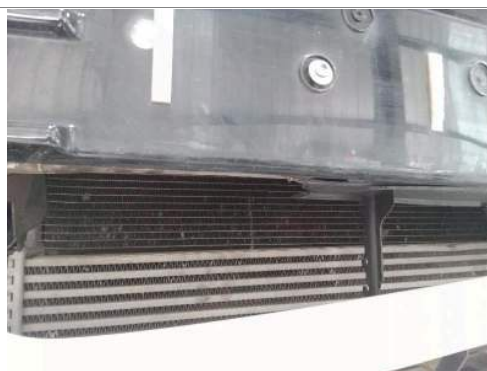
| Damage | Repair Way |
|---|---|
| Radiator Defective | Repair |

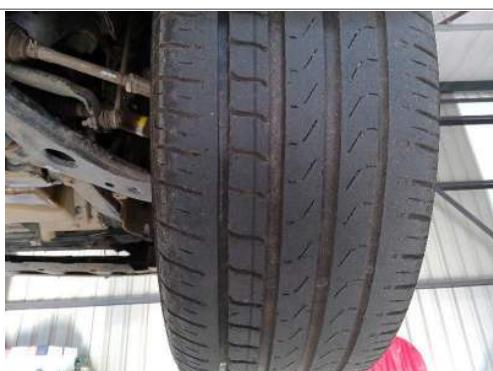
| Damage | Repair Way |
|---|---|
| Tyre Front Right Damaged | Replace |

| | Size | Load/Speed Index | Manufacture | Model | Type* | Production Date | Tread Depth (mm) |
|---|---|---|---|---|---|---|---|
| Front Right | 255/45 R19 | 100V | Pirelli | Scorpion | V | 1618 | 0 mm |

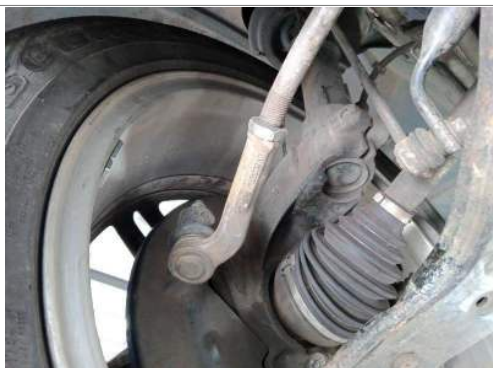
| Damage | Repair Way |
|---|---|
| Tie Rod End left Damaged | Replace |

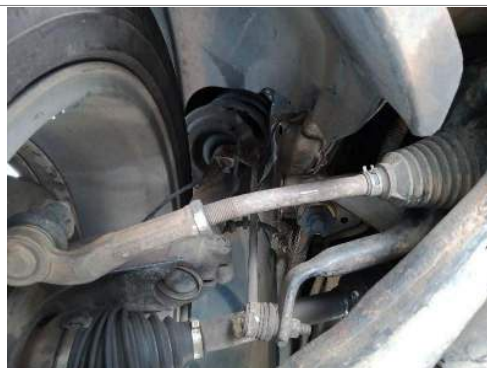
| Damage | Repair Way |
|---|---|
| Tie Rod left Damaged | Replace |

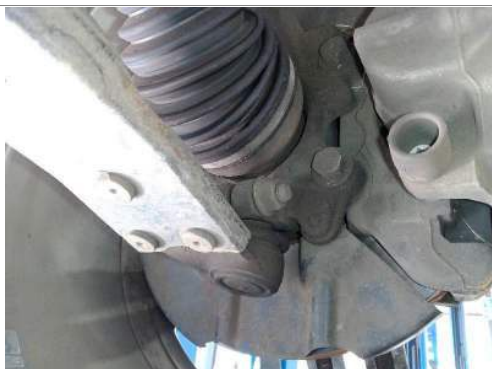
| Damage | Repair Way |
|---|---|
| Ball Joint(s) Front Axle Left Damaged | Replace |

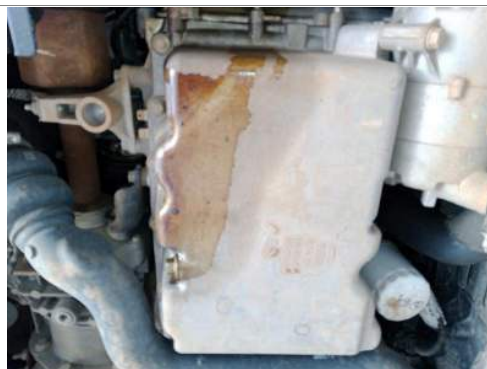
| Damage | Repair Way |
|---|---|
| Engine Oil Leak | Repair |

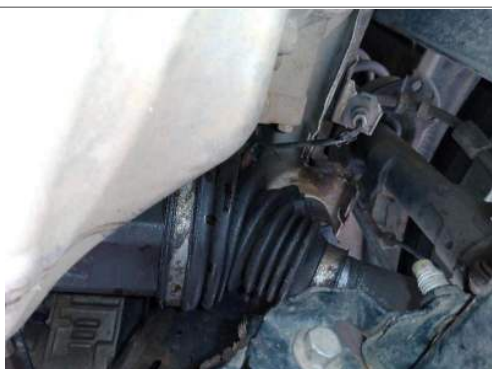
| Damage | Repair Way |
|---|---|
| CV Joint(s) Boot(s) Front Left (inner/outer) Damaged | Replace |

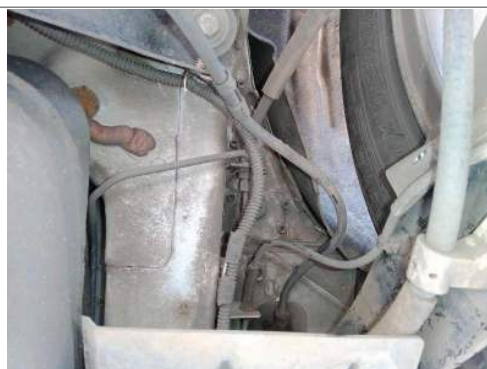
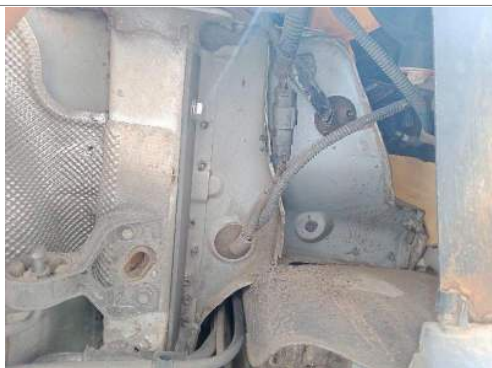
| Damage | Repair Way |
|---|---|
| Rear Fender Right / Inner Tray Residual Traces of Repair | Repair |

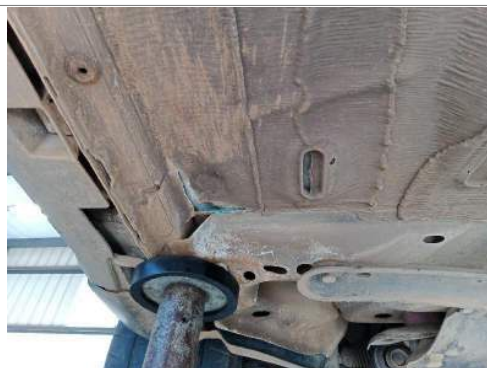
| Damage | Repair Way |
|---|---|
| Chassis Damaged | Repair |

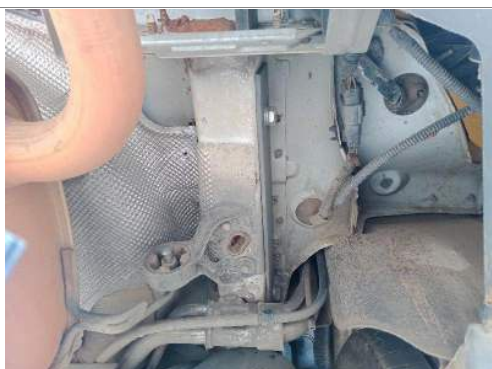
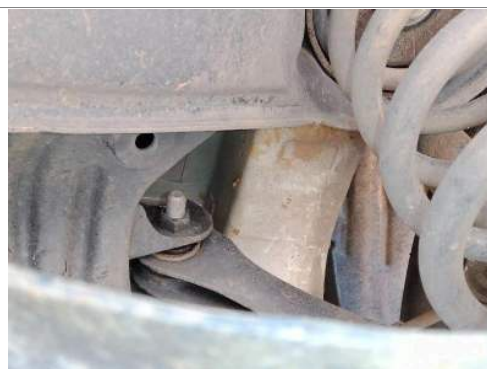
| Damage | Repair Way |
|---|---|
| Main Beam Right Residual Traces of Repair | Repair |

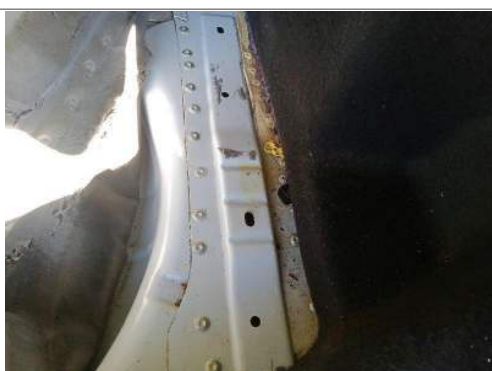
| Damage | Repair Way |
|---|---|
| Inner Boot Floor Pan and Spare Wheel Well Residual Traces of Repair | Repair |

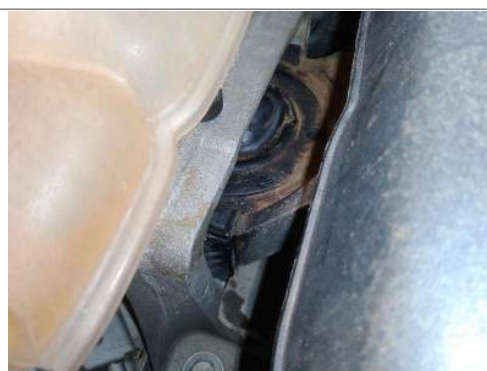
| Damage | Repair Way |
|---|---|
| Engine mountings Damaged | Replace |

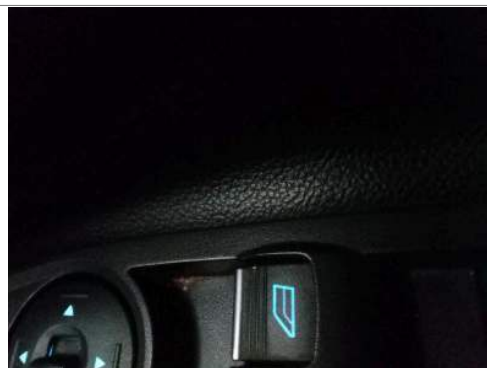
| Damage | Repair Way |
|---|---|
| Switch Electrical Window Winder front right Malfunction | Replace |
