DEKRA MFC
M57 Pretoria Rd - 1619
KEMPTON PARK - GT
08610 33572

Vehicle Type	PASSENGER VEHICLE	Registered Owner	MFC
Manufacturer	FORD	Registration Number	HV06RLGP
Model	FIESTA	Register Number	
VIN	WFOJXXGAHJJB66814	Date Of First Licensing	
Engine Number		Last COR	
Doors	5	License Expiry Date	31/12/2023
Color	BROWN	Power / Displacement	
Year Model		Paint Finish	TWO COAT METALLIC
Km Reading	64,852 KM	Fuel	PETROL
Cab / Body Type	HATCHBACK	Transmission	MANUAL

CONDITION REPORT

Report No: 2016212366

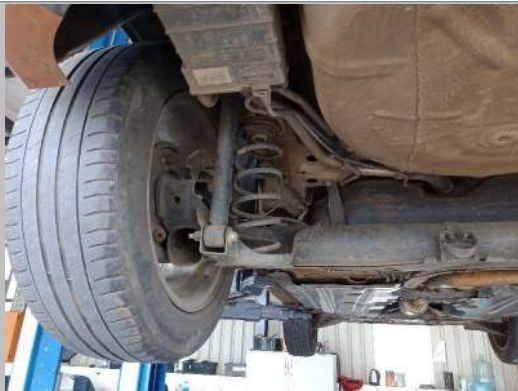
LR TYRE TREAD

Size	Load/Speed Index	Manufacture	Model	Type*	Production Date	Tread Depth (mm)
Front Left	195/55 R16	91H	Campiro	GT Radial	V	3721	3 mm
Front Right	195/55 R16	91H	Campiro	GT Radial	V	5021	3 mm
Rear Left	195/55 R16	87V	Michelin	Primacy	V	3218	1 mm
Rear Right	195/55 R16	91V	Michelin	Primacy	V	0620	3 mm
Spare	195/50 R15	82V	Sumitomo	HTR V5	V	0322	7 mm

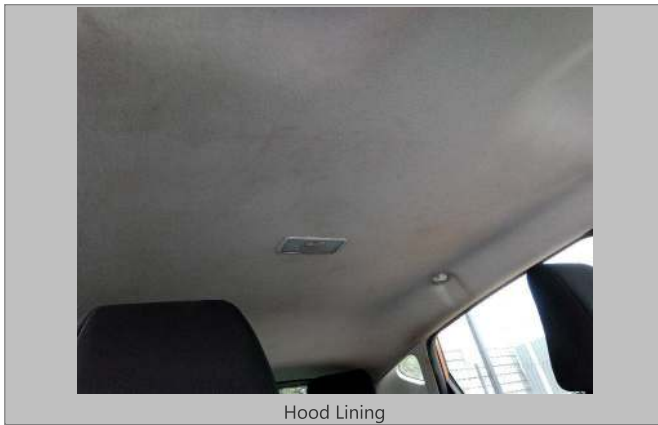
Damage	Repair Way
Engine Oil Leak	Repair
Air cleaner Defective	Repair
Switch Electrical Window Winder front left Defective	Repair
Switch Electrical Window Winder front right Damaged	Replace
Seat Front Left Dirty	Repair
Seat Front Right Defective	Repair
Seat Rear Damaged	Repair
Hood Lining Defective	Repair
Side Mirror Left Paintwork • Scratched	Repair
Side Mirror Right Paintwork • Scratched	Repair
Front Bumper Residual Traces of Repair	Repair
Bonnet Residual Traces of Repair	Repair
Front Fender Left Paintwork • Scratched	Repair
Front Fender Right Residual Traces of Repair	Repair
Rear Fender Left Dented	Repair
Rear Fender Right Paintwork • Scratched	Repair
Door Front Left Paintwork • Scratched	Repair
Door Front Right Dented	Repair
Door Rear Left Paintwork • Scratched	Repair
Door Rear Right Dented	Repair
Rear bumper Paintwork • Scratched	Repair
Fuel Cap Damaged	Replace
Rocker Panel Left Dented	Repair
Rocker Panel Right Dented	Repair

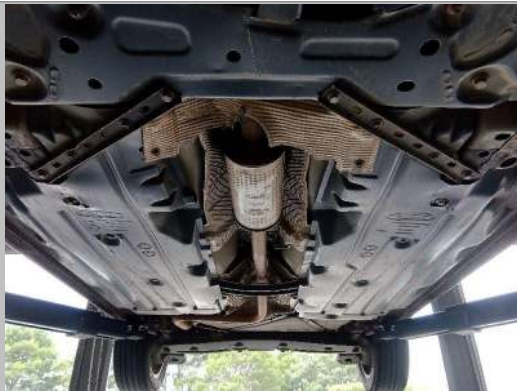
Damage	Repair Way
Cross Member Front Left Dented	Repair
Cross Member Front Right Dented	Repair
Sub Frame Dented	Repair
Engine to silencer pipe Defective	Repair
Belly plates Damaged	Replace
Gearbox Mountings Defective	Replace
Engine Noise Excessive	Repair
Triangle Missing	Replace

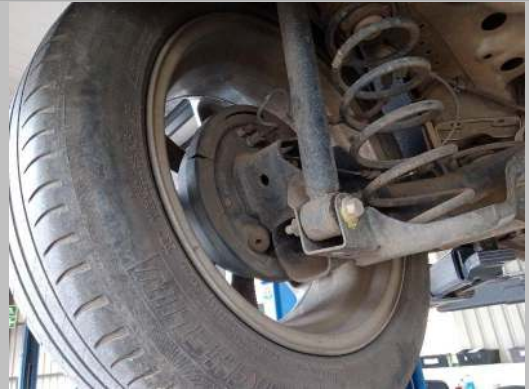
Roof Paintwork • Scratched	Repair
Windscreen Chipped	Replace
Rim Rear Left Dented	Repair
Main Beam Left Defective	Repair
Chassis Dented	Repair
