## CONDITION REPORT

Report No: 2016395361

DATE  
27/05/2024

| Manufacturer | FORD | Registration Number | HY11HTGP |

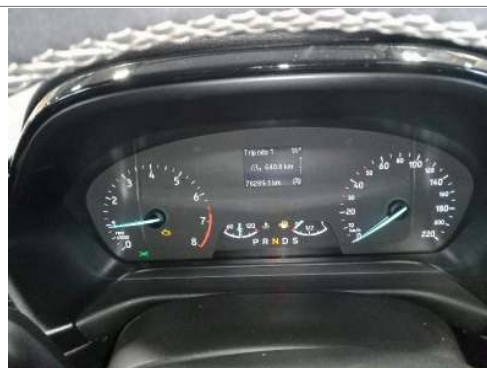
DASHBOARD (W/ ENGINE RUNNING)

| Damage | Repair Way |
|---|---|
| Engine light on | Repair |

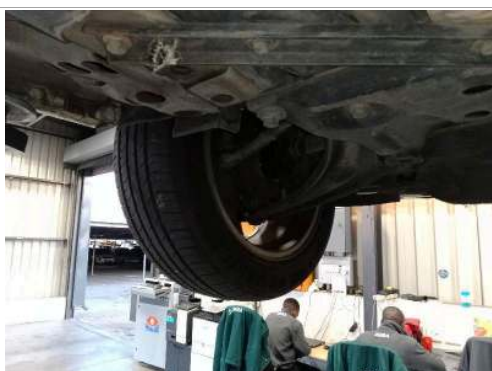
LF TYRE TREAD

| | Size | Load/Speed Index | Manufacture | Model | Type* | Production Date | Tread Depth (mm) |
|---|---|---|---|---|---|---|---|
| Front Left | 195/55R16 | 87V | Davanti | Dx390 | V | 0520 | 2 mm |

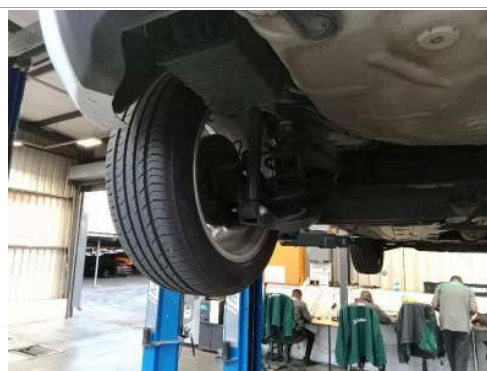
LR TYRE TREAD

| | Size | Load/Speed Index | Manufacture | Model | Type* | Production Date | Tread Depth (mm) |
|---|---|---|---|---|---|---|---|
| Rear Left | 195/55R16 | 87V | Davanti | Dx390 | V | 0521 | 3 mm |

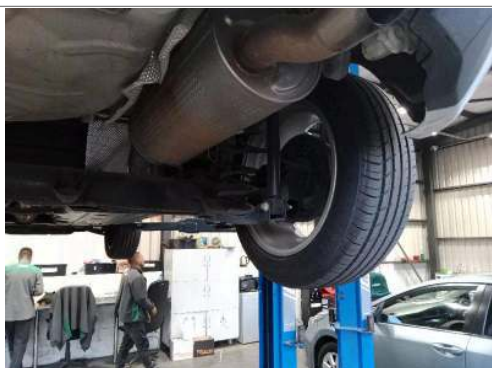
RR TYRE TREAD

| | Size | Load/Speed Index | Manufacture | Model | Type* | Production Date | Tread Depth (mm) |
|---|---|---|---|---|---|---|---|
| Rear Right | 195/55R16 | 87V | Davanti | Dx390 | V | 0521 | 3 mm |

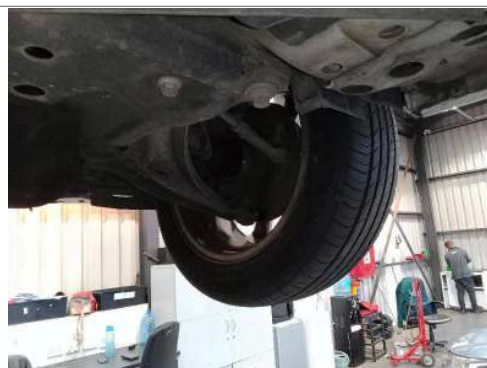
RF TYRE TREAD

| | Size | Load/Speed Index | Manufacture | Model | Type* | Production Date | Tread Depth (mm) |
|---|---|---|---|---|---|---|---|
| Front Right | 195/55R16 | 87V | Davanti | Dx390 | V | 0521 | 2 mm |

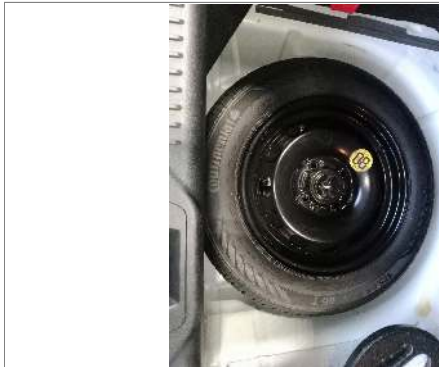
Spare wheel

| | Size | Load/Speed Index | Manufacture | Model | Type* | Production Date | Tread Depth (mm) |
|---|---|---|---|---|---|---|---|
| Spare | 175/65R14 | 86T | Continental | Contact | V | 2118 | 5 mm |

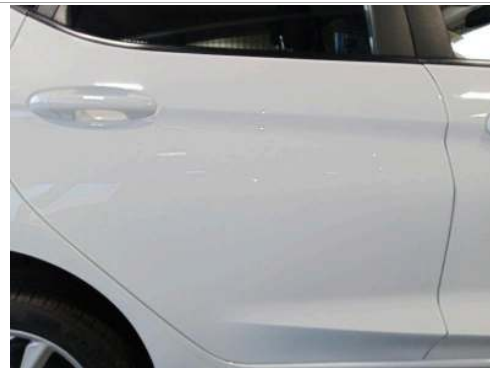
| Damage | Repair Way |
|---|---|
| Door Rear Right Paintwork • Scratched | Repair |

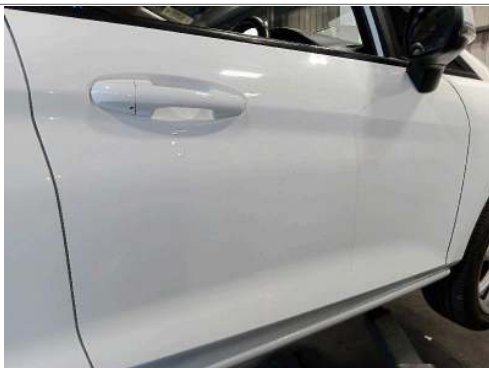
| Damage | Repair Way |
|---|---|
| Door Front Right Paintwork • Scratched | Repair |

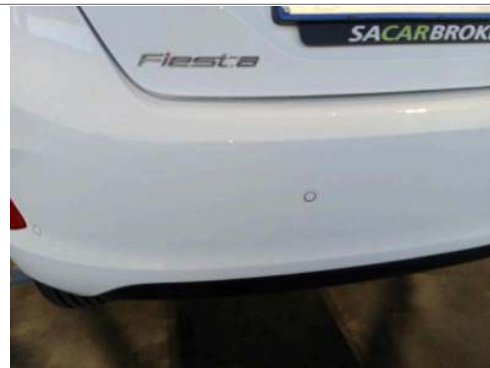
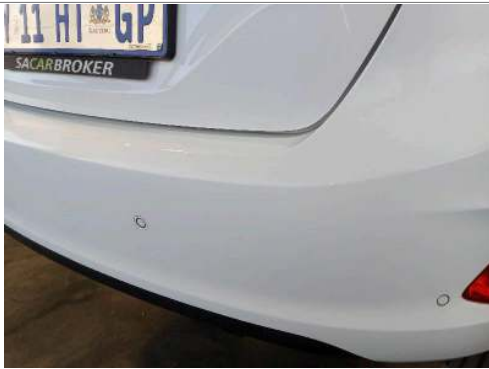
| Damage | Repair Way |
|---|---|
| Rear bumper Paintwork • Scratched | Repair |
