## CONDITION REPORT

Report No: 2016824067

DATE  
02/04/2025

| Manufacturer | FORD | Registration Number | KST174MP |

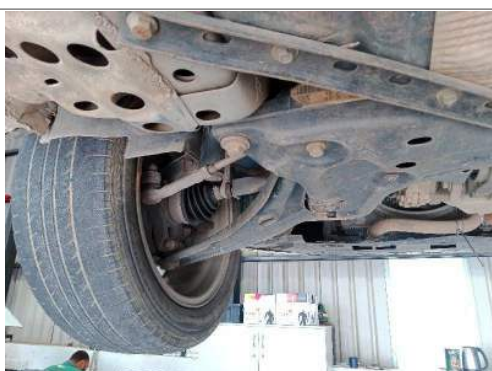
LF TYRE TREAD

| | Size | Load/Speed Index | Manufacture | Model | Type* | Production Date | Tread Depth (mm) |
|---|---|---|---|---|---|---|---|
| Front Left | 195/55 R16 | 91H | Campiro | GT Radial | V | 2321 | 1 mm |

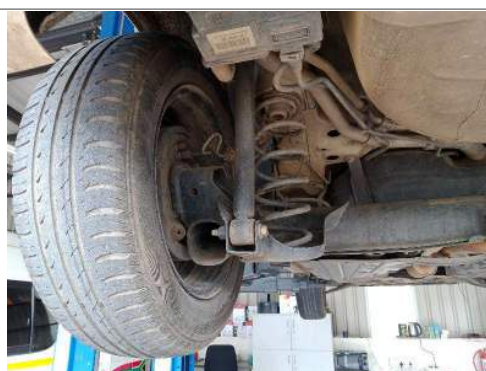
LR TYRE TREAD

| Damage | Repair Way |
|---|---|
| Tyres and rims | Rear left and right tyre sizes different |

| | Size | Load/Speed Index | Manufacture | Model | Type* | Production Date | Tread Depth (mm) |
|---|---|---|---|---|---|---|---|
| Rear Left | 175/65 R14 | 82T | Continental | ContiEco | V | 3413 | 1 mm |

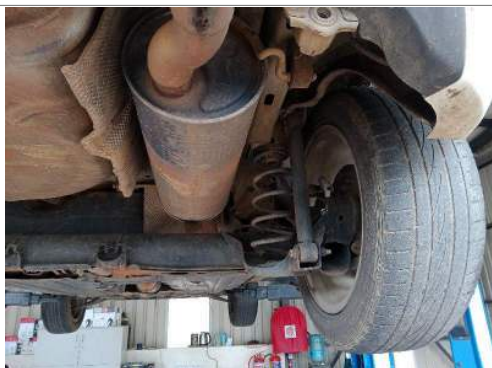
RR TYRE TREAD

| | Size | Load/Speed Index | Manufacture | Model | Type* | Production Date | Tread Depth (mm) |
|---|---|---|---|---|---|---|---|
| Rear Right | 195/55 R16 | 91V | Sumitomo | BC100 | V | 1419 | 0 mm |

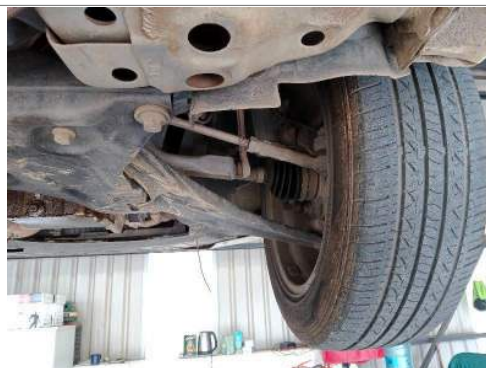
RF TYRE TREAD

| | Size | Load/Speed Index | Manufacture | Model | Type* | Production Date | Tread Depth (mm) |
|---|---|---|---|---|---|---|---|
| Front Right | 195/55 R16 | 87V | Anchee | Radial | V | 3823 | 2 mm |

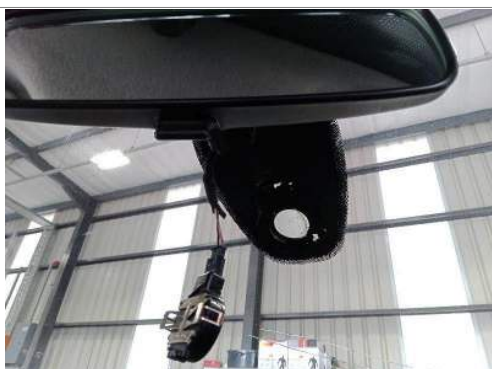
| Damage | Repair Way |
|---|---|
| Electrical instruments and components | Rain sensor damaged |

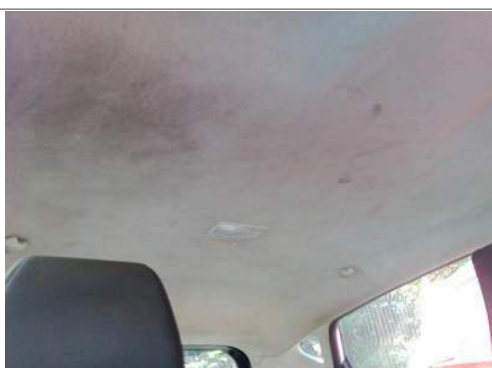
| Damage | Repair Way |
|---|---|
| Hood Lining Dirty | Repair |

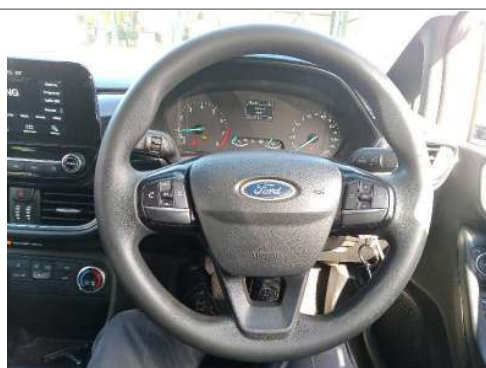
| Damage | Repair Way |
|---|---|
| Steering Wheel Trim Defective | Repair |

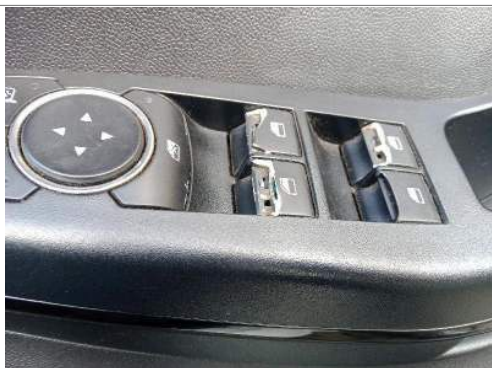
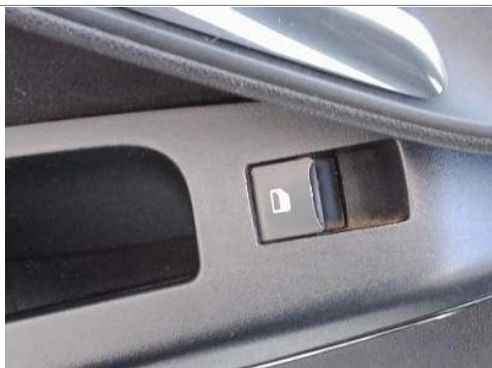
| Damage | Repair Way |
|---|---|
| Switch Electrical Window Winder front left Defective | Replace |

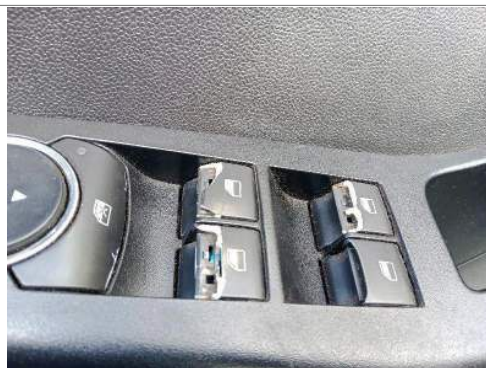
| Damage | Repair Way |
|---|---|
| Switch Electrical Window Winder front right Damaged | Replace |

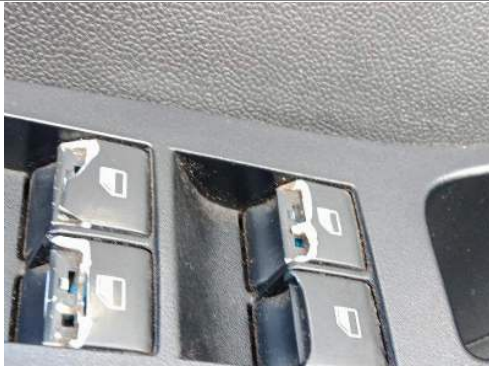
| Damage | Repair Way |
|---|---|
| Switch Electrical Window Winder rear right Damaged | Replace |

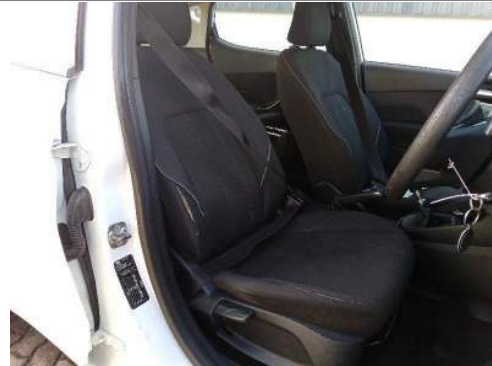
| Damage | Repair Way |
|---|---|
| Seat Front Right Damaged | Repair |

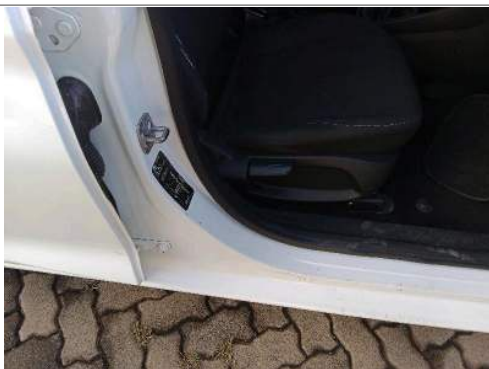
| Damage | Repair Way |
|---|---|
| B • Pillar Right Dented | Repair |

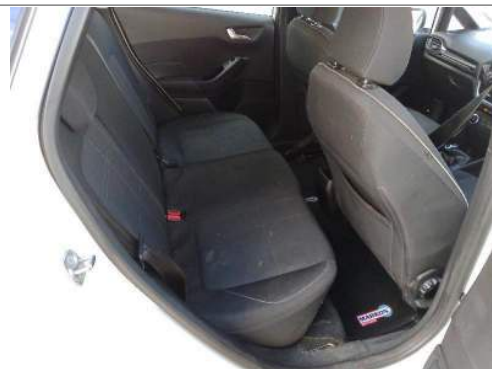
| Damage | Repair Way |
|---|---|
| Seat Rear Damaged | Repair |

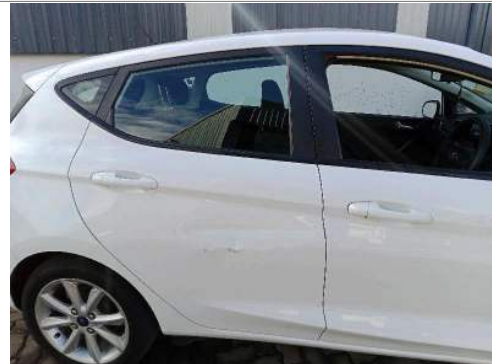
| Damage | Repair Way |
|---|---|
| Door Rear Right Damaged | Repair |

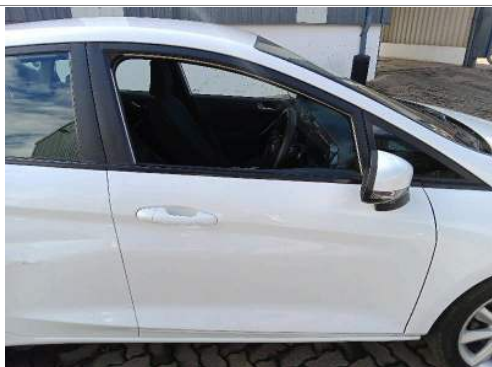
| Damage | Repair Way |
|---|---|
| Door Front Right Damaged | Repair |

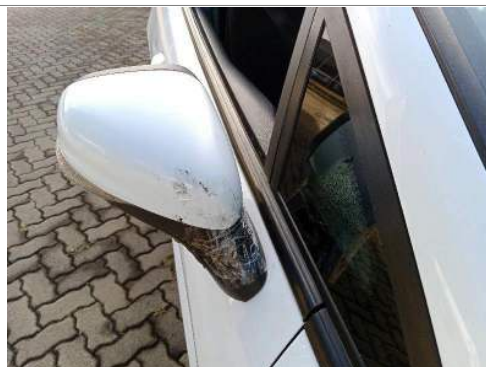
| Damage | Repair Way |
|---|---|
| Side Mirror Right Damaged | Repair |

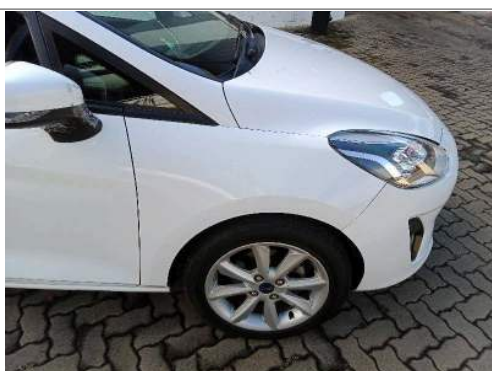
| Damage | Repair Way |
|---|---|
| Front Fender Right Paintwork • Scratched | Repair |

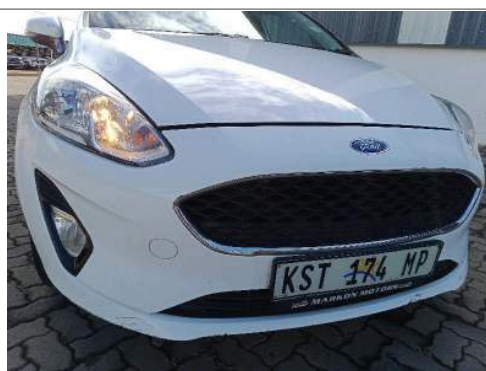
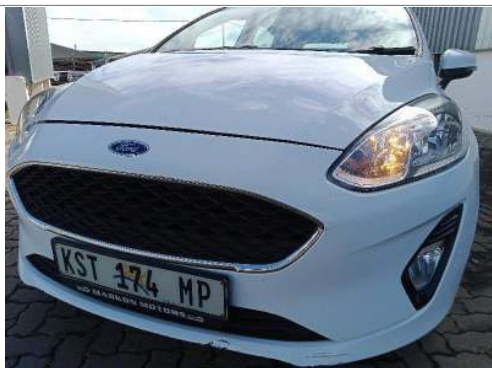
| Damage | Repair Way |
|---|---|
| Front Bumper Damaged | Repair |

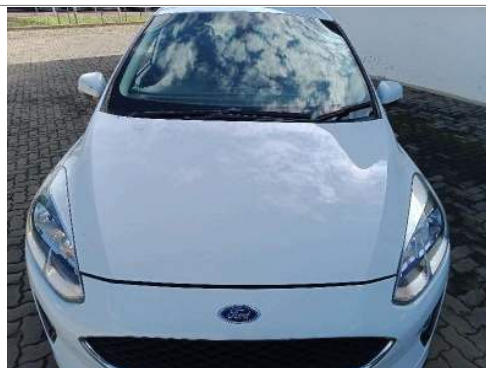
| Damage | Repair Way |
|---|---|
| Bonnet Dented | Repair |

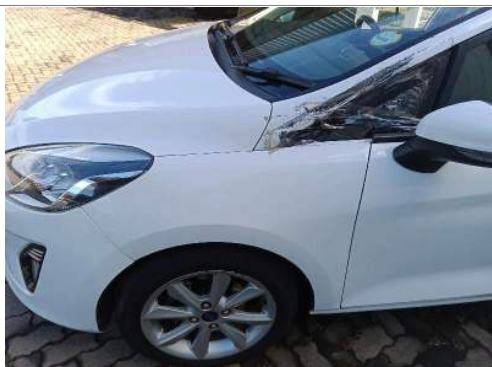
| Damage | Repair Way |
|---|---|
| Front Fender Left Damaged | Replace |

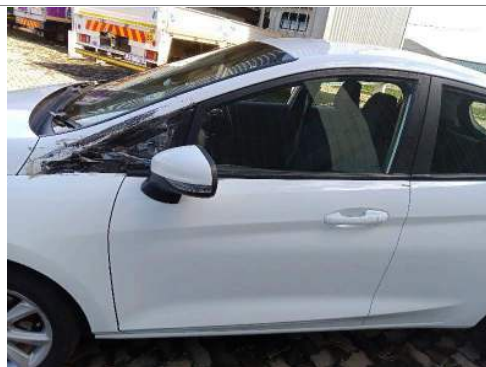
| Damage | Repair Way |
|---|---|
| Door Front Left Paintwork • Scratched | Repair |

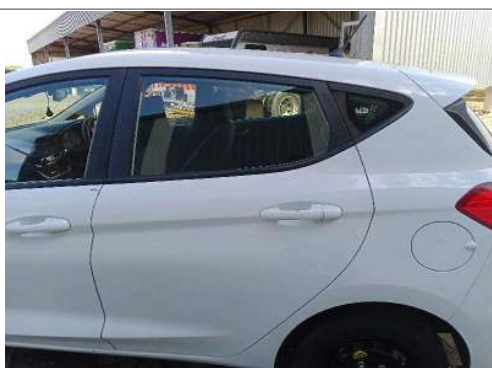
| Damage | Repair Way |
|---|---|
| Door Rear Left Paintwork • Scratched | Repair |

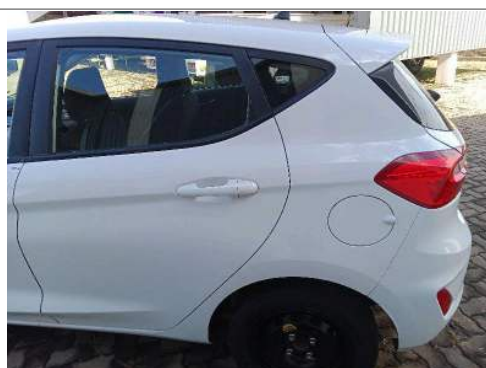
| Damage | Repair Way |
|---|---|
| Rear Fender Left Paintwork • Scratched | Repair |

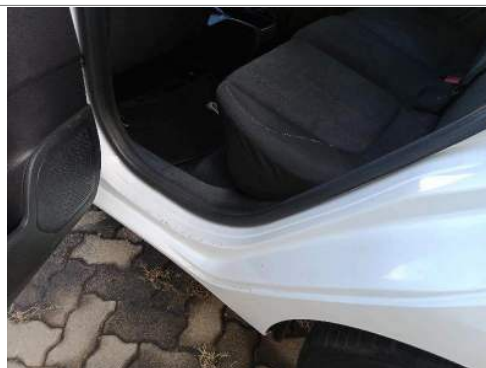
| Damage | Repair Way |
|---|---|
| Sill Panel Left Paintwork • Scratched | Repair |

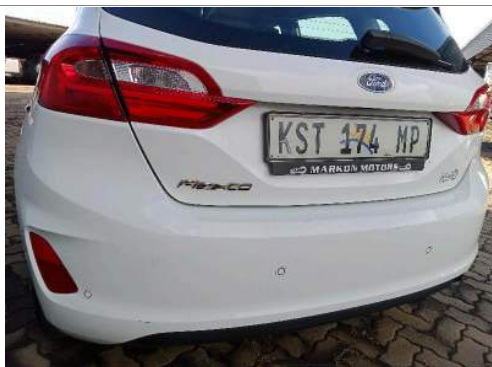
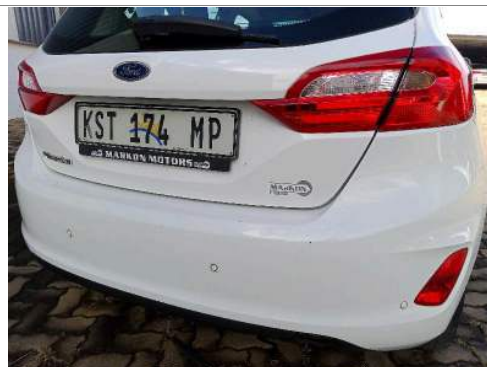
| Damage | Repair Way |
|---|---|
| Rear bumper Paintwork • Scratched | Repair |

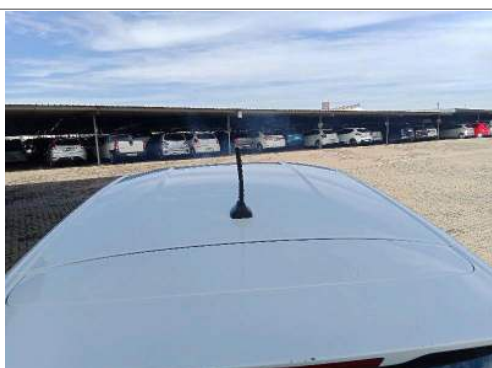
| Damage | Repair Way |
|---|---|
| Roof Dented | Repair |

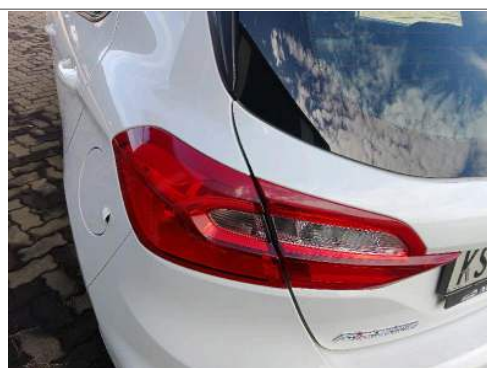
| Damage | Repair Way |
|---|---|
| Tail Light Left Cracked | Replace |

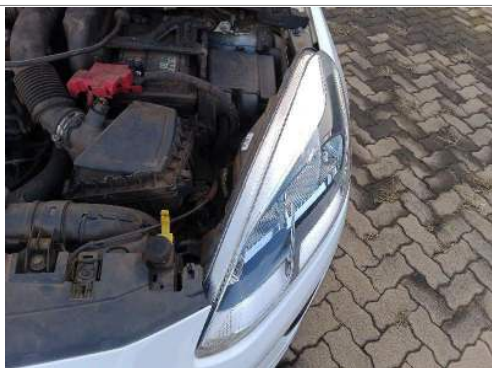
| Damage | Repair Way |
|---|---|
| Headlight Left Defective | Replace |

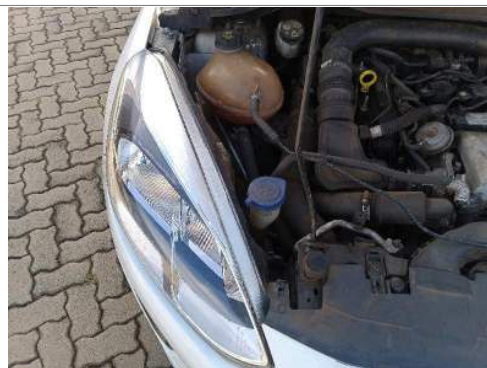
| Damage | Repair Way |
|---|---|
| Headlight Right Damaged | Replace |

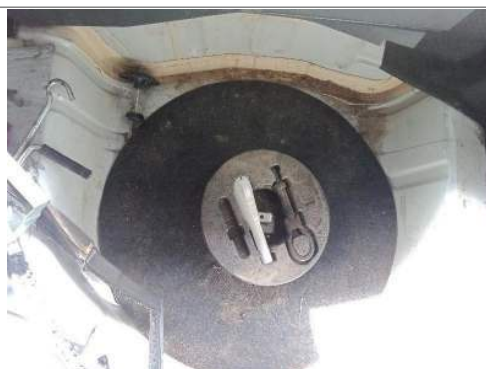
| Damage | Repair Way |
|---|---|
| Inner Boot Floor Pan and Spare Wheel Well Dented | Repair |

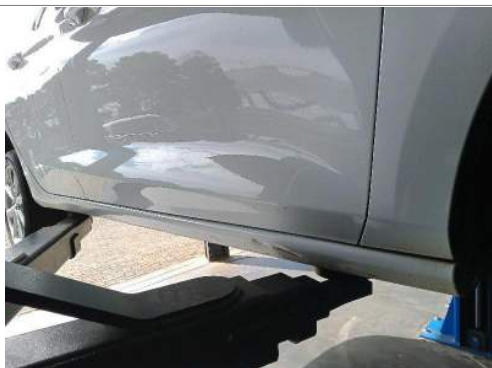
| Damage | Repair Way |
|---|---|
| Sill Panel Right Dented | Repair |

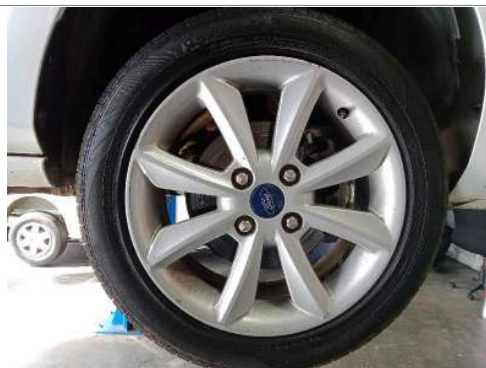
| Damage | Repair Way |
|---|---|
| Rim Front Right Scratched | Repair |

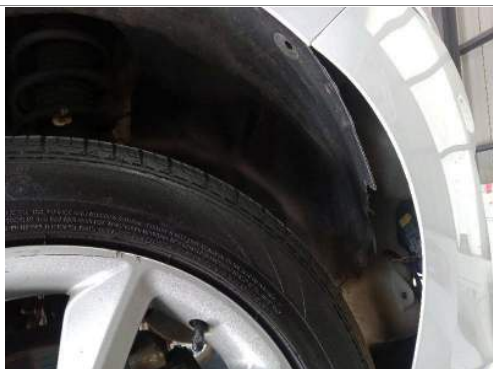
| Damage | Repair Way |
|---|---|
| Front Fender Right / Inner Tray Damaged | Repair |

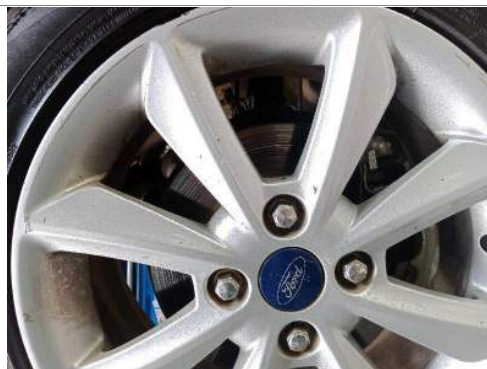
| Damage | Repair Way |
|---|---|
| Brake disc 1. Axle right Defective | Replace |

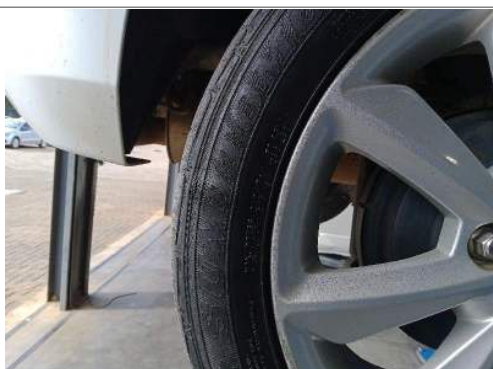
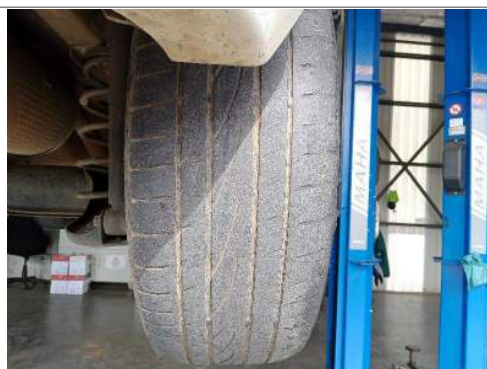
| Damage | Repair Way |
|---|---|
| Tyre Rear Right Damaged | Replace |

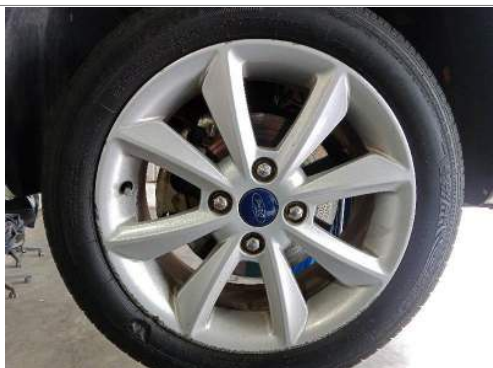
| Damage | Repair Way |
|---|---|
| Rim Front Left Scratched | Repair |

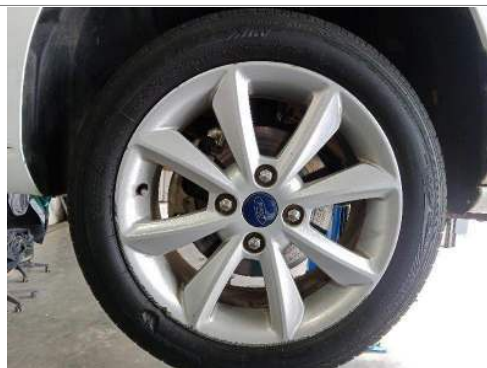
| Damage | Repair Way |
|---|---|
| Tyre Front Left Damaged | Replace |

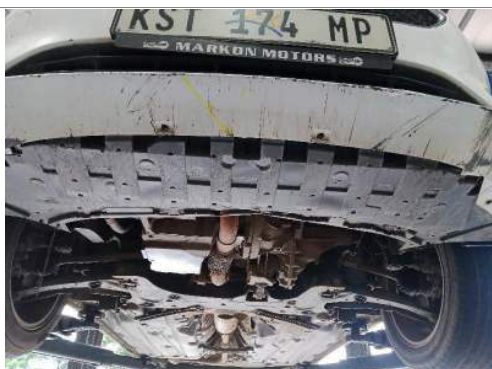
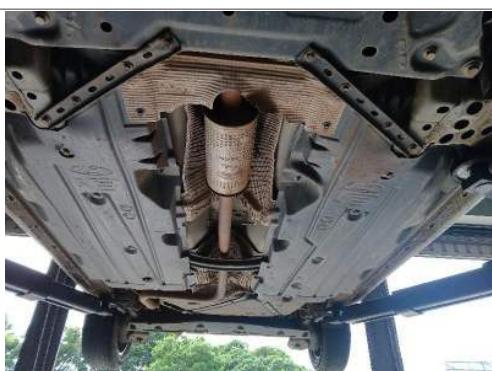
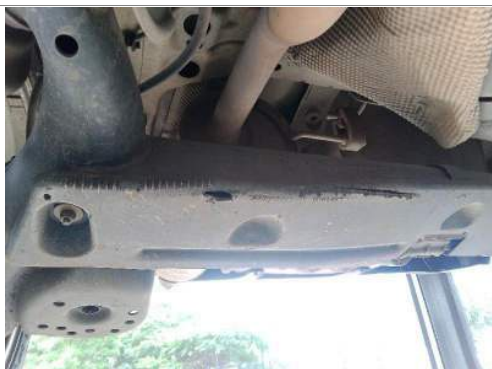
| Damage | Repair Way |
|---|---|
| Belly plates Damaged | Repair |

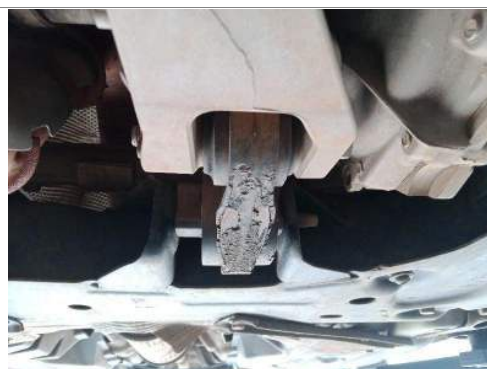
| Damage | Repair Way |
|---|---|
| Gearbox Mountings Damaged | Replace |

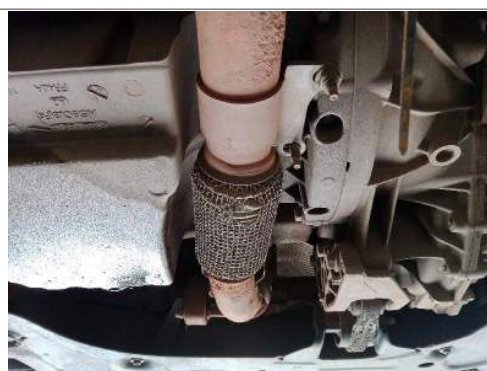
| Damage | Repair Way |
|---|---|
| Engine to silencer pipe Defective | Repair |

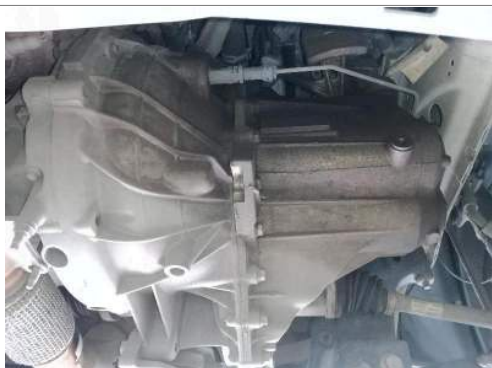
| Damage | Repair Way |
|---|---|
| Gearbox Oil Sweat | Repair |

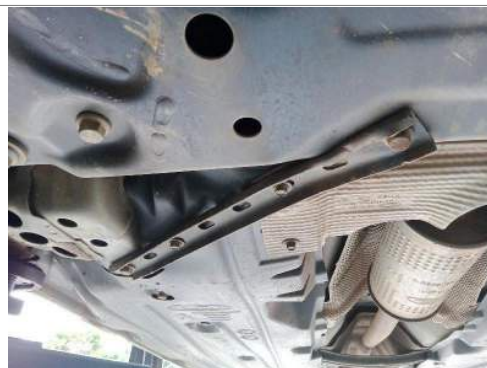
| Damage | Repair Way |
|---|---|
| Cross Member Rear Right Dented | Repair |
