## CONDITION REPORT

Report No: 2016403928

| Manufacturer | FORD | Registration Number | DV83MHGP |
| Model | FOCUS ST | Register Number | |

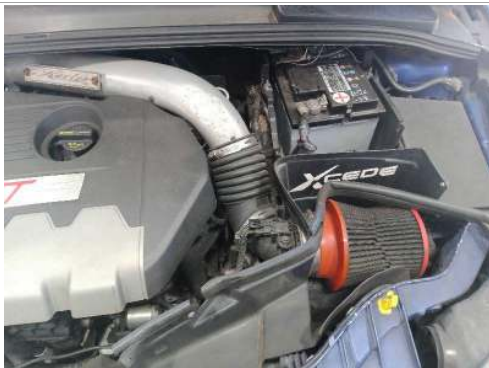
Aftermarket air filter fitted

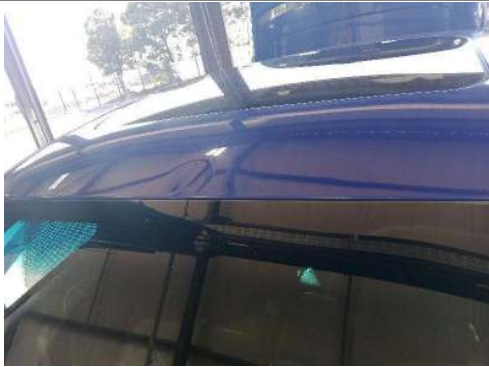
| Damage | Repair Way |
|---|---|
| Roof Dented | Repair |

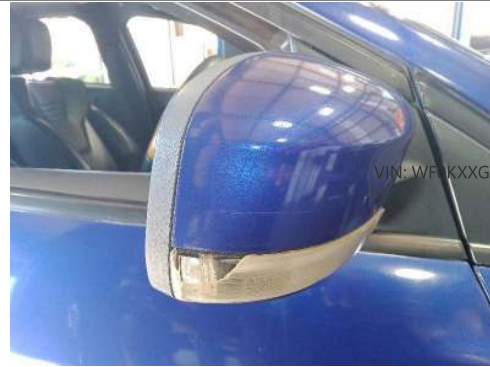
| Damage | Repair Way |
|---|---|
| Side Mirror Right Damaged | Repair |

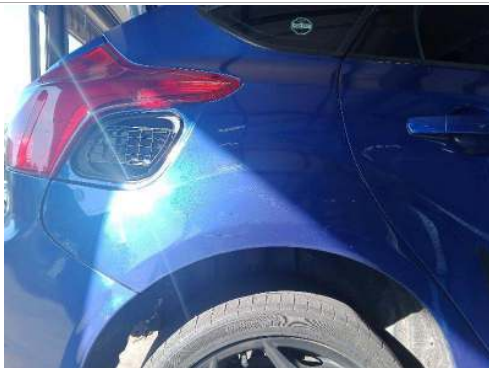
| Damage | Repair Way |
|---|---|
| Rear Fender Right Paintwork • Scratched | Repair |

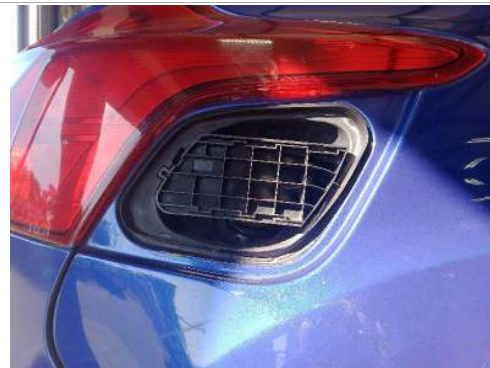
| Damage | Repair Way |
|---|---|
| Fuel Flap Damaged | Replace |

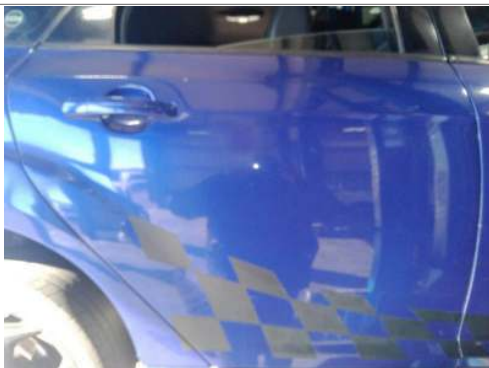
| Damage | Repair Way |
|---|---|
| Door Rear Right Paintwork • Scratched | Repair |

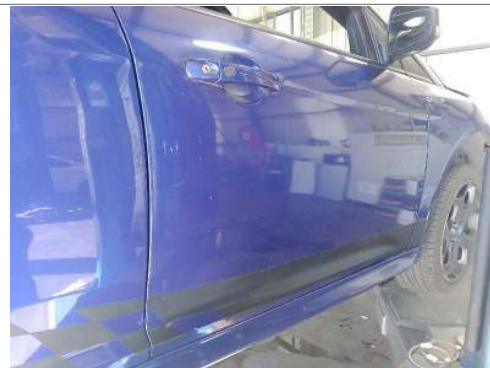
| Damage | Repair Way |
|---|---|
| Door Front Right Paintwork • Scratched | Repair |

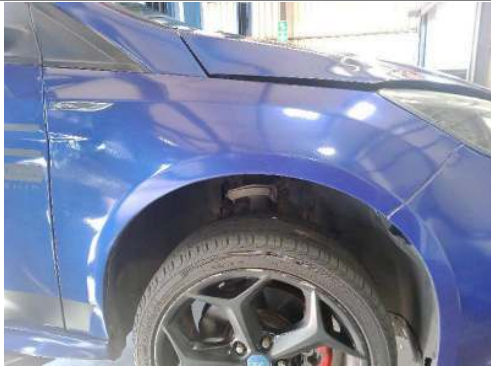
| Damage | Repair Way |
|---|---|
| Front Fender Right Paintwork • Pitmarks | Repair |

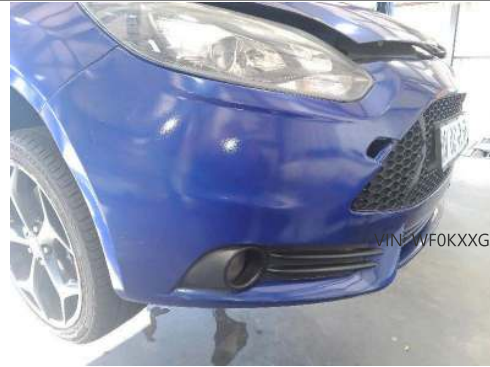
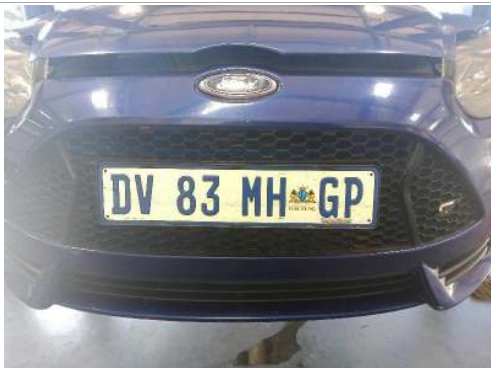
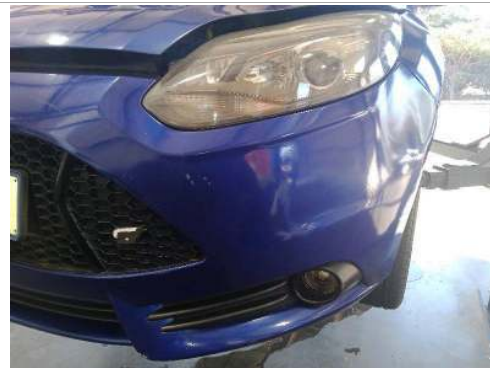
| Damage | Repair Way |
|---|---|
| Front Bumper Paintwork • Scratched | Repair |

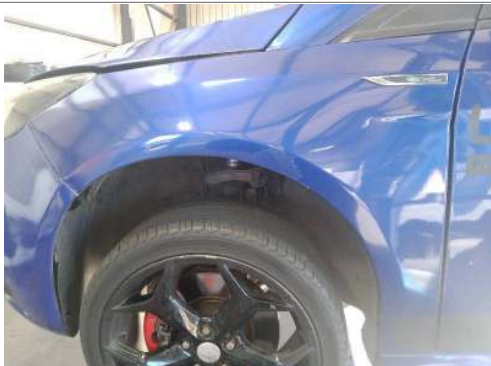
| Damage | Repair Way |
|---|---|
| Front Fender Left Paintwork • Flaking | Repair |

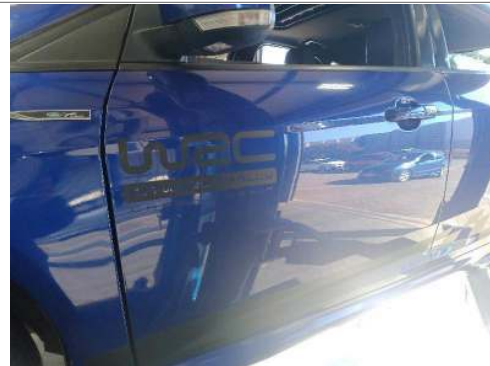
| Damage | Repair Way |
|---|---|
| Door Front Left Dented | Repair |

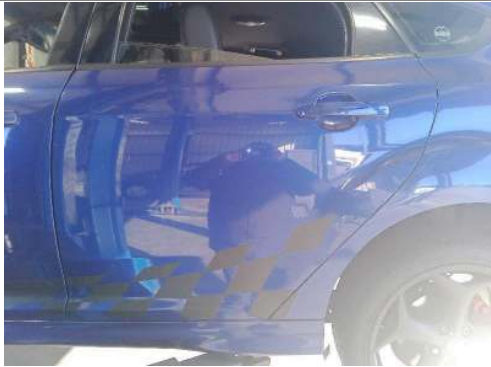
| Damage | Repair Way |
|---|---|
| Door Rear Left Paintwork • Scratched | Repair |

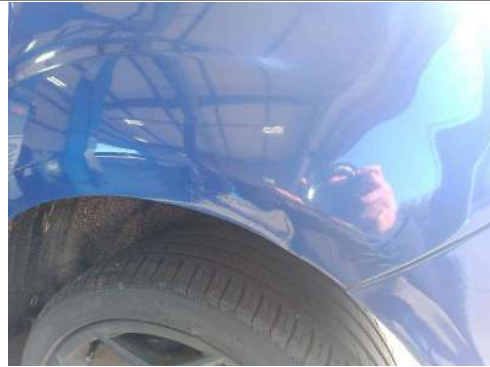
| Damage | Repair Way |
|---|---|
| Rear Fender Left Cracked | Repair |

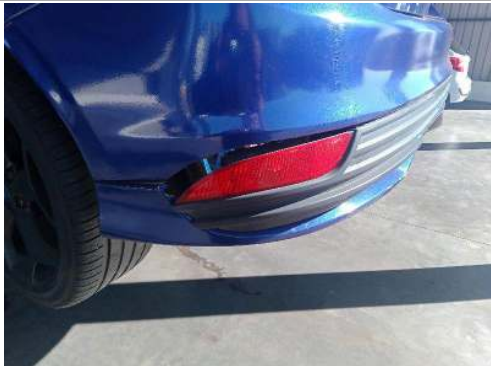
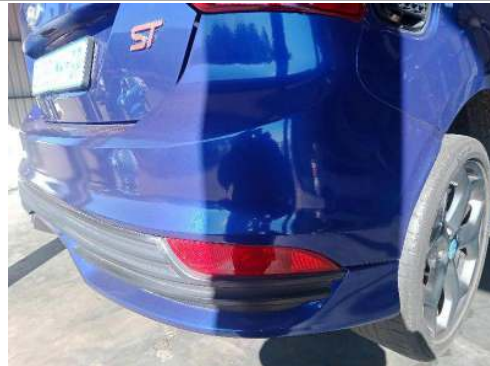
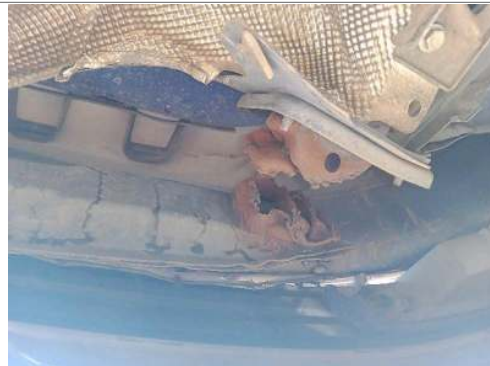
| Damage | Repair Way |
|---|---|
| Rear bumper Damaged | Repair |

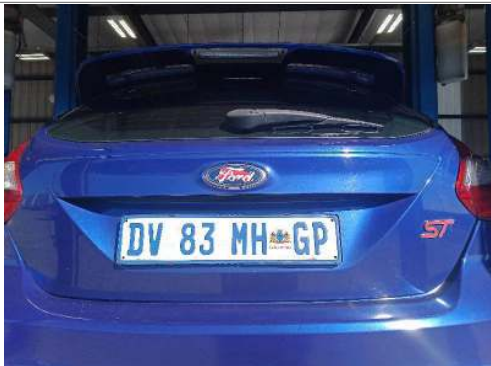
| Damage | Repair Way |
|---|---|
| Boot Lid / Hatch door Paintwork • Scratched | Repair |

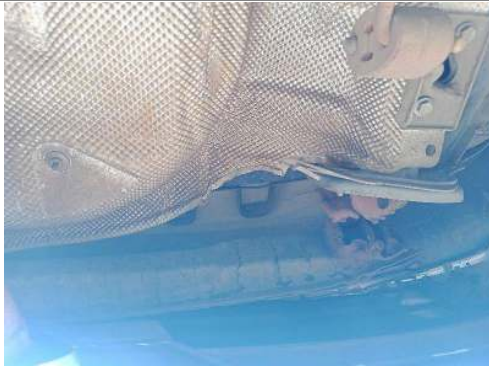
| Damage | Repair Way |
|---|---|
| Inner Boot Floor Pan and Spare Wheel Well Dented | Repair |

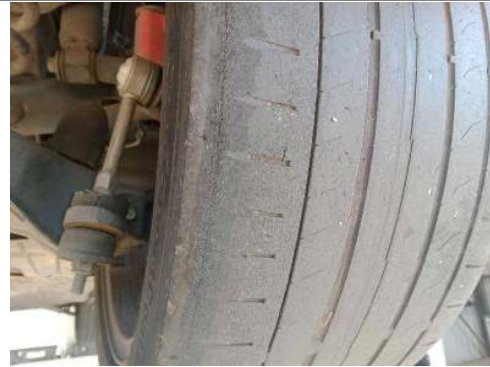
| Damage | Repair Way |
|---|---|
| Tyre Rear Right Smooth | Replace |

| | Size | Load/Speed Index | Manufacture | Model | Type* | Production Date | Tread Depth (mm) |
|---|---|---|---|---|---|---|---|
| Rear Right | 255/35R18 | 94Y | Continental | Contact | V | 2217 | 0 mm |

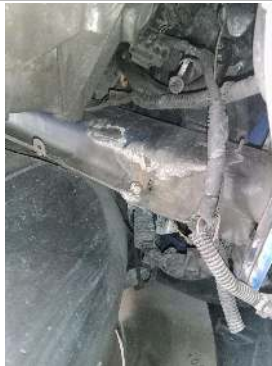
| Damage | Repair Way |
|---|---|
| Main Beam Left Welded | Repair |

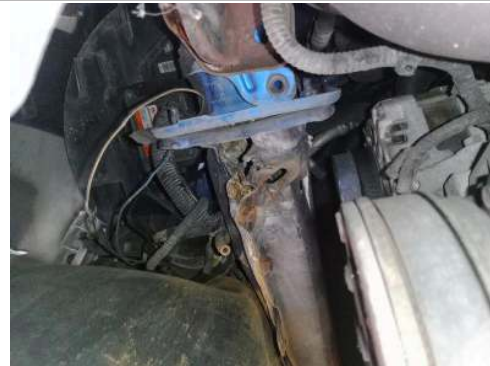
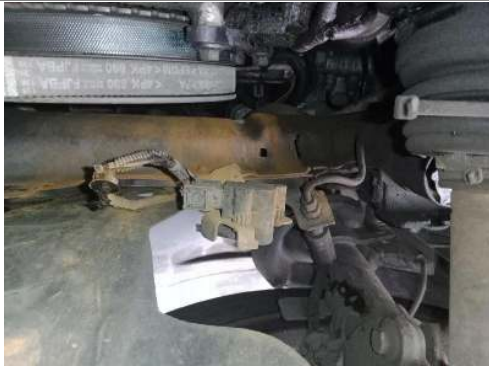
| Damage | Repair Way |
|---|---|
| Main Beam Right Welded | Repair |

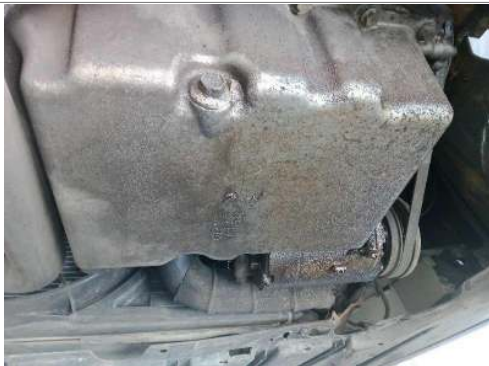
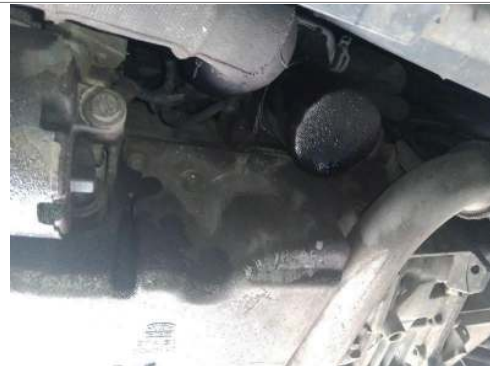
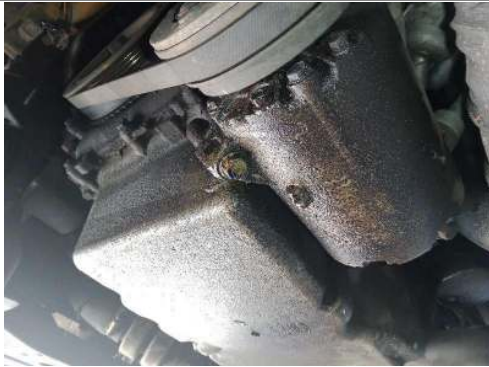
| Damage | Repair Way |
|---|---|
| Engine Oil Leak | Repair |

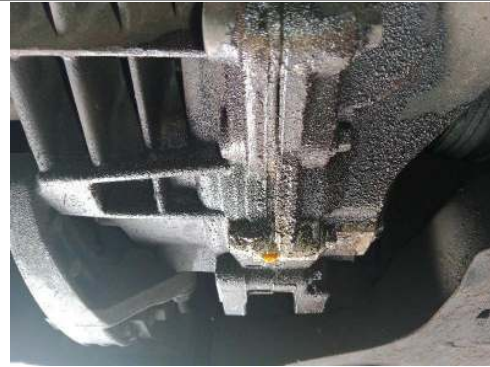
| Damage | Repair Way |
|---|---|
| Gearbox Oil Leak | Repair |

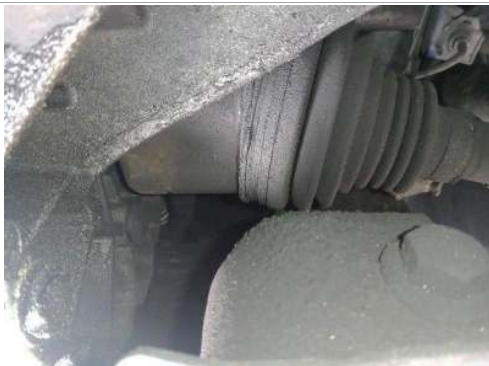
| Damage | Repair Way |
|---|---|
| CV Joint(s) Boot(s) Front Left (inner/outer) Defective | Repair |

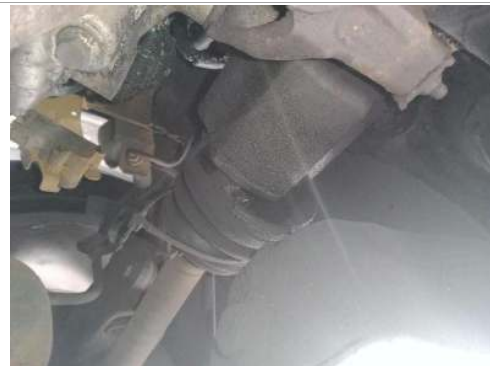
| Damage | Repair Way |
|---|---|
| CV Joint(s) Boot(s) Front Right (inner/outer) Damaged | Replace |

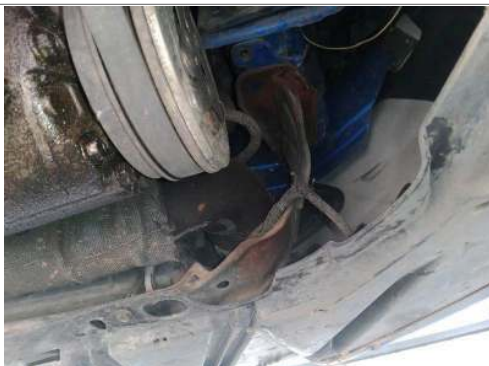
| Damage | Repair Way |
|---|---|
| Radiator Cradle Dented | Repair |

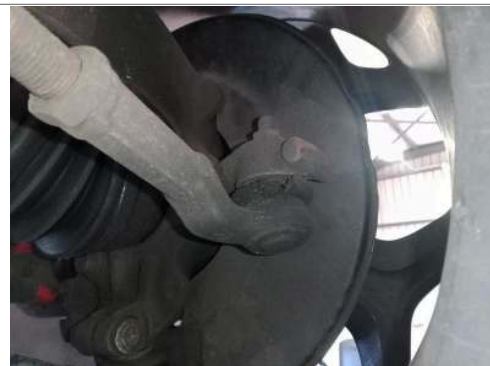
| Damage | Repair Way |
|---|---|
| Tie Rod End right Damaged | Replace |

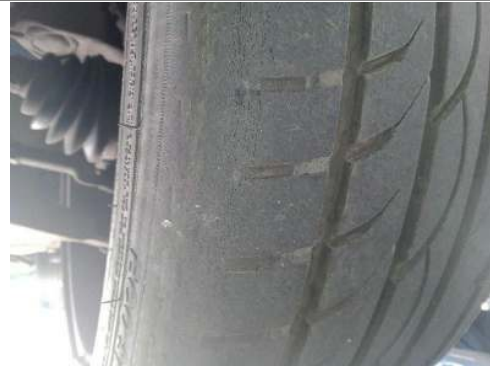
| Damage | Repair Way |
|---|---|
| Tyre Front Left Smooth | Replace |

| | Size | Load/Speed Index | Manufacture | Model | Type* | Production Date | Tread Depth (mm) |
|---|---|---|---|---|---|---|---|
| Front Left | 225/40R18 | 92W | Timax | Eco sport 59 | V | 5119 | 0 mm |

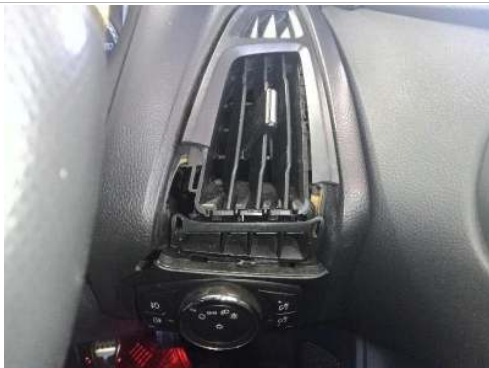
| Damage | Repair Way |
|---|---|
| Central Air Vent Damaged | Repair |

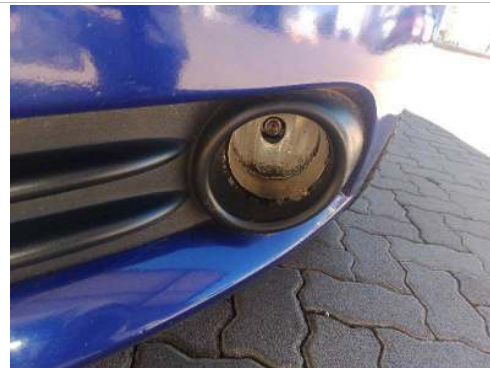
| Damage | Repair Way |
|---|---|
| Fog Light Front Left Damaged | Replace |

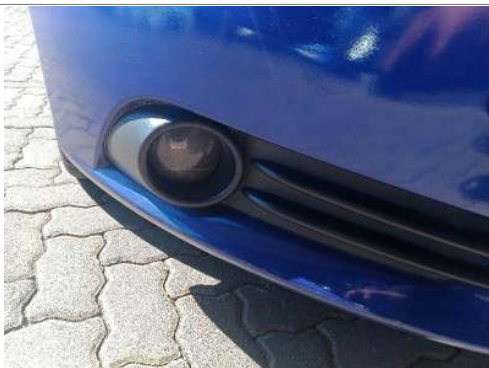
| Damage | Repair Way |
|---|---|
| Fog Light Front Right Malfunction | Repair |
