## CONDITION REPORT

Report No:  
2016957999  
DATE  
25/07/2025

MFC Auction House  
M57 Pretoria Rd, Glenmarais, KEMPTON PARK  
Gauteng

| Manufacturer | FORD | Registration Number | KNX706MP |

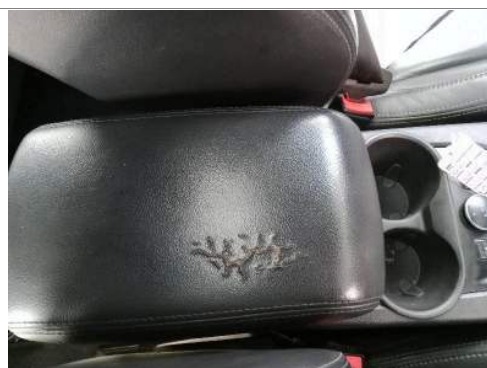
Oil cap and dipstick

| Damage | Repair Way |
|---|---|
| Center Console / Cubbyhole + Lid Damaged | Repair |

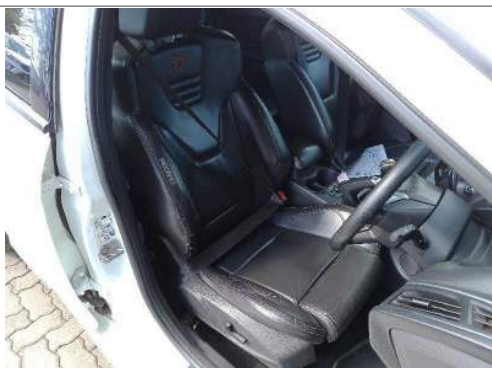
Center Console / Cubbyhole + Lid

| Damage | Repair Way |
|---|---|
| Seat Front Right Damaged | Repair |

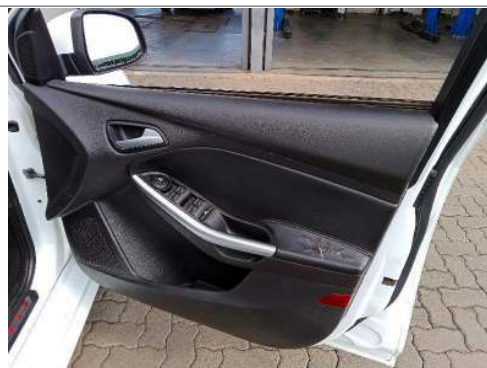
Seat Front Right

| Damage | Repair Way |
|---|---|
| Door Panel Front Right Damaged | Repair |

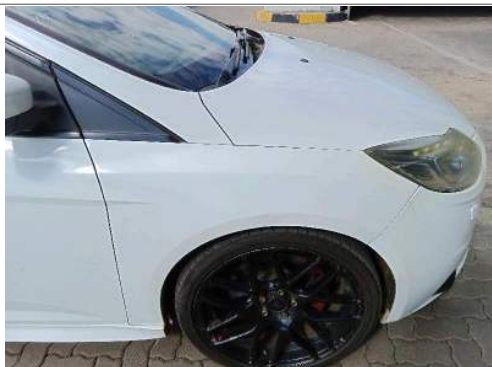
| Damage | Repair Way |
|---|---|
| Front Fender Right Residual Traces of Repair | Repair |

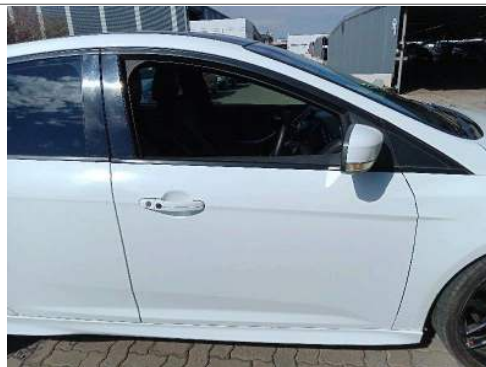
| Damage | Repair Way |
|---|---|
| Door Front Right Paintwork • Scratched | Repair |

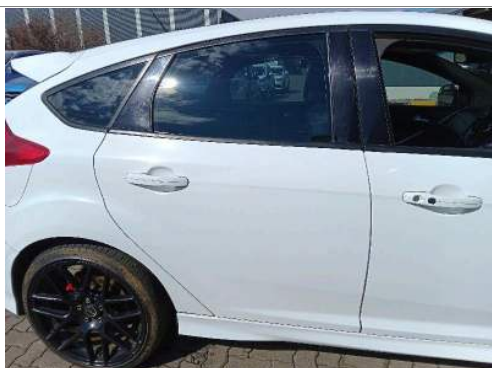
| Damage | Repair Way |
|---|---|
| Door Rear Right Dented | Repair |

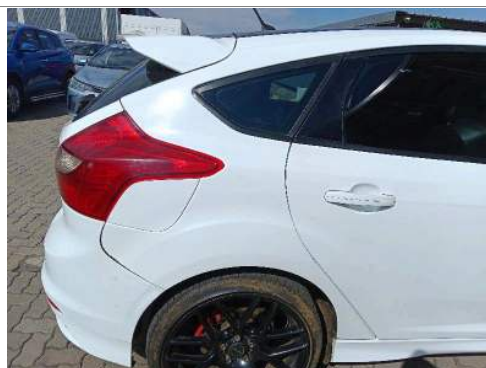
| Damage | Repair Way |
|---|---|
| Rear Fender Right Damaged | Repair |

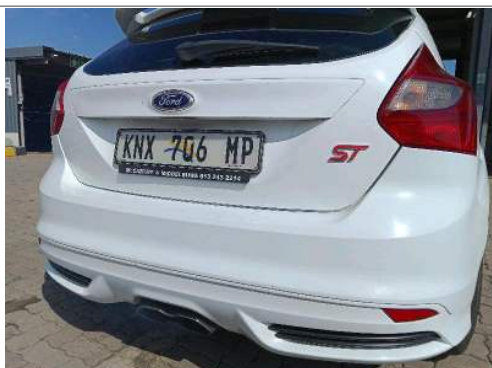
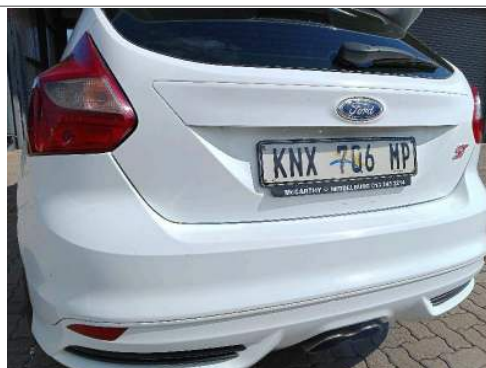
| Damage | Repair Way |
|---|---|
| Rear bumper Paintwork • Scratched | Repair |

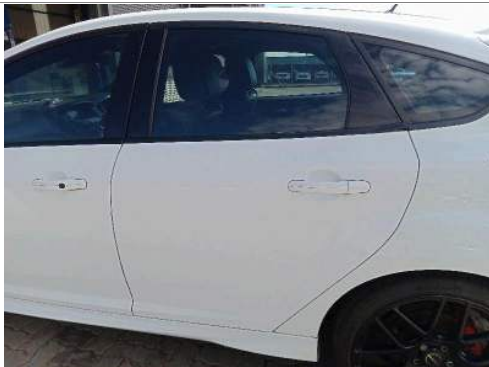
| Damage | Repair Way |
|---|---|
| Rear Fender Left Dented | Repair |

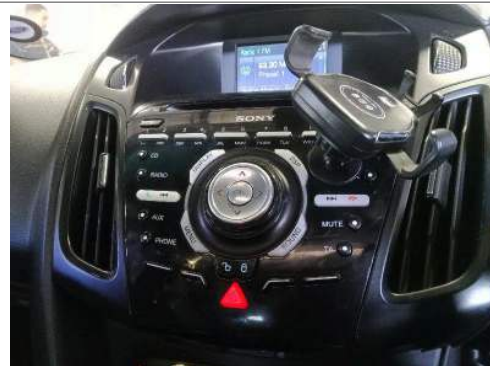
| Damage | Repair Way |
|---|---|
| Central Air Vent Cracked | Repair |

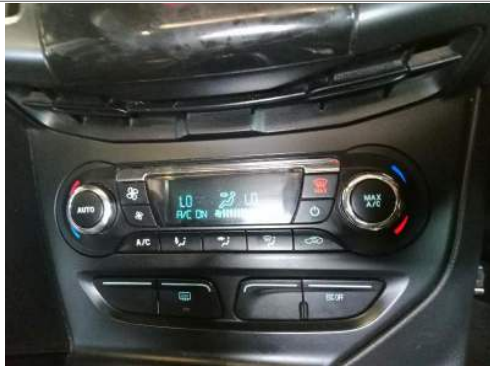
| Damage | Repair Way |
|---|---|
| Air Conditioner Insufficient | Replace |

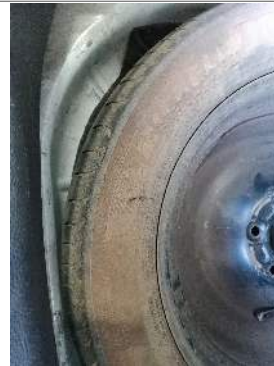
| Damage | Repair Way |
|---|---|
| Spare Tyre Torn / Cut | Replace |

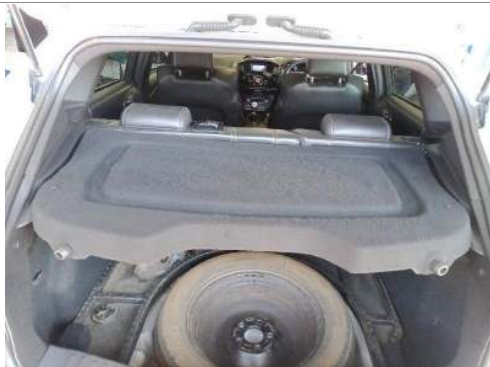
| Damage | Repair Way |
|---|---|
| Parcel Tray Damaged | Repair |

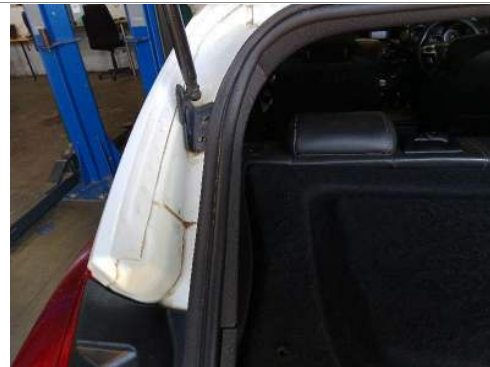
| Damage | Repair Way |
|---|---|
| C • Pillar Left Residual Traces of Repair | Repair |

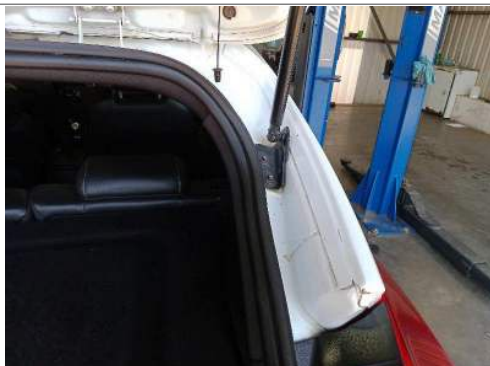
| Damage | Repair Way |
|---|---|
| C • Pillar Right Residual Traces of Repair | Repair |

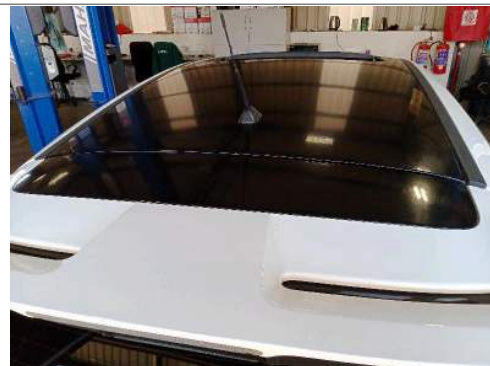
| Damage | Repair Way |
|---|---|
| Roof Residual Traces of Repair | Repair |

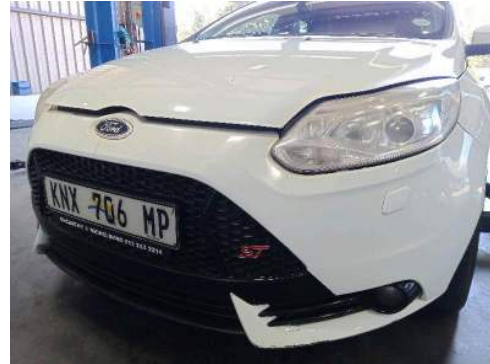
| Damage | Repair Way |
|---|---|
| Front Fender Left Damaged | Repair |

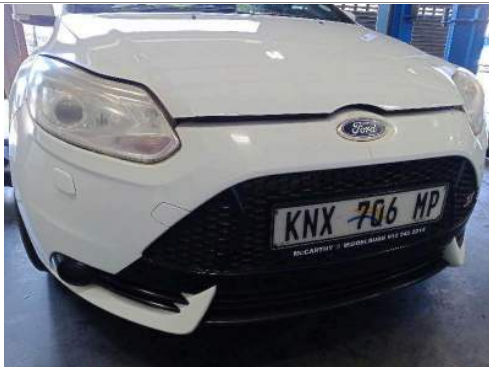
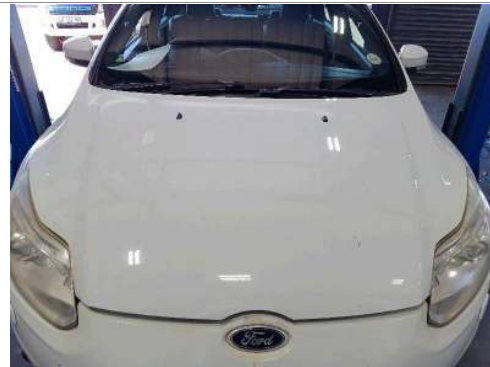
| Damage | Repair Way |
|---|---|
| Front Bumper Damaged | Repair |

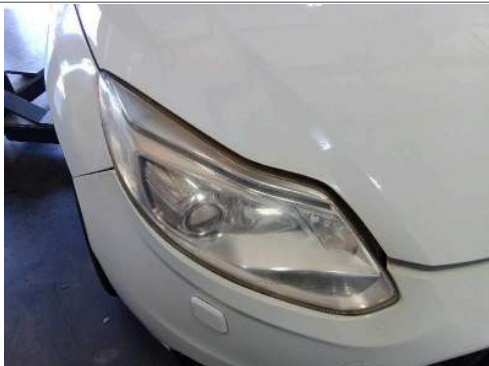
| Damage | Repair Way |
|---|---|
| Bonnet Damaged | Repair |

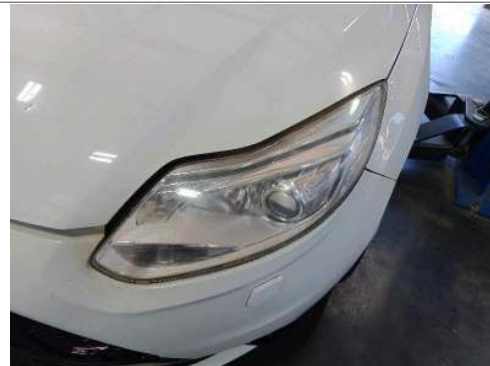
| Damage | Repair Way |
|---|---|
| Headlight Right Defective | Repair |

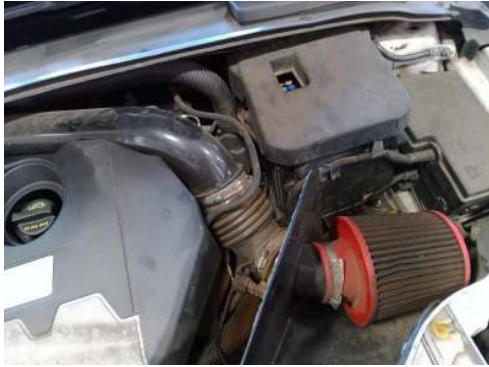
| Damage | Repair Way |
|---|---|
| Air cleaner Defective | Replace |

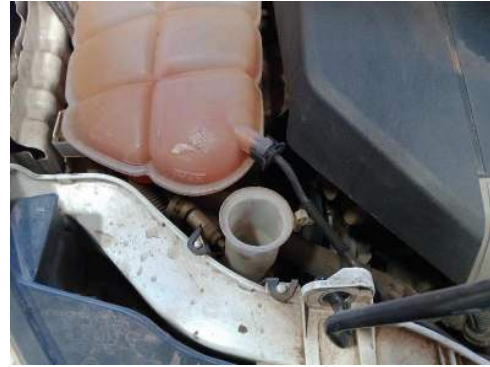
| Damage | Repair Way |
|---|---|
| Caps Missing | Replace |

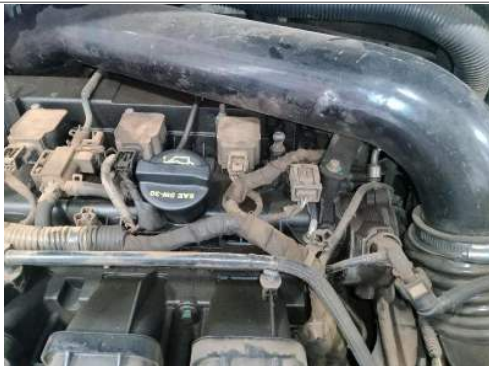
| Damage | Repair Way |
|---|---|
| Engine Oil Leak | Repair |

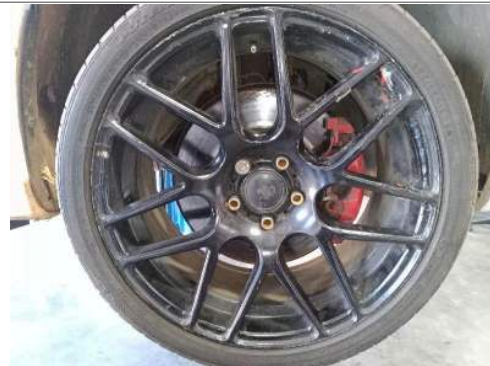
| Damage | Repair Way |
|---|---|
| Rim Front Right Dented | Repair |

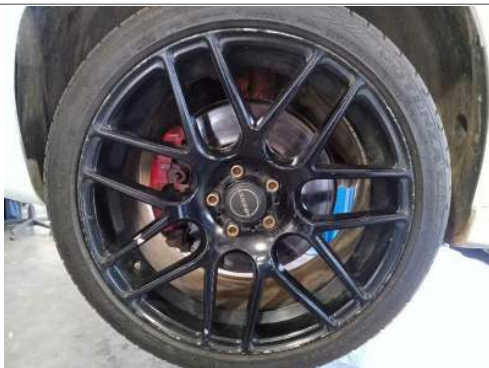
| Damage | Repair Way |
|---|---|
| Rim Rear Left Dented | Repair |

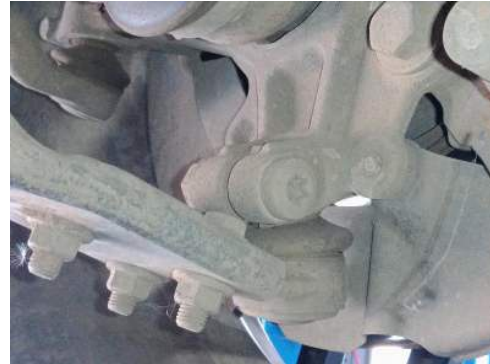
| Damage | Repair Way |
|---|---|
| Shock Absorber Front Left Sweat | Replace |

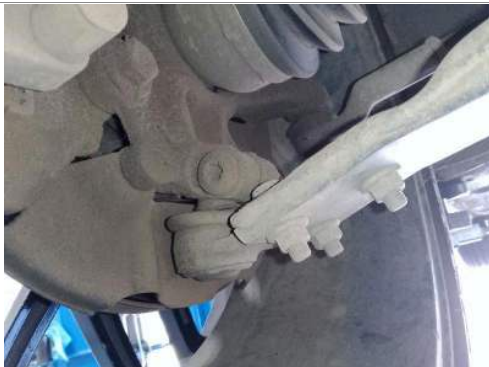
| Damage | Repair Way |
|---|---|
| Ball Joint(s) Front Axle Left Loose / Excessive Play | Replace |

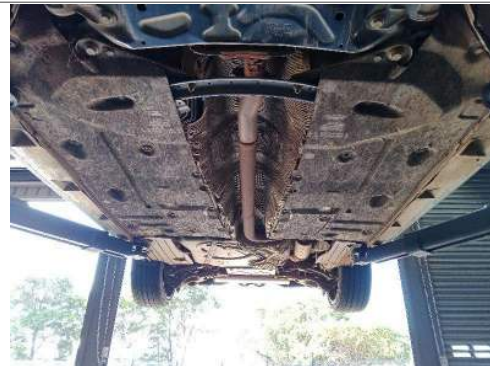
| Damage | Repair Way |
|---|---|
| Belly plates Defective | Repair |

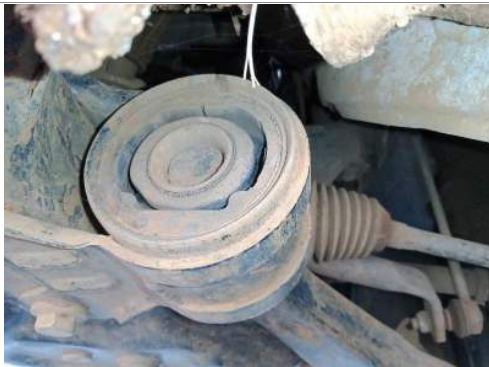
| Damage | Repair Way |
|---|---|
| Control Arm Bush(es) Front Axle Left Cracked | Replace |

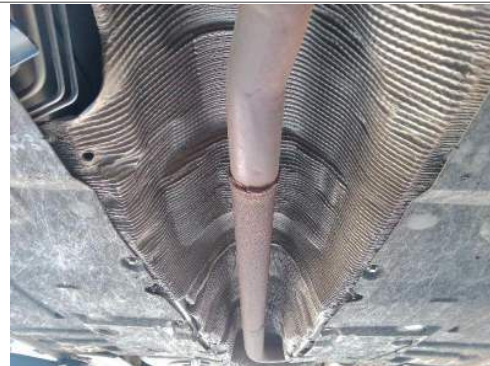
| Damage | Repair Way |
|---|---|
| Catalytic converter Missing | Replace |

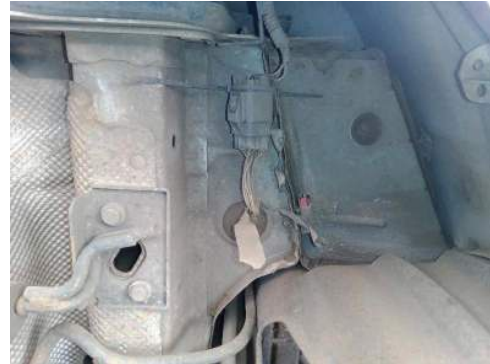
| Damage | Repair Way |
|---|---|
| Silencer Defective | Replace |
