## CONDITION REPORT

Report No:  
2017304536  
DATE  
29/09/2026

| Manufacturer | FORD | Registration Number | HBS917L |
| Model | FOCUS | Register Number | |

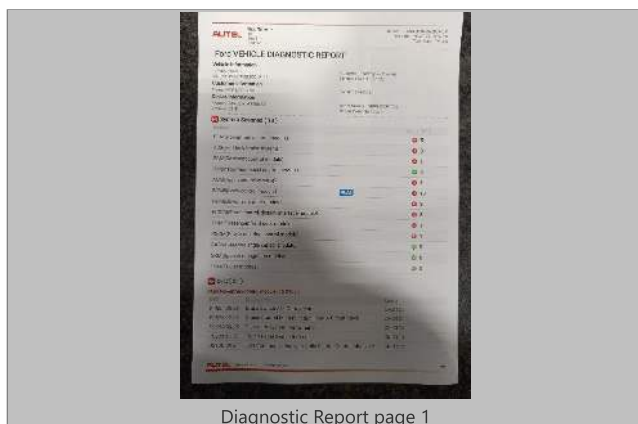
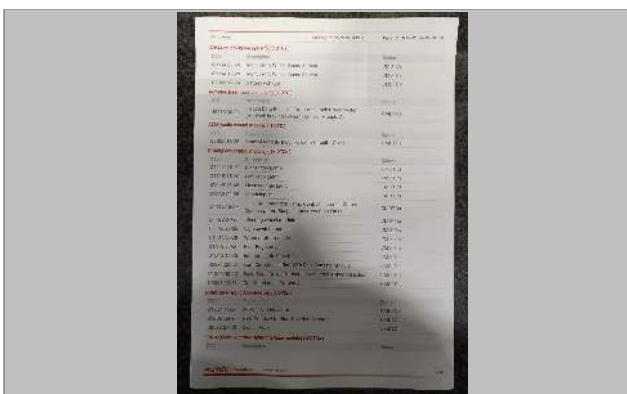
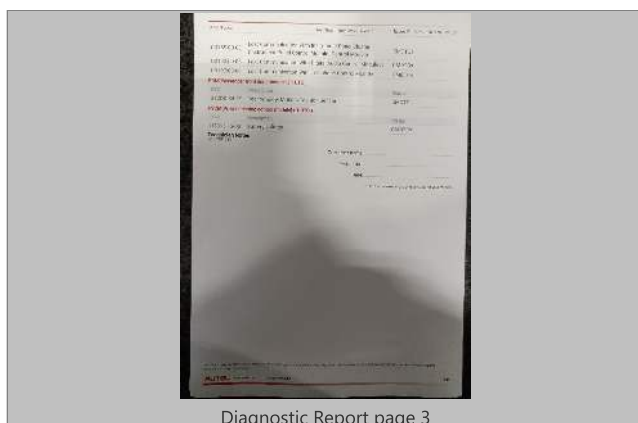
Diagnostic Report page 1

| No | System | Code | Description | Status |
|---|---|---|---|---|
| 1 | POWERTRAC CONTROL MODULE | P0504:92-28 | BRAKE SWITCH A/B CORRELATION | |

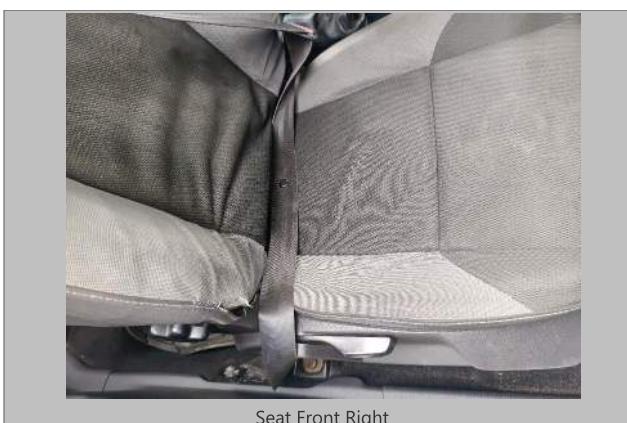
| Seat Front Right Torn / Cut | Repair |

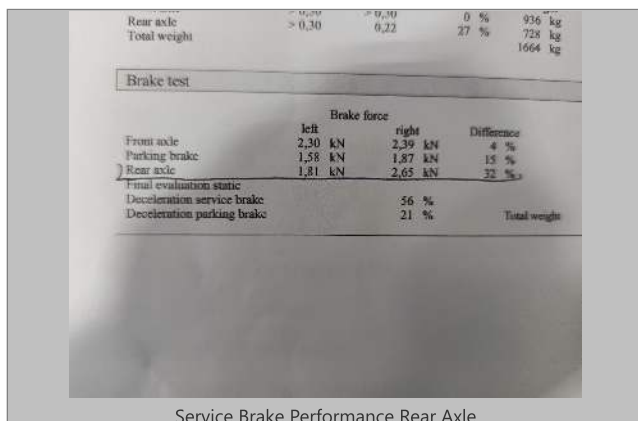
| Service Brake Performance Rear Axle Left / Right | Repair |
| Difference out of legal range | Repair |

| | Left | Right | | |
|---|---|---|---|---|
| Rear | 1.8 | 2.6 | - | |

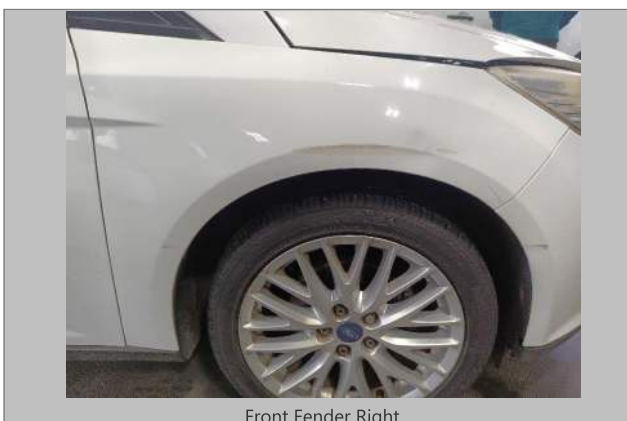
| Front Fender Right Paintwork • Scratched | Repair |

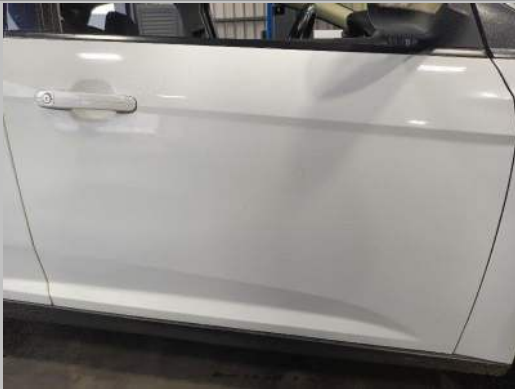
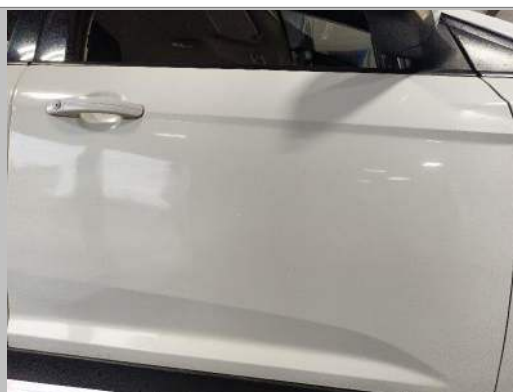
| Door Front Right Residual Traces of Repair | Repair |

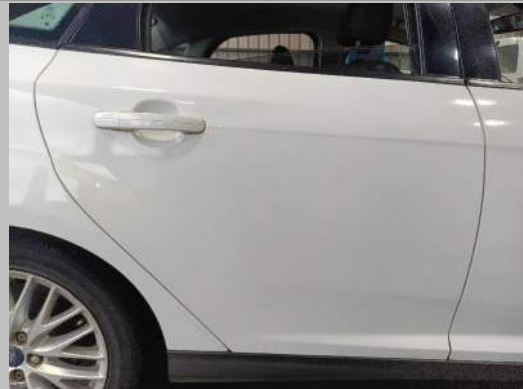
| Door Rear Right Residual Traces of Repair | Repair |

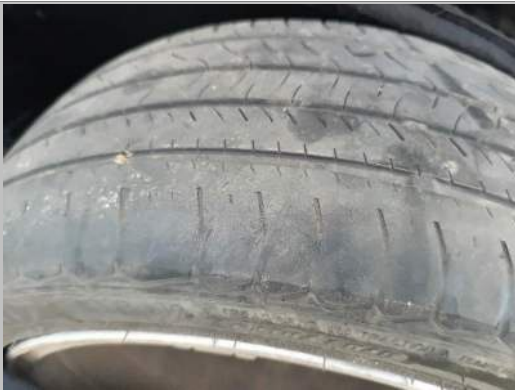
| Spare Tyre Smooth | Replace |

| | Size | Load/Speed Index | Manufacture | Model | Type* | Production Date | Tread Depth (mm) |
|---|---|---|---|---|---|---|---|
| Spare | 215/45R17 | 91W | Annaite | AN606 | V | 0000 | 0 mm |

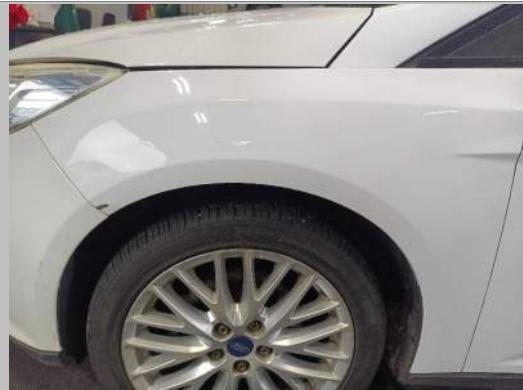
| Front Fender Left Paintwork • Scratched | Repair |

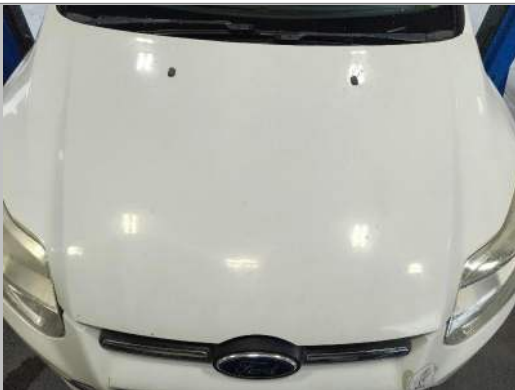
| Bonnet Residual Traces of Repair | Repair |

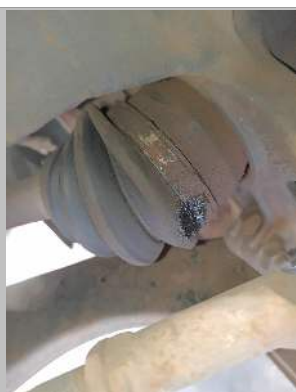
| CV Joint(s) Boot(s) Front Right (inner/outer) Damaged | Replace |

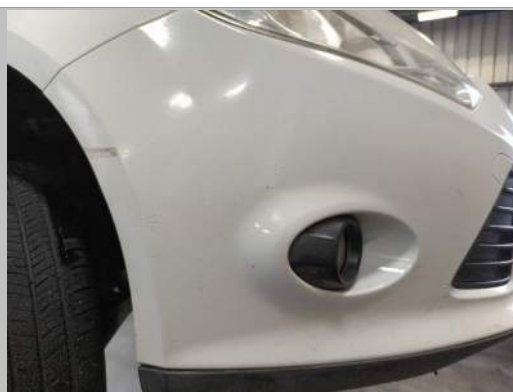
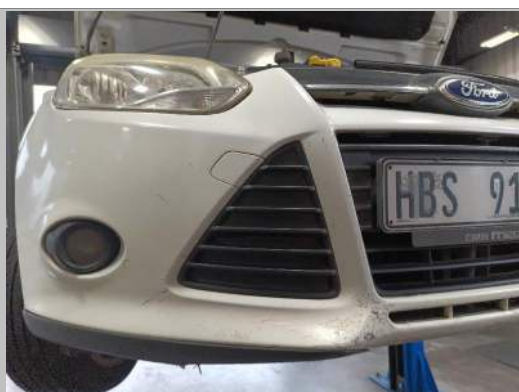
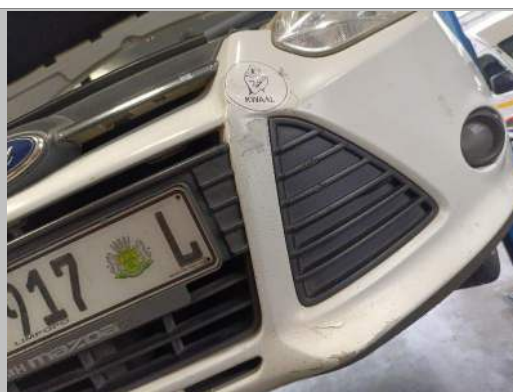
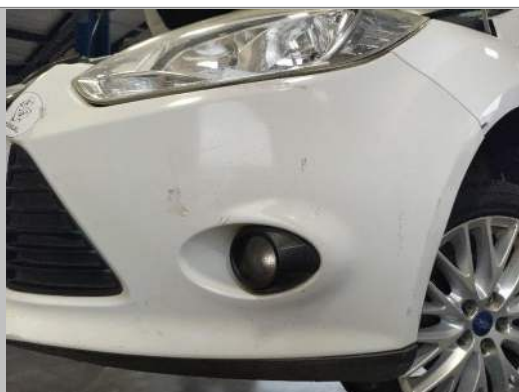
| Front Bumper Paintwork • Scratched | Repair |

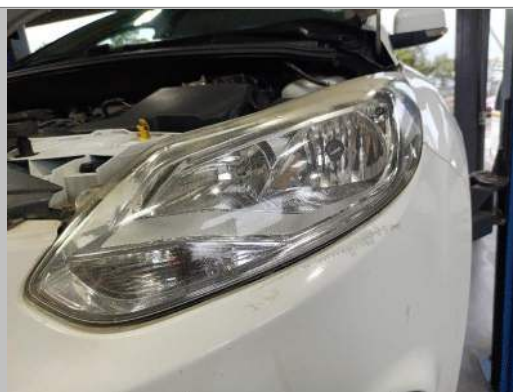
| Dim Light Left Defective | Repair |

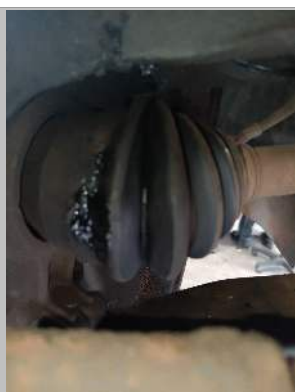
| CV Joint(s) Boot(s) Front Left (inner/outer) Damaged | Replace |

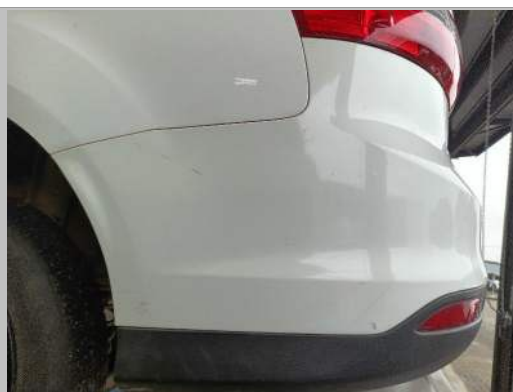
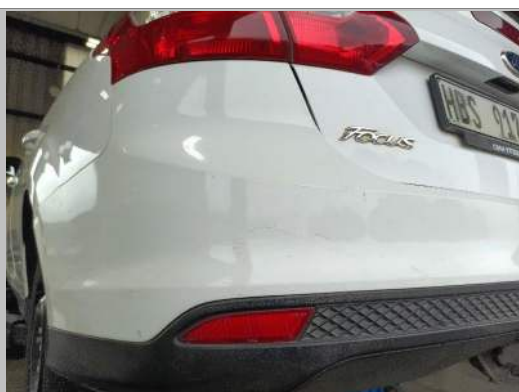
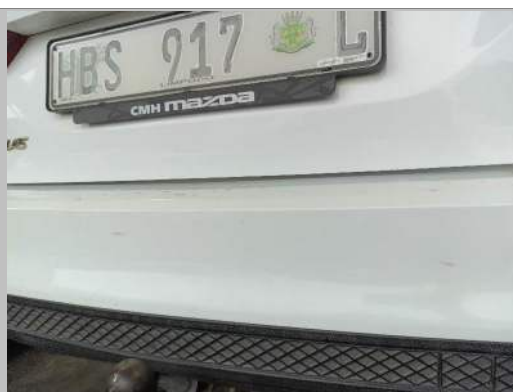
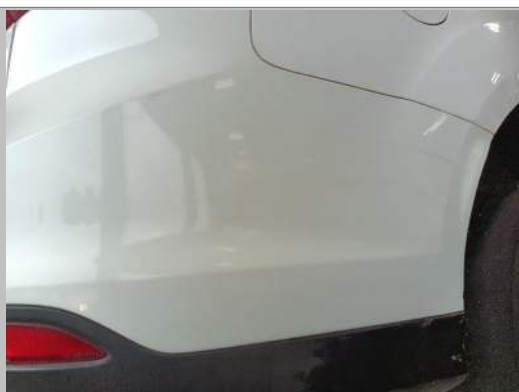
| Rear bumper Paintwork • Scratched | Repair |

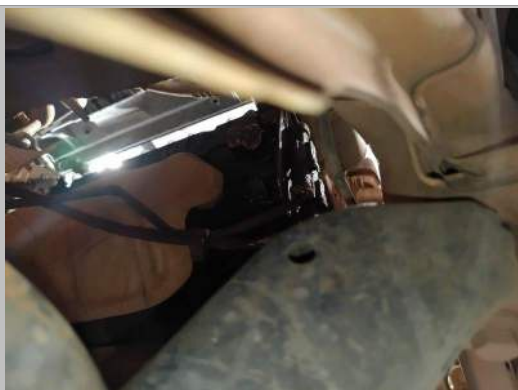
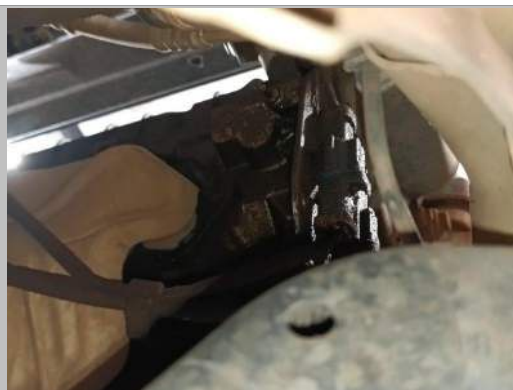
| Engine Oil Leak | Repair |

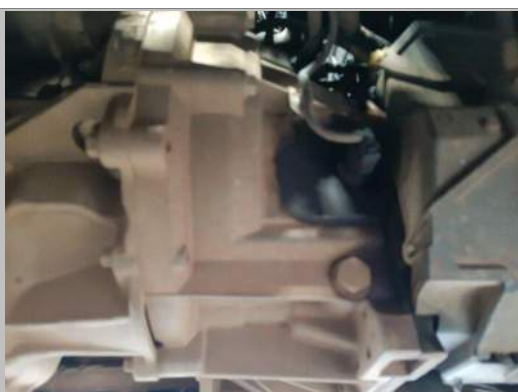
| Gearbox Oil Sweat | Repair |

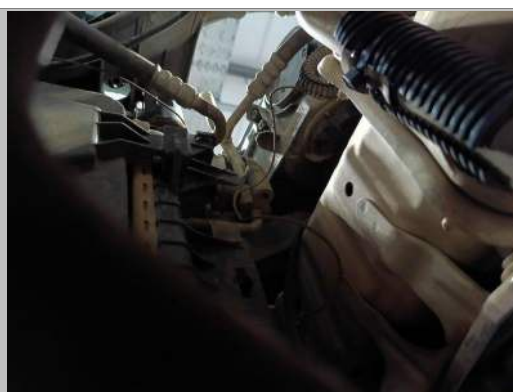
| Engine Wiring Defective | Repair |

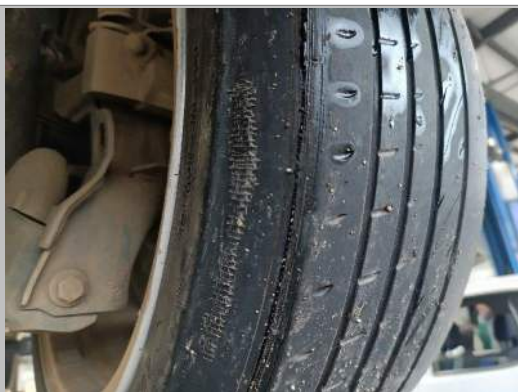
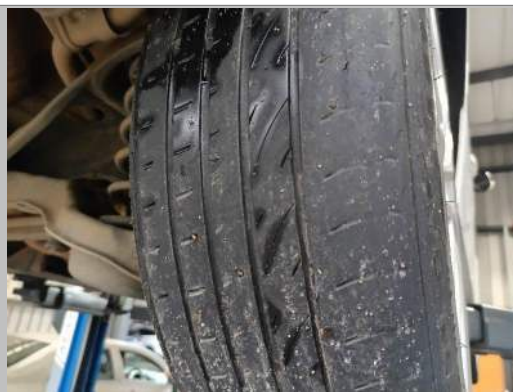
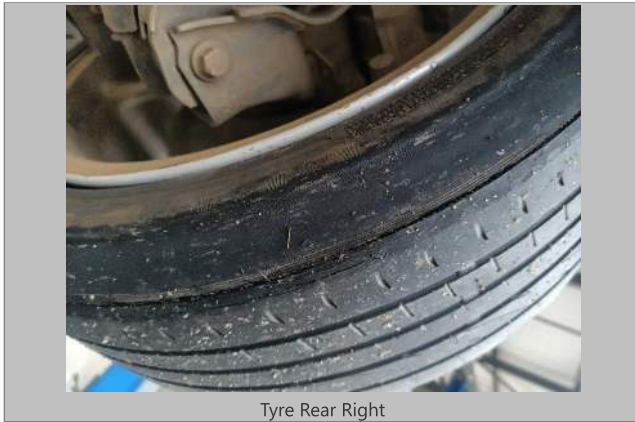
| Tyre Rear Right Excessive Wear & Tear | Replace |

| | Size | Load/Speed Index | Manufacture | Model | Type* | Production Date | Tread Depth (mm) |
|---|---|---|---|---|---|---|---|
| Rear Right | 215/45R17 | 91W | Aptany | Sport | V | 1924 | 0 mm |
