## CONDITION REPORT

Report No:  
2017301938  
DATE  
22/09/2026

| Manufacturer | FORD | Registration Number | YXM824GP |
| Model | FOCUS 2.5 ST 5-DR [2008-2012] | Register Number | |

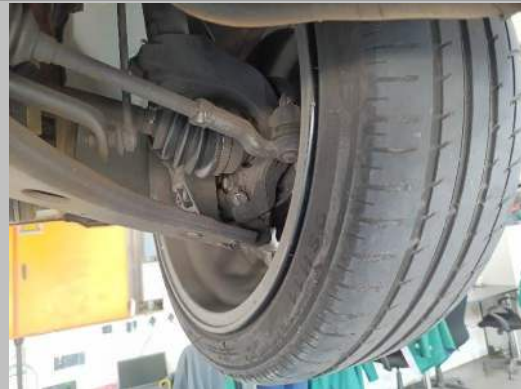
RF TYRE TREAD

| | Size | Load/Speed Index | Manufacture | Model | Type* | Production Date | Tread Depth (mm) |
|---|---|---|---|---|---|---|---|
| Front Right | 225/40R18 | 92Y | Diamond Blac | DSH | V | 2821 | 2 mm |

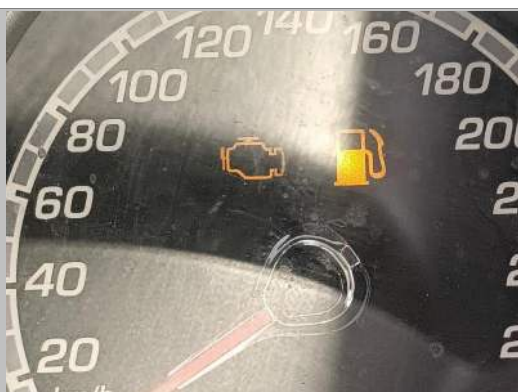
| Warning lights illuminated | Repair |

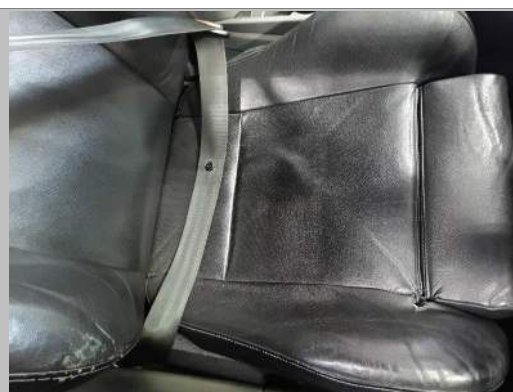
| Seat Front Right Torn / Cut | Repair |

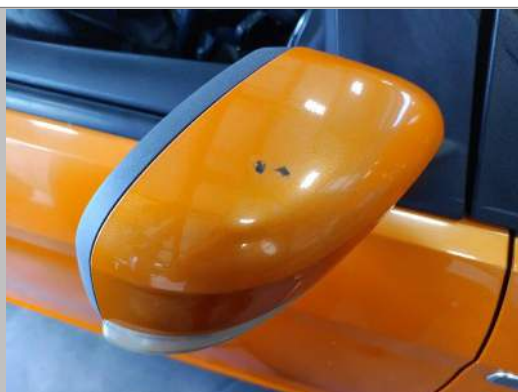
| Side Mirror Right Paintwork • Flaking | Repair |

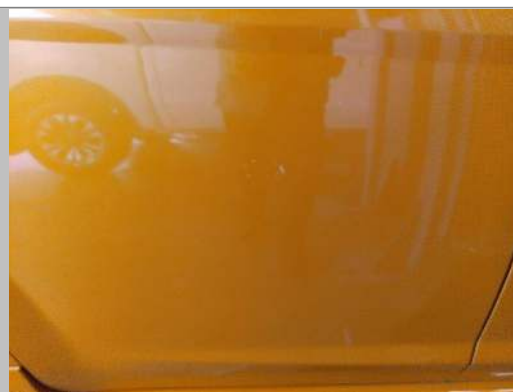
| Door Rear Right Paintwork • Flaking | Repair |

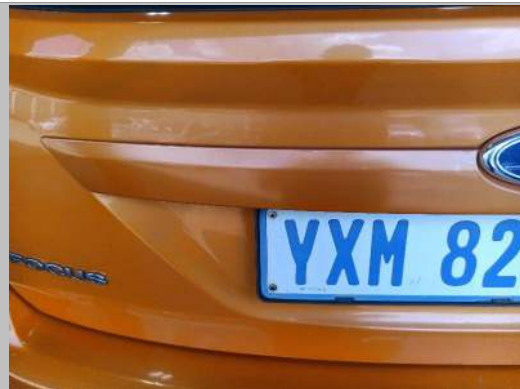
| Boot Lid / Hatch door Paintwork • Flaking | Repair |

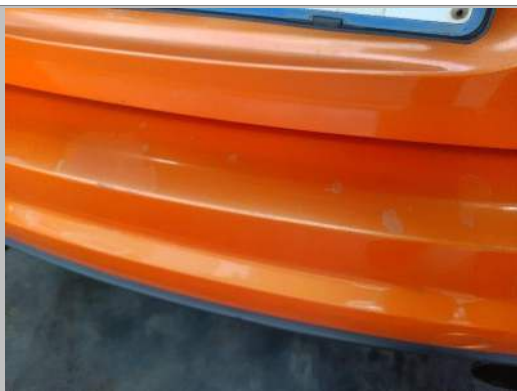
| Rear bumper Paintwork • Flaking | Repair |

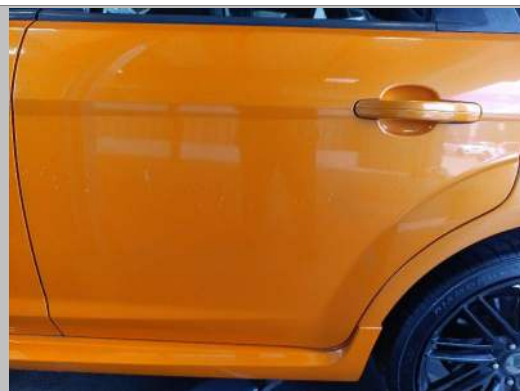
| Door Rear Left Paintwork • Scratched | Repair |

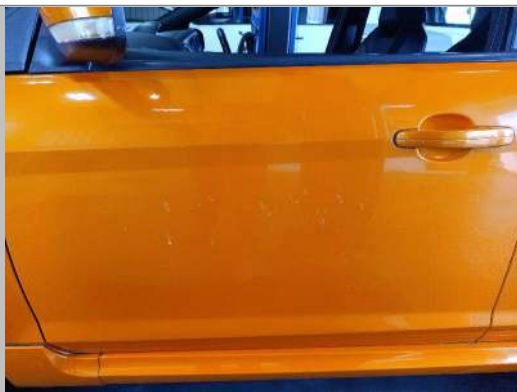
| Door Front Left Paintwork • Scratched | Repair |

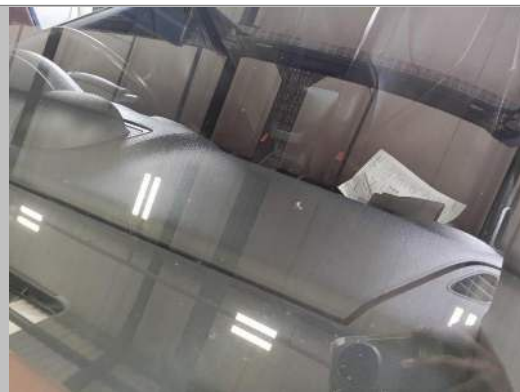
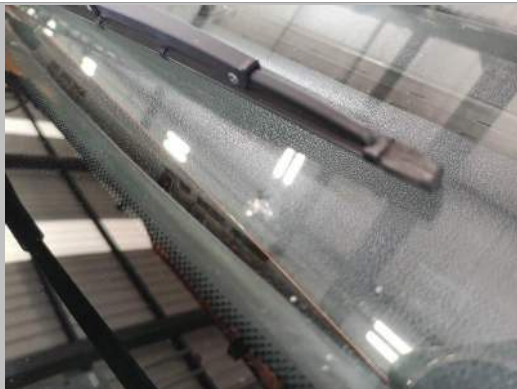
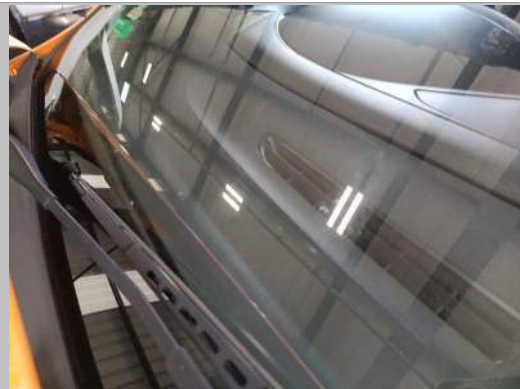
| Windscreen Cracked | Replace |

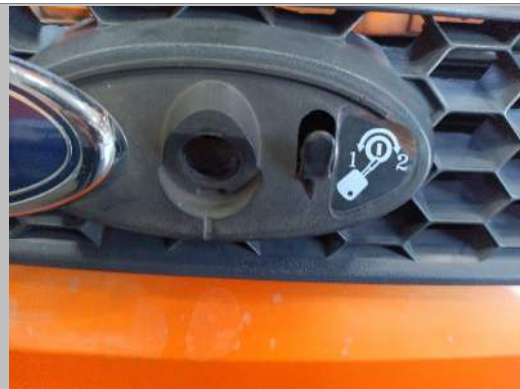
| Bonnet cable Missing | Replace |

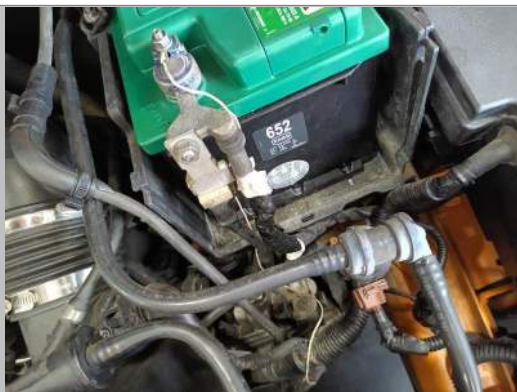
| Engine Wiring Defective | Repair |

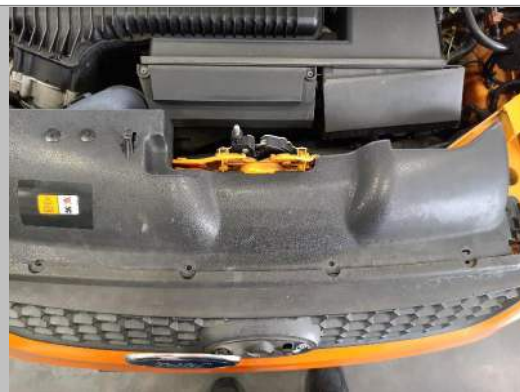
| Bonnet slam plate (Shock tower/ Inner tray) Defective | Repair |

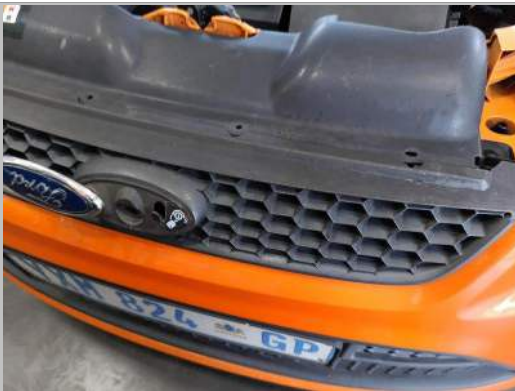
| Grill Damaged | Repair |

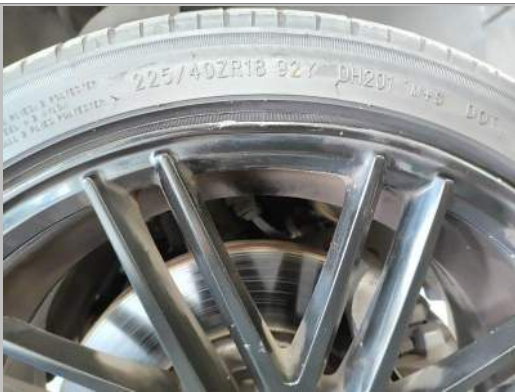
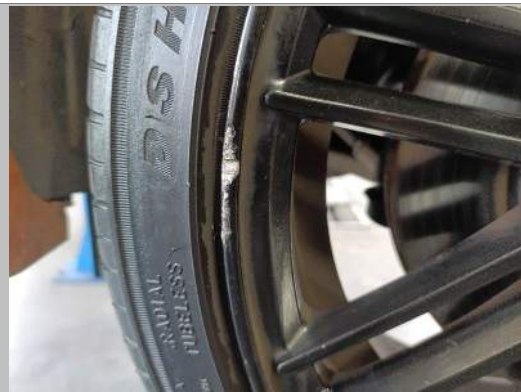
| Rim Front Right Deformed | Repair |

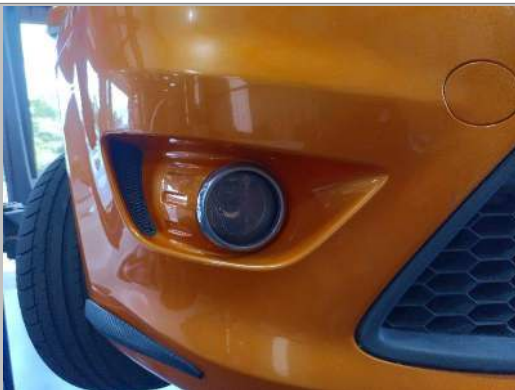
| Fog Light Front Right Defective | Repair |

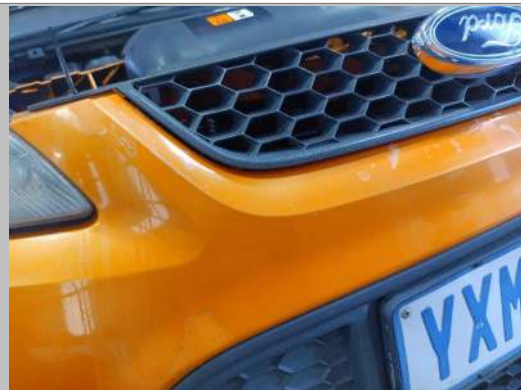
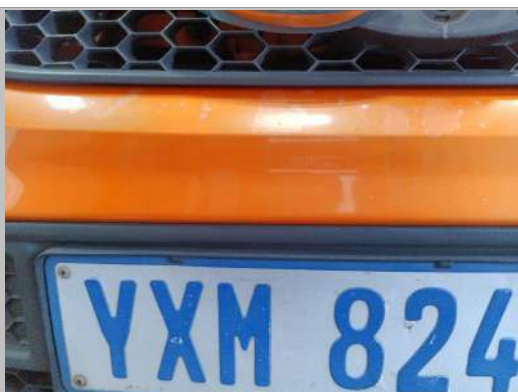
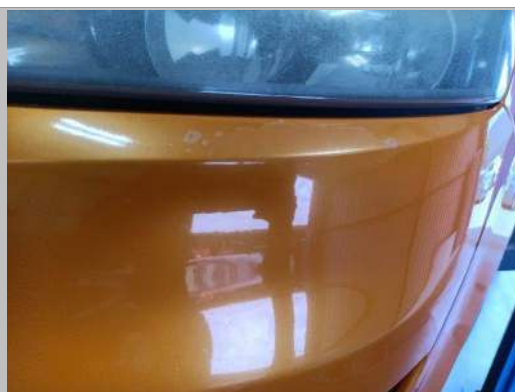
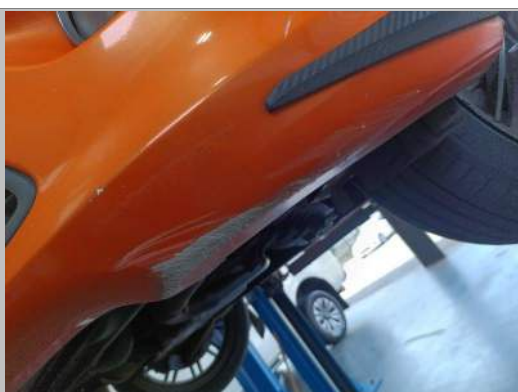
| Front Bumper Paintwork • Flaking | Repair |

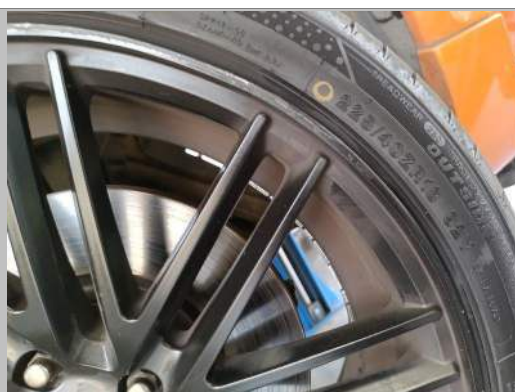
| Rim Front Left Deformed | Repair |

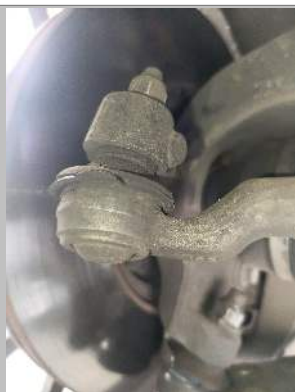
| Tie Rod End left Damaged | Replace |

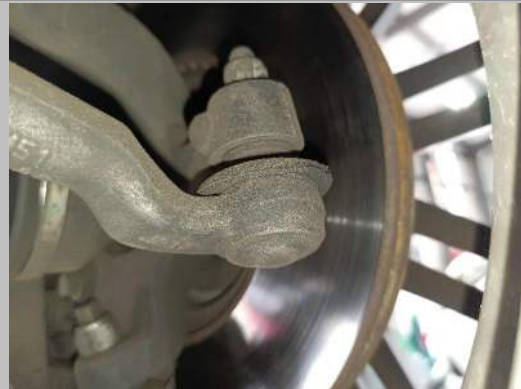
| Tie Rod End right Cracked | Replace |

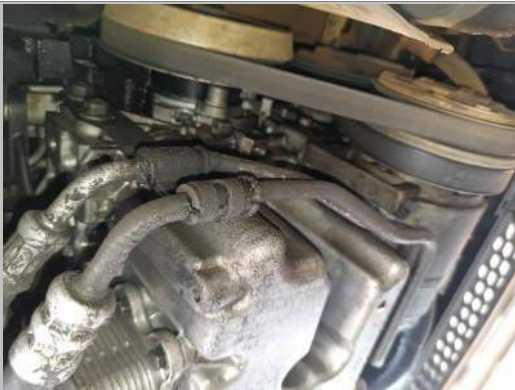
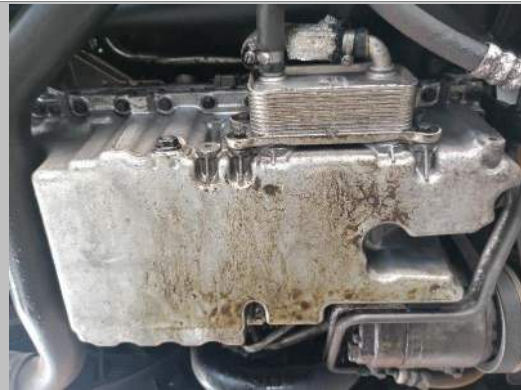
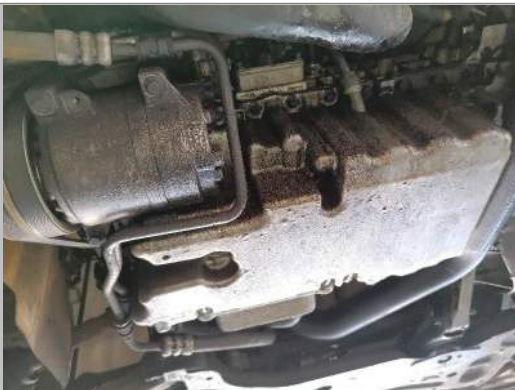
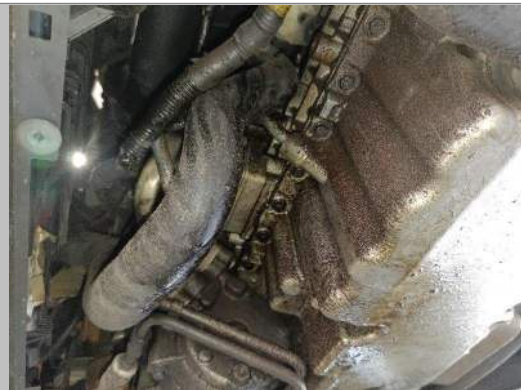
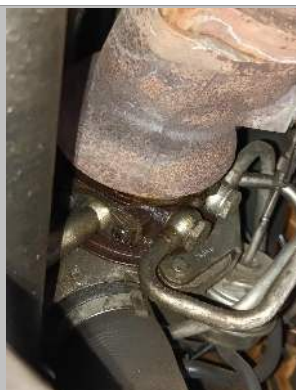
| Engine Oil Leak | Repair |

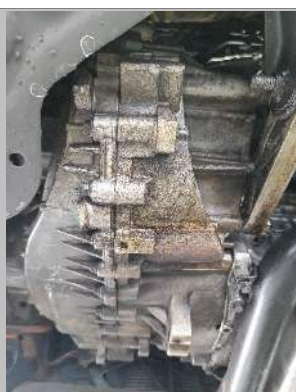
| Gearbox Oil Leak | Repair |

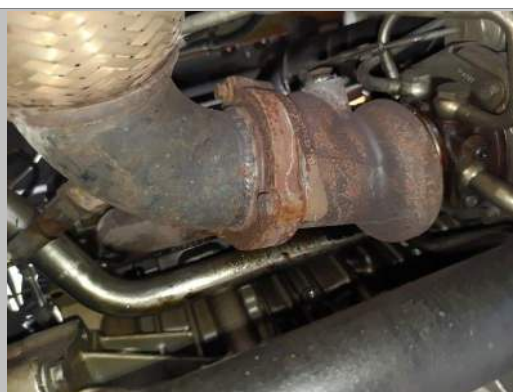
| Catalytic converter Missing | Replace |

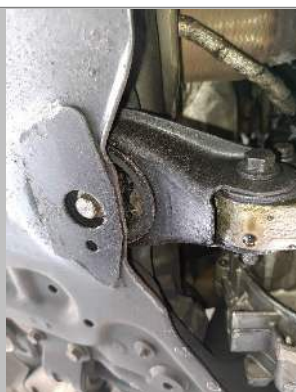
| Gearbox Mountings Cracked | Replace |

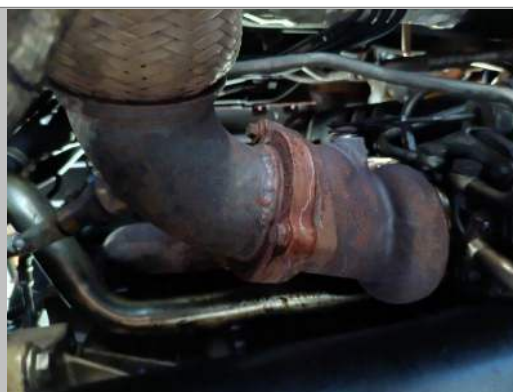
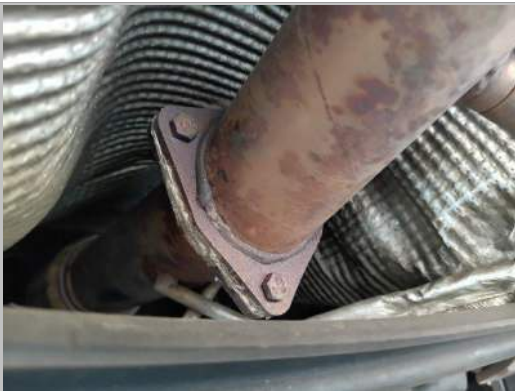
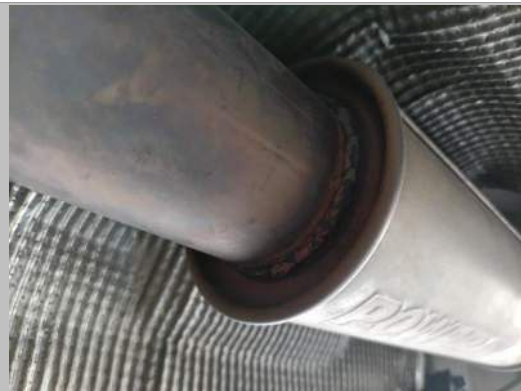
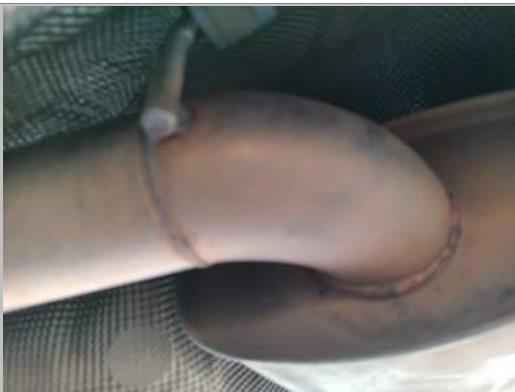
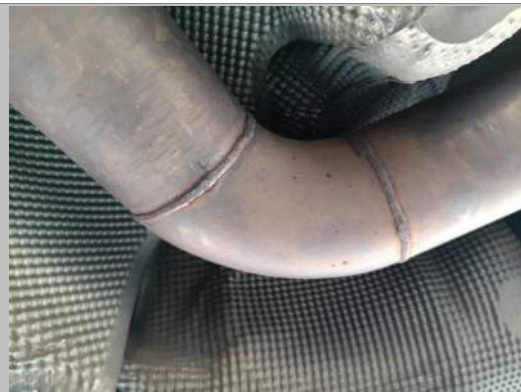
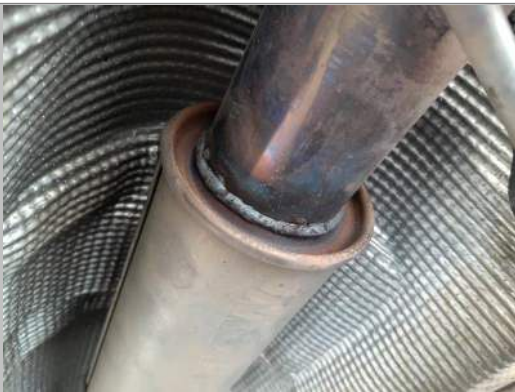
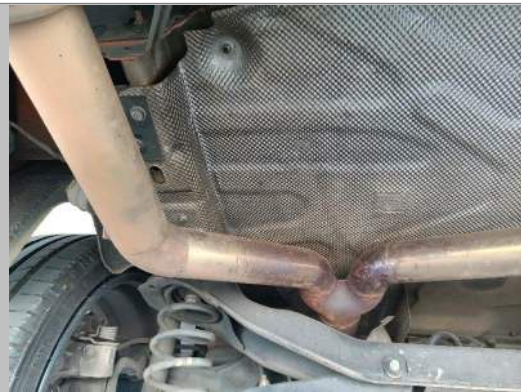
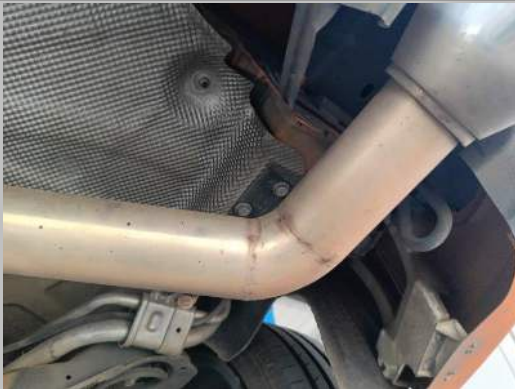
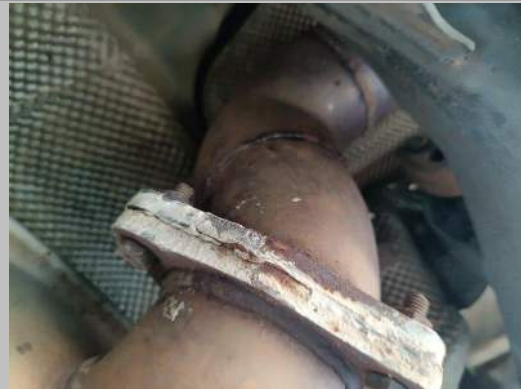
| Engine to silencer pipe Welded | Replace |

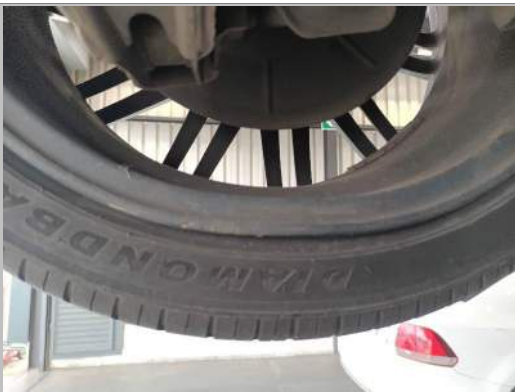
| Rim Rear Left Deformed | Repair |
