## CONDITION REPORT

Report No: 2016304290

MFC Auction House  
M57 Pretoria Rd, Glenmarais, KEMPTON PARK  
Gauteng

Vehicle Type	PASSENGER VEHICLE	Registered Owner	MFC AUCTION HOUSE
Manufacturer	MINI	Registration Number	JP36MXGP
Model	COOPER S	Register Number	
VIN	WMWMM320X0TN78817	Date Of First Licensing	
Engine Number		Last COR	
Doors	4	License Expiry Date	31/07/2022
Color	BROWN	Power / Displacement	
Year Model		Paint Finish	TWO COAT METALLIC
Km Reading	161,102 KM	Fuel	PETROL
Cab / Body Type	STATION WAGON	Transmission	MANUAL

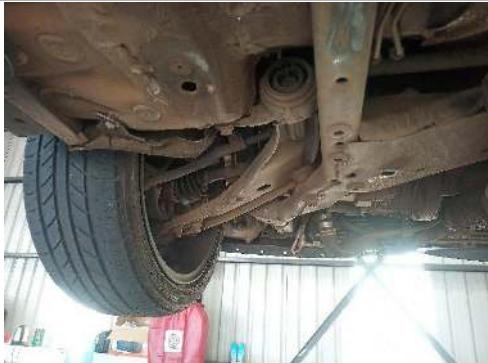
LF TYRE TREAD

Size	Load/Speed Index	Manufacture	Model	Type*	Production Date	Tread Depth (mm)
Front Left	205/45R17	88W	Pacek	Radial	V	0615	1 mm
Front Right	205/45R17	88W	Pacek	Radial	V	0615	1 mm
Rear Left	225/45R17	94W	Wanli	Radial	V	3119	0 mm
Rear Right	205/45R17	88W	Achilles	Radial	V	0513	0 mm

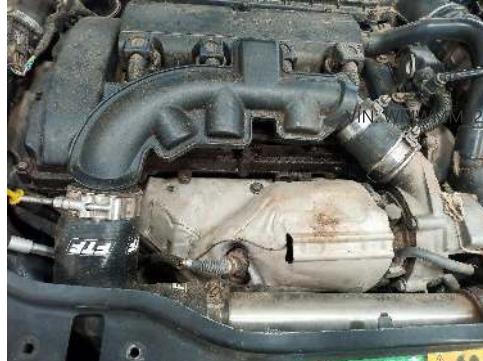
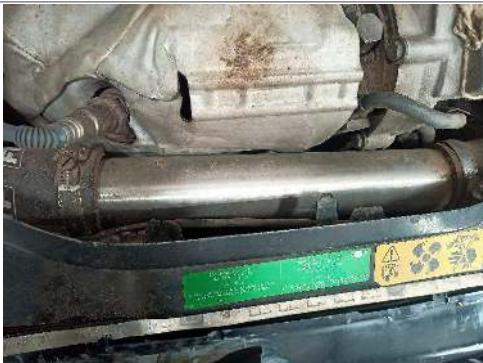
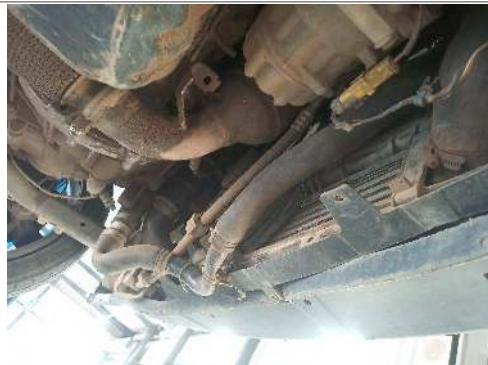
Damage	Repair Way
Engine Oil Leak	Repair
Engine Wiring Damaged	Replace
Hoses Damaged	Repair
Windscreen Wiper Damaged	Replace
Tail Light Left Damaged	Replace
Sun Visor Left Damaged	Replace
Sun Visor Right Damaged	Repair
Front Bumper Damaged	Repair
Grill Damaged	Replace
Bonnet Damaged	Repair
A • Pillar Right Damaged	Repair
Front Fender Left Damaged	Repair
Front Fender Right Damaged	Repair
Rear Fender Left Damaged	Repair
Rear Fender Right Damaged	Repair
Door Front Left Damaged	Repair
Door Front Right Damaged	Repair
Door Rear Right Damaged	Repair
Windscreen Damaged	Replace
Tyre Rear Left Worn	Replace
Tyre Rear Right Worn	Replace
Gearbox Oil Leak	Repair
Radiator Cradle Damaged	Replace
Body and exterior	Minor dents and scratches and stone chips.
Body and exterior	Signs of repair work done to somebody panels.
Body and exterior	Poor alignment to some body panels.
Body and exterior	Signs of impact damage to front of vehicle.
