MFC Auction House
M57 Pretoria Rd, Glenmarais, KEMPTON PARK
Gauteng

DEKRA MFC
M57 Pretoria Rd - 1619
KEMPTON PARK - GT
08610 33572

VEHICLE INSPECTION

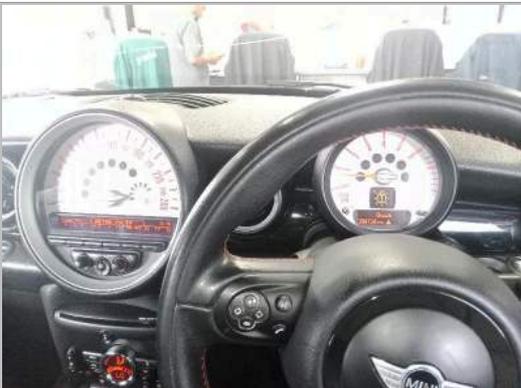
DASHBOARD (W/ ENGINE RUNNING)

| Damage | Repair Way |
|---|---|
| Engine management lights illuminated | Repair |

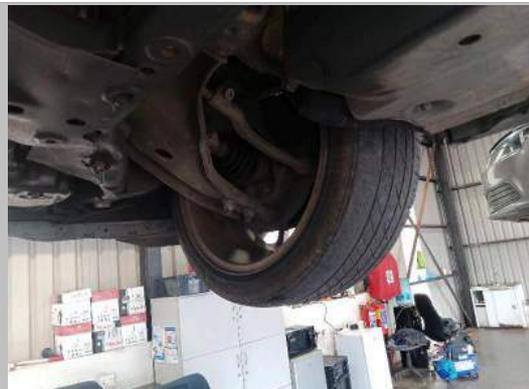
RF TYRE TREAD

| | Size | Load/Speed Index | Manufacture | Model | Type* | Production Date | Tread Depth (mm) |
|---|---|---|---|---|---|---|---|
| Front Right | 205/45R17 | 88W | Bridgestone | Eco product | V | 0516 | 1 mm |

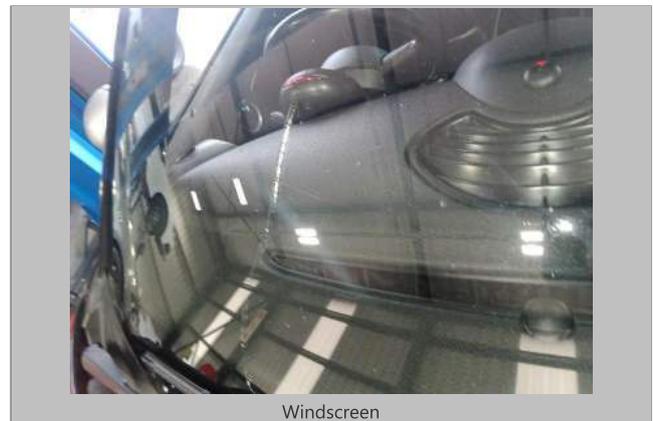
| Damage | Repair Way |
|---|---|
| Windscreen Cracked | Replace |

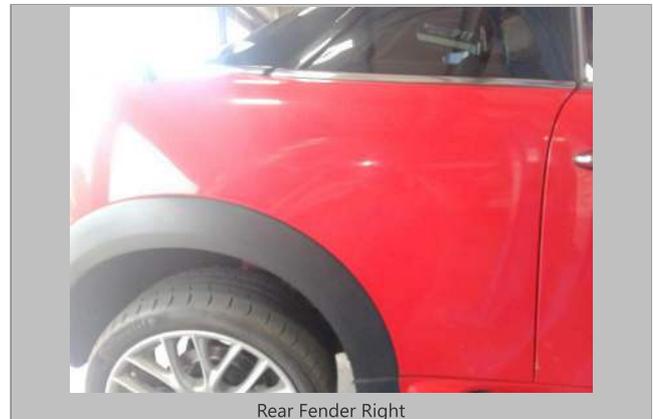
| Damage | Repair Way |
|---|---|
| Rear Fender Right Paintwork • Scratched | Repair |

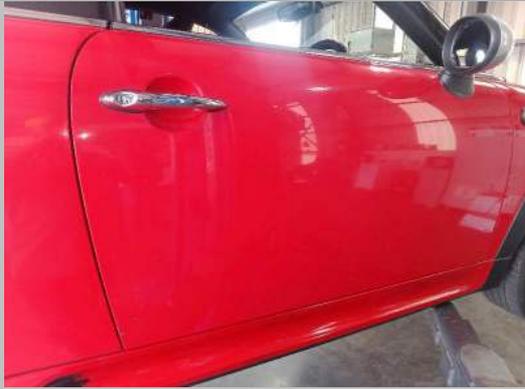
| Damage | Repair Way |
|---|---|
| Door Front Right Paintwork • Scratched | Repair |

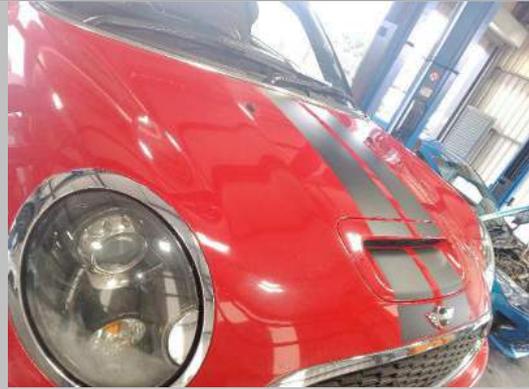
| Damage | Repair Way |
|---|---|
| Bonnet Paintwork • Scratched | Repair |

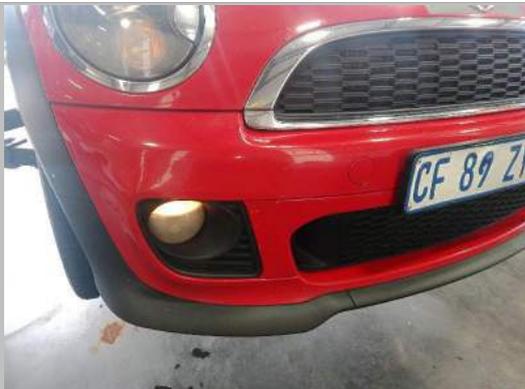
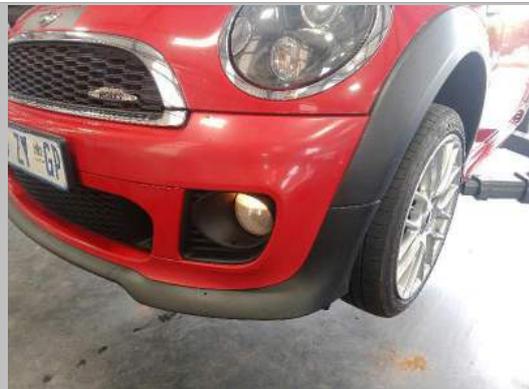
| Damage | Repair Way |
|---|---|
| Front Bumper Paintwork • Chipmarks | Repair |

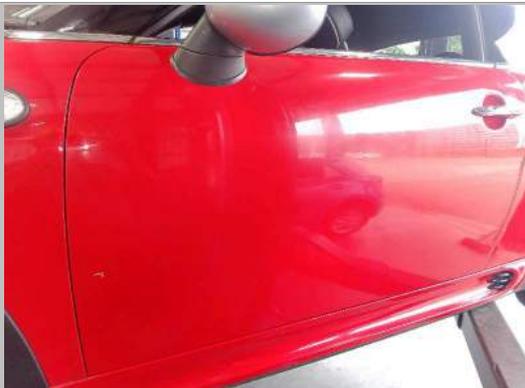
| Damage | Repair Way |
|---|---|
| Door Front Left Paintwork • Scratched | Repair |

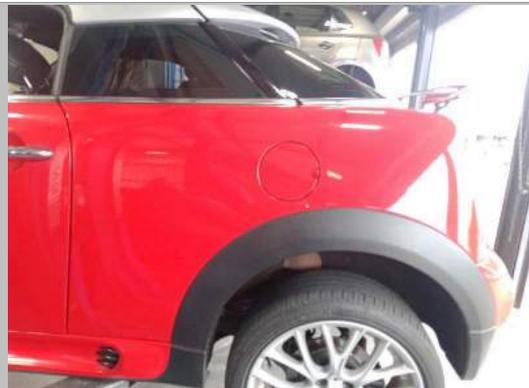
| Damage | Repair Way |
|---|---|
| Rear Fender Left Paintwork • Scratched | Repair |

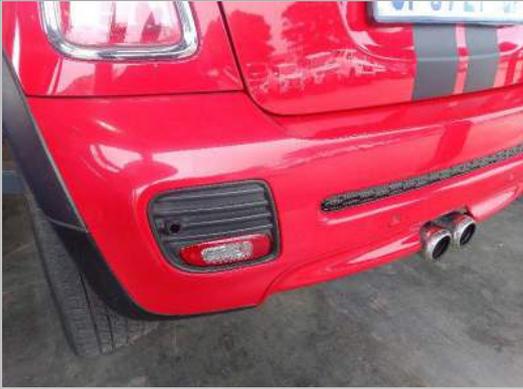
| Damage | Repair Way |
|---|---|
| Rear bumper Paintwork • Scratched | Repair |

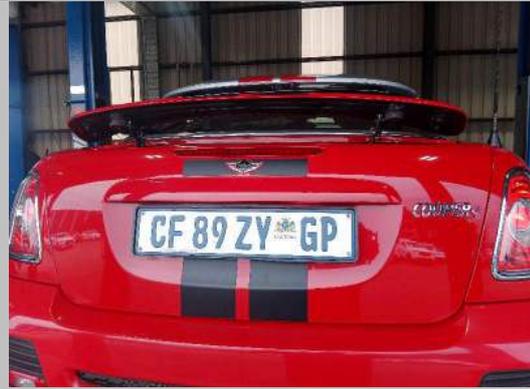
| Damage | Repair Way |
|---|---|
| Boot Lid / Hatch door Paintwork • Scratched | Repair |

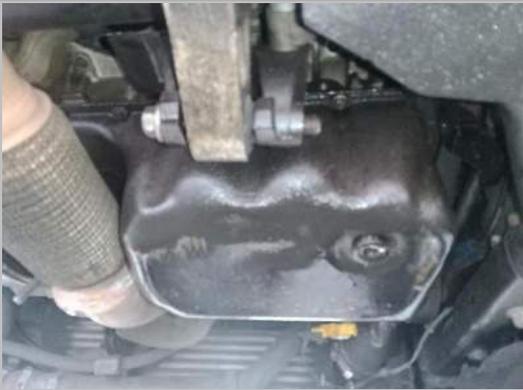
| Damage | Repair Way |
|---|---|
| Engine Oil Leak | Repair |
