CONDITION REPORT

Report No: 2016595023

MFC Auction House  
M57 Pretoria Rd, Glenmarais, KEMPTON PARK  
Gauteng

| Model | AMAROK 2.0 BITDI D-CAB 4MOTION<br>HIGHLINE 132KW DSL PU AT [2012-2014] | Register Number | |

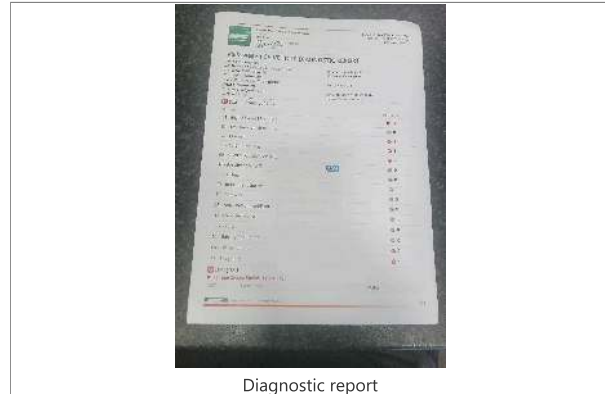
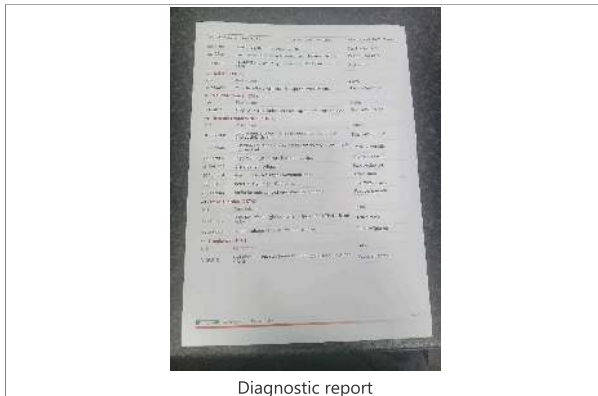
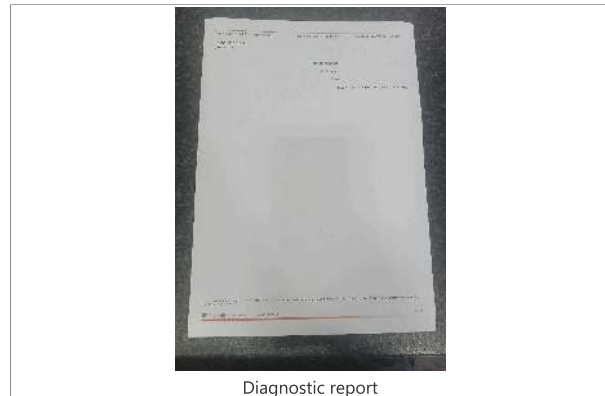
Diagnostic report

| No | System | Code | Description | Status |
|---|---|---|---|---|
| 1 | ENGINE CONTROL MODULE | P068A00 | ECM/PCM POWER RELAY DE-ENERGIZED PERFORMANCE -TOO EARLY | |

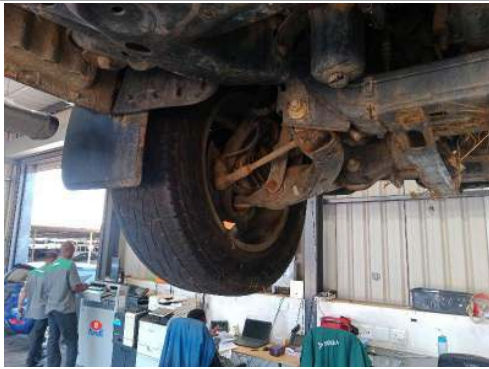
LF TYRE TREAD

| | Size | Load/Speed Index | Manufacture | Model | Type* | Production Date | Tread Depth (mm) |
|---|---|---|---|---|---|---|---|
| Front Left | 255/60R18 | 112T | Pirelli | Scorpion | V | 4316 | 2 mm |

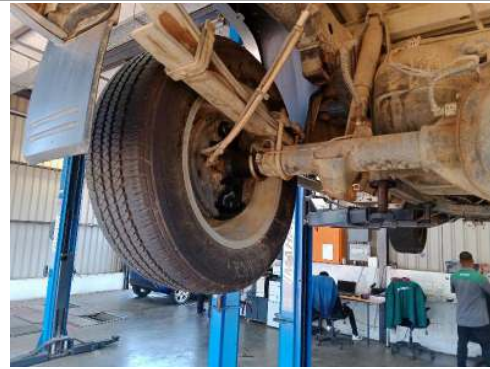
LR TYRE TREAD

| | Size | Load/Speed Index | Manufacture | Model | Type* | Production Date | Tread Depth (mm) |
|---|---|---|---|---|---|---|---|
| Rear Left | 255/60R18 | 112T | Bridgestone | Dueler | V | 1613 | 3 mm |

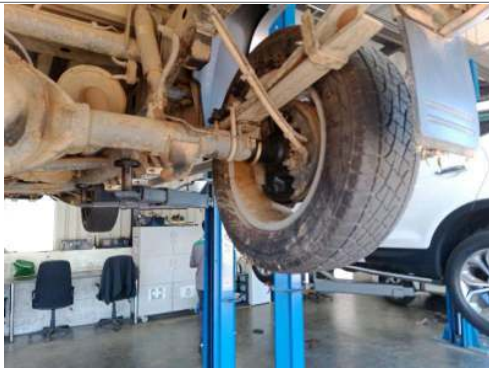
RR TYRE TREAD

| | Size | Load/Speed Index | Manufacture | Model | Type* | Production Date | Tread Depth (mm) |
|---|---|---|---|---|---|---|---|
| Rear Right | 255/60R18 | 112T | Pirelli | Scorpion | V | 2017 | 2 mm |

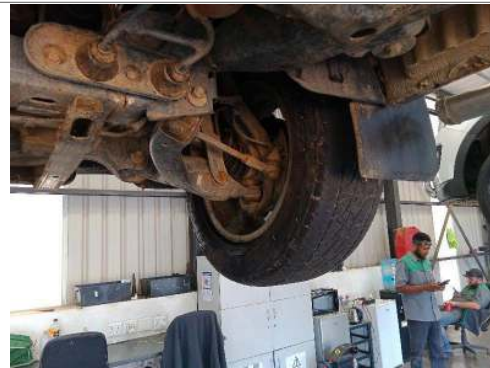
RF TYRE TREAD

| | Size | Load/Speed Index | Manufacture | Model | Type* | Production Date | Tread Depth (mm) |
|---|---|---|---|---|---|---|---|
| Front Right | 255/60R18 | 112T | Pirelli | Scorpion | V | 3216 | 2 mm |

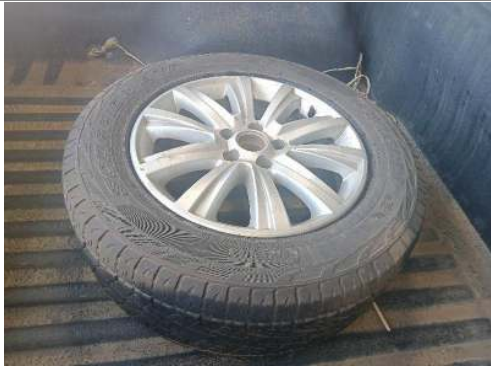
Spare wheel

| | Size | Load/Speed Index | Manufacture | Model | Type* | Production Date | Tread Depth (mm) |
|---|---|---|---|---|---|---|---|
| Spare | 255/60R18 | 112T | Pirelli | Scorpion | V | 3316 | 2 mm |

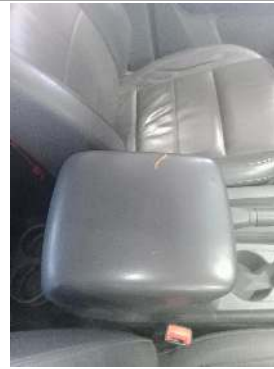
| Damage | Repair Way |
|--|---|
| Center Console / Cubbyhole + Lid Damaged | Repair |

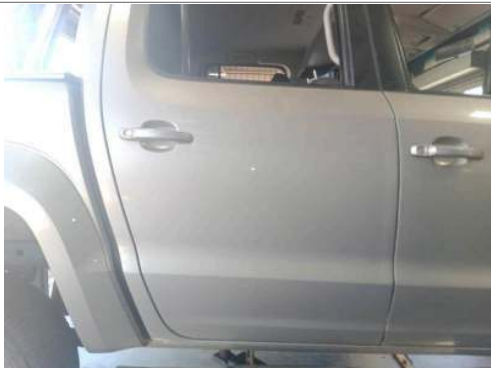
| Damage | Repair Way |
|--|---|
| Door Rear Right Dented | Repair |

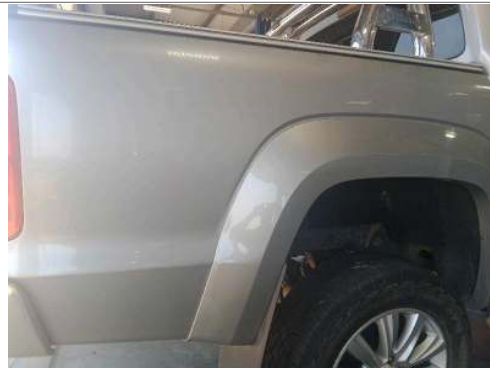
| Damage | Repair Way |
|--|---|
| Rear Fender Right Paintwork • Scratched | Repair |

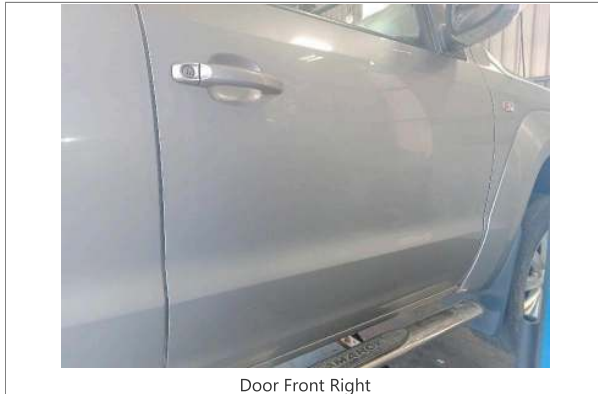
| Damage | Repair Way |
|--|---|
| Door Front Right Paintwork • Scratched | Repair |

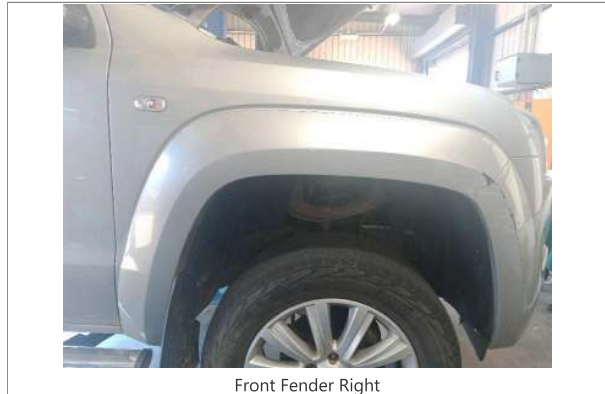
| Damage | Repair Way |
|--|---|
| Front Fender Right Paintwork • Scratched | Repair |

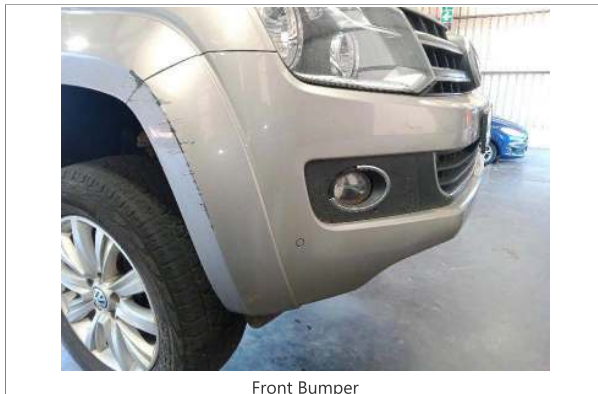
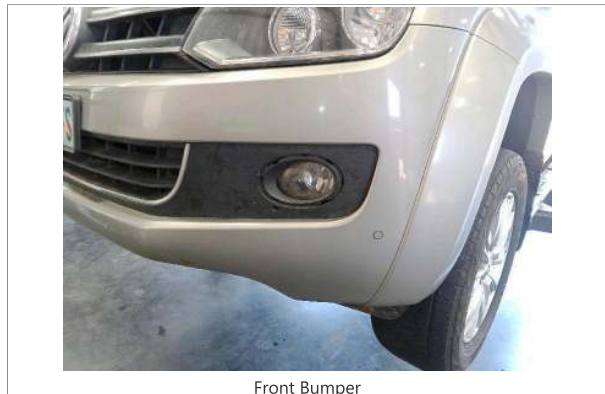
| Damage | Repair Way |
|--|---|
| Front Bumper Paintwork • Scratched | Repair |

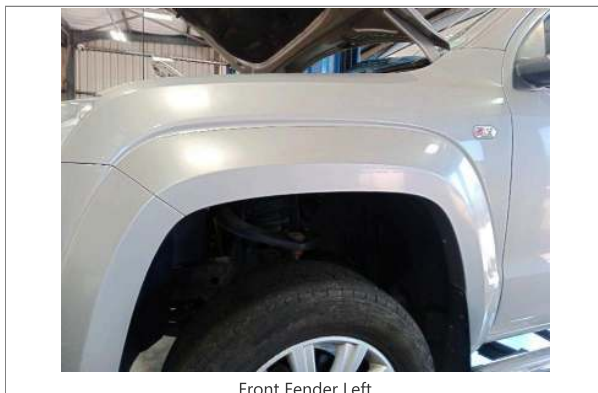
| Damage | Repair Way |
|--|---|
| Front Fender Left Paintwork • Scratched | Repair |

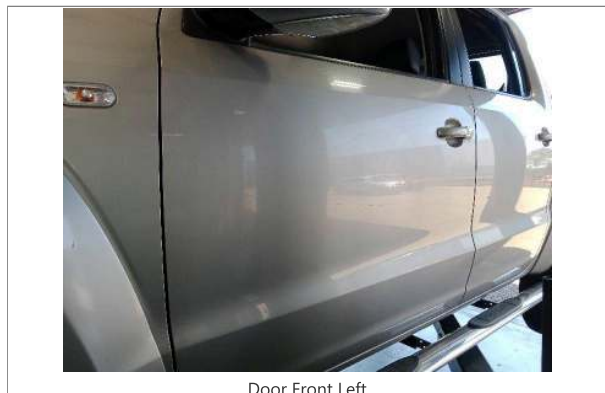
| Damage | Repair Way |
|--|---|
| Door Front Left Paintwork • Scratched | Repair |

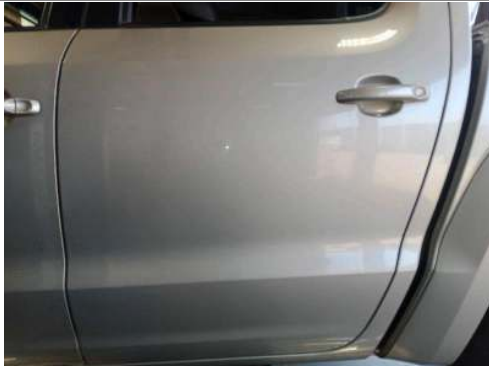
| Damage | Repair Way |
|--|---|
| Door Rear Left Paintwork • Scratched | Repair |

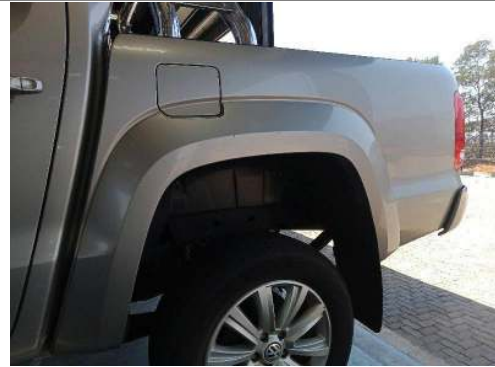
| Damage | Repair Way |
|--|---|
| Rear Fender Left Paintwork • Scratched | Repair |

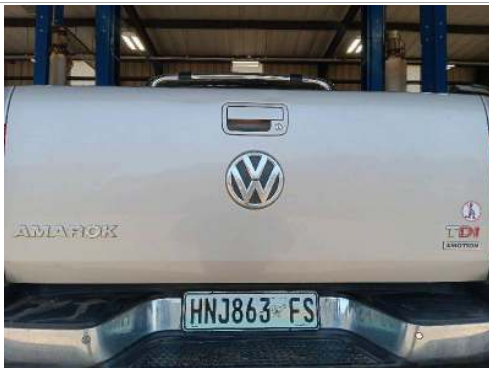
| Damage | Repair Way |
|--|---|
| Tailgate Paintwork • Scratched | Repair |

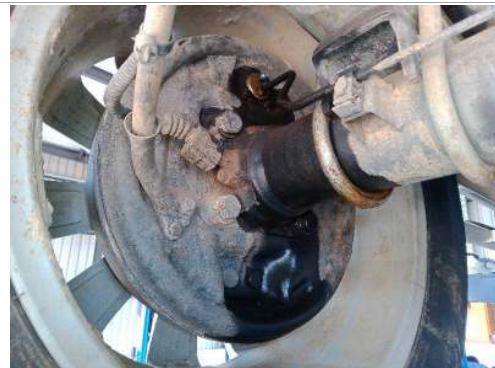
| Damage | Repair Way |
|--|---|
| Brake Drum 2. Axle left Defective | Repair |

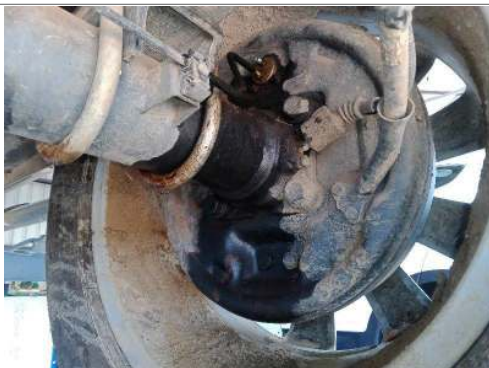
| Damage | Repair Way |
|--|---|
| Brake Drum 2. Axle right Defective | Repair |

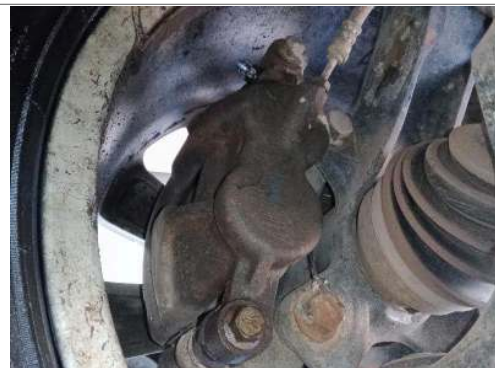
| Damage | Repair Way |
|--|---|
| Caliper 1. Axle right Leak | Repair |

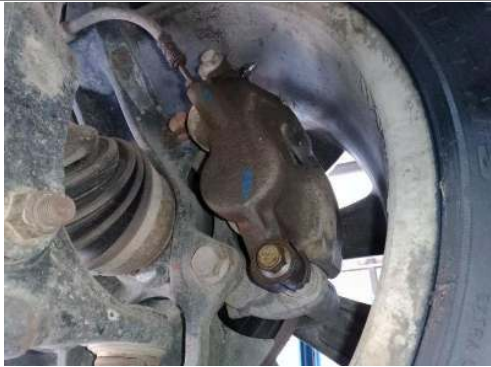
| Damage | Repair Way |
|--|---|
| Caliper 1. Axle left Leak | Repair |
