## CONDITION REPORT

Report No:  
2017305918  
DATE  
01/10/2026

| Manufacturer | VOLKSWAGEN | Registration Number | LBS172NW |
| Model | AMAROK 2.0 BITDI D-CAB HIGHLINE DSL PU AT [2015-2017] | Register Number | |

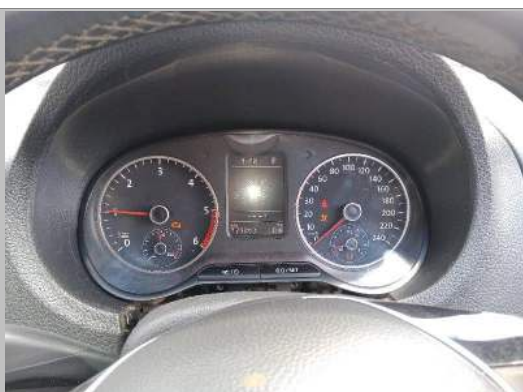
DASHBOARD (W/ ENGINE RUNNING)

| Airbag warning light illuminated | Repair |
| Engine management light illuminated | Repair |

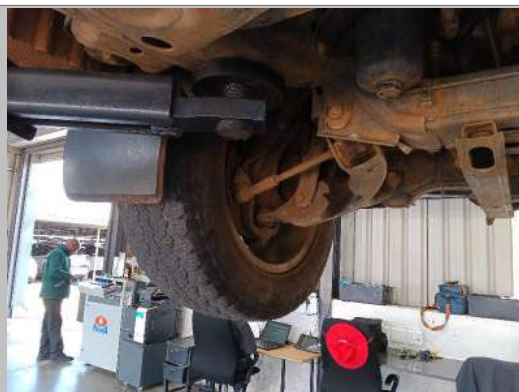
LF TYRE TREAD

| | Size | Load/Speed Index | Manufacture | Model | Type* | Production Date | Tread Depth (mm) |
|---|---|---|---|---|---|---|---|
| Front Left | 255/60R18 | 112H | General | Grabber | V | 3821 | 2 mm |

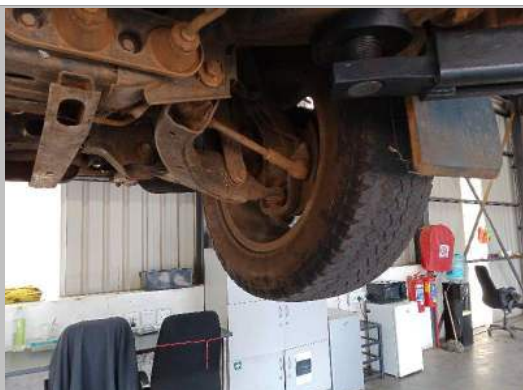
RF TYRE TREAD

| | Size | Load/Speed Index | Manufacture | Model | Type* | Production Date | Tread Depth (mm) |
|---|---|---|---|---|---|---|---|
| Front Right | 255/60R18 | 112H | General | Grabber | V | 3921 | 3 mm |

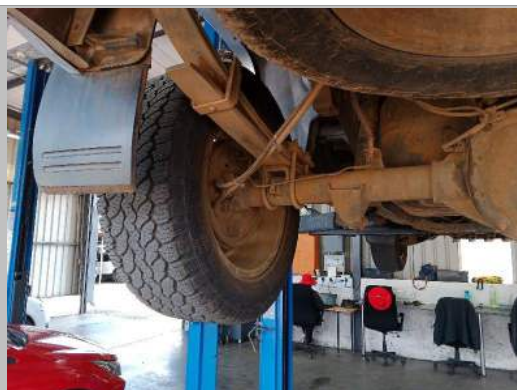
LR TYRE TREAD

| | Size | Load/Speed Index | Manufacture | Model | Type* | Production Date | Tread Depth (mm) |
|---|---|---|---|---|---|---|---|
| Rear Left | 255/60R18 | 112H | General | Grabber | V | 0724 | 5 mm |

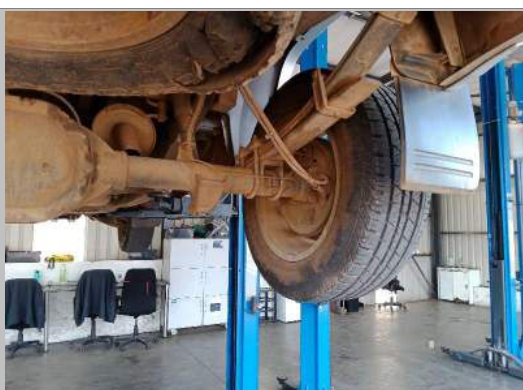
RR TYRE TREAD

| | Size | Load/Speed Index | Manufacture | Model | Type* | Production Date | Tread Depth (mm) |
|---|---|---|---|---|---|---|---|
| Rear Right | 255/60R18 | 112T | Continental | Contact | V | 5015 | 3 mm |

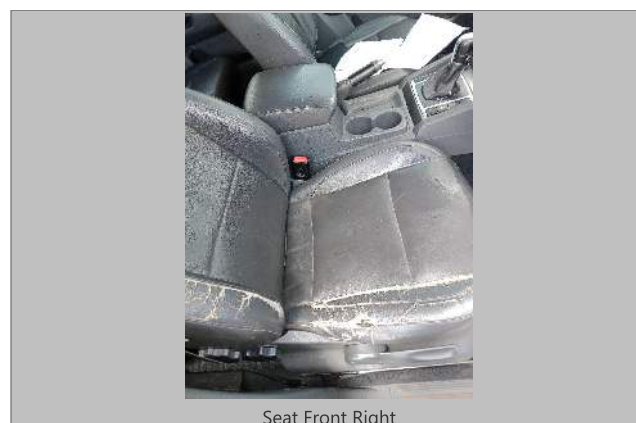
| Seat Front Right Torn / Cut | Repair |

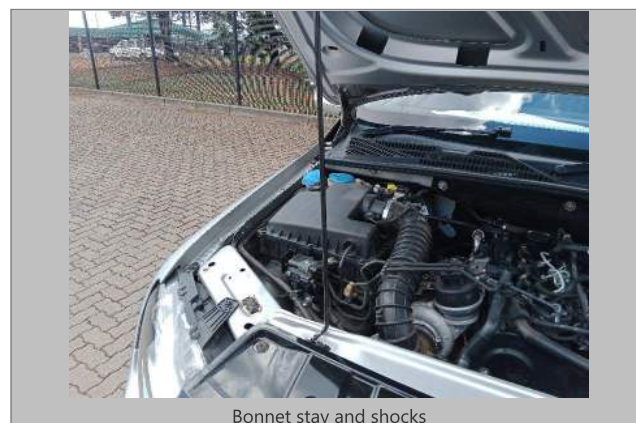
| Bonnet stay and shocks Defective | Repair |

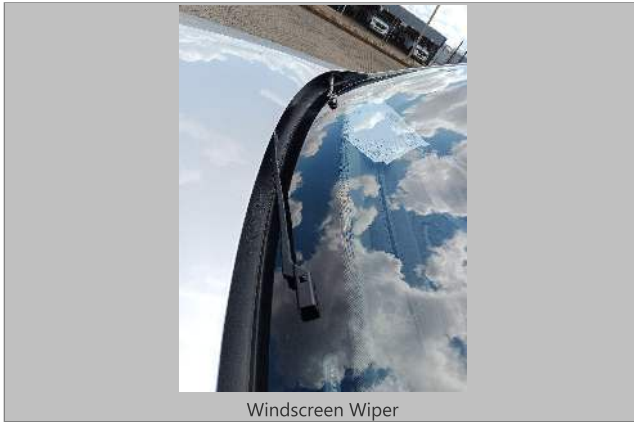
| Windscreen Wiper Missing | Replace |

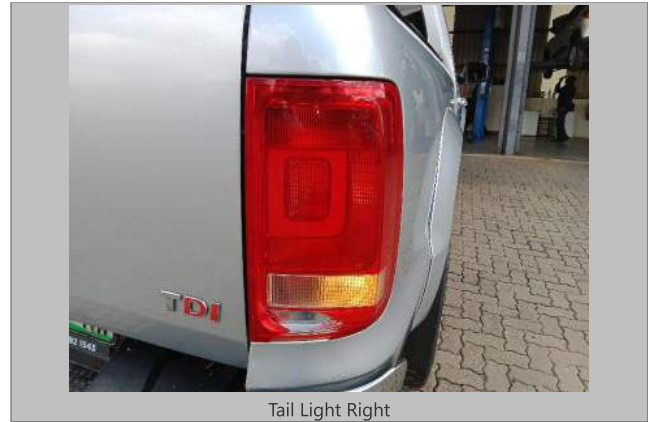
| Tail Light Right Damaged | Replace |

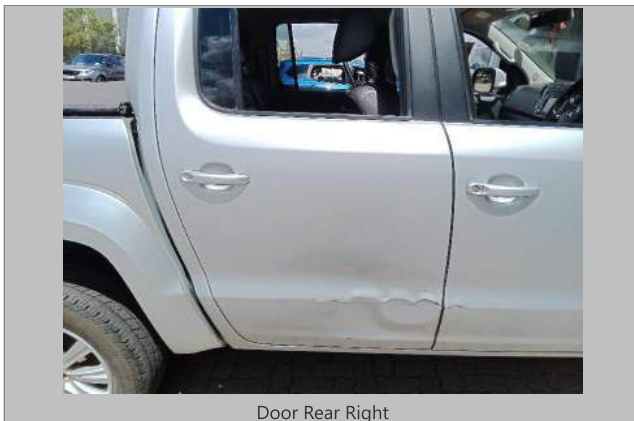
| Door Rear Right Dented | Repair |

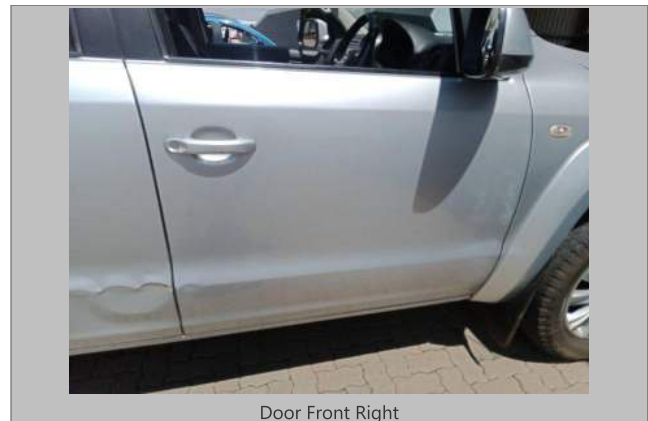
| Door Front Right Dented | Repair |

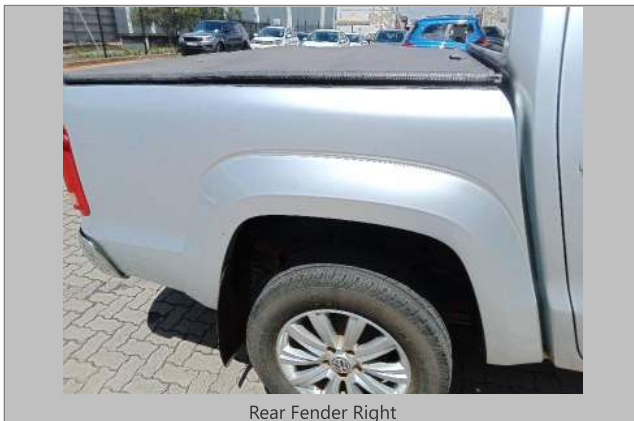
| Rear Fender Right Paintwork • Scratched | Repair |

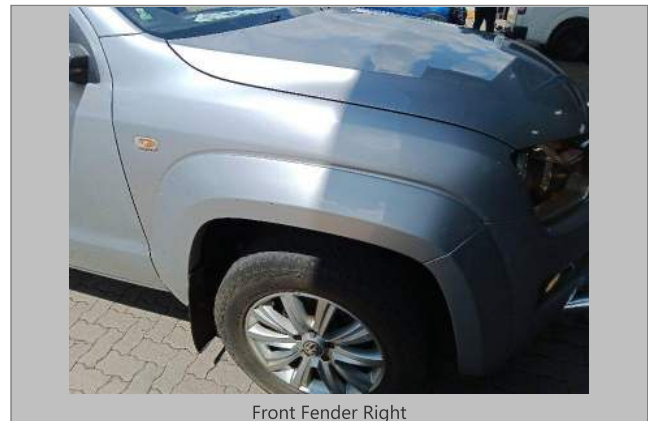
| Front Fender Right Paintwork • Scratched | Repair |

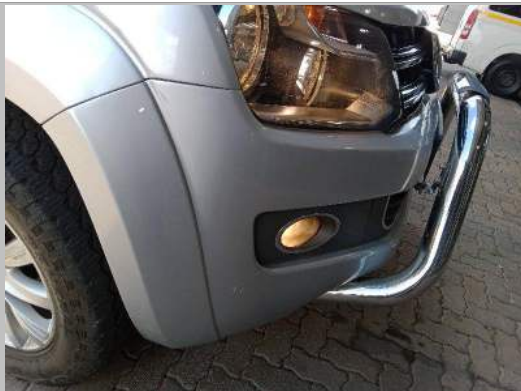
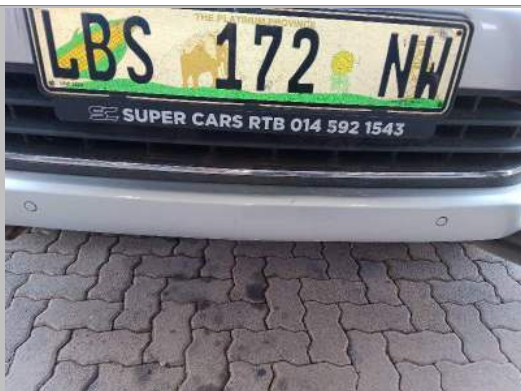
| Front Bumper Paintwork • Scratched | Repair |

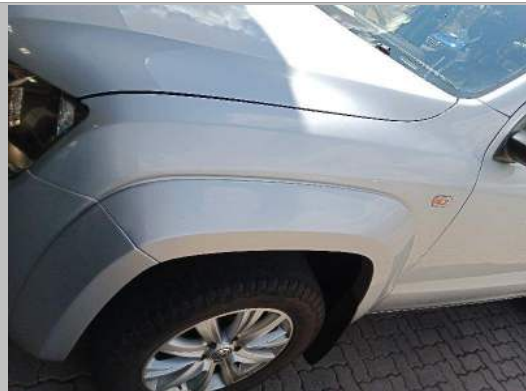
| Front Fender Left Paintwork • Scratched | Repair |

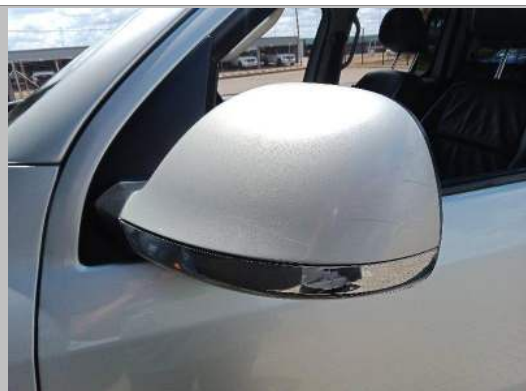
| Side Mirror Right Paintwork • Scratched | Repair |

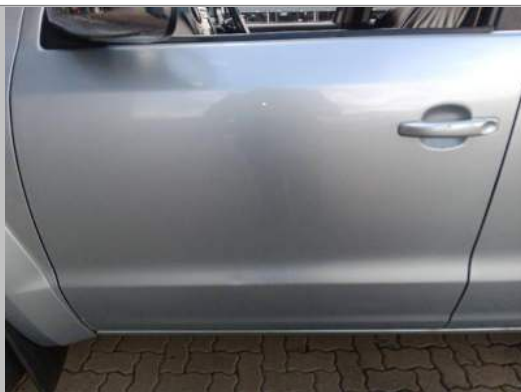
| Door Front Left Dented | Repair |

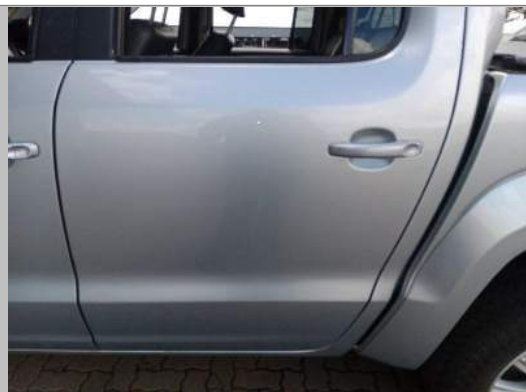
| Door Rear Left Paintwork • Scratched | Repair |

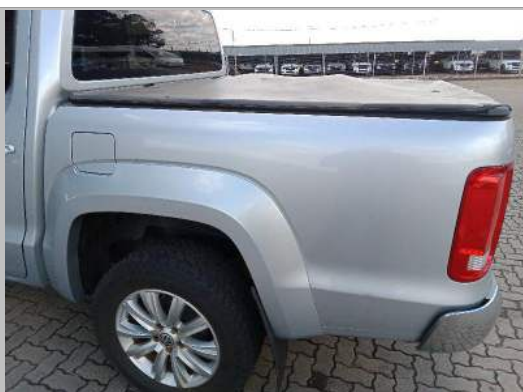
| Rear Fender Left Paintwork • Scratched | Repair |

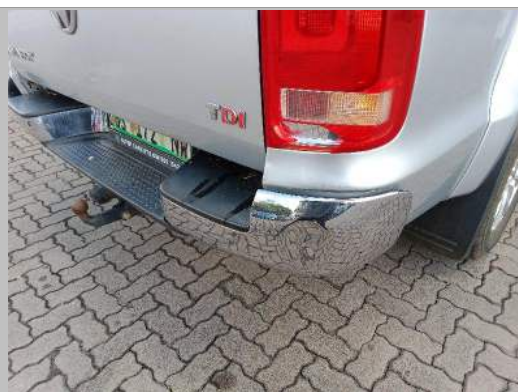
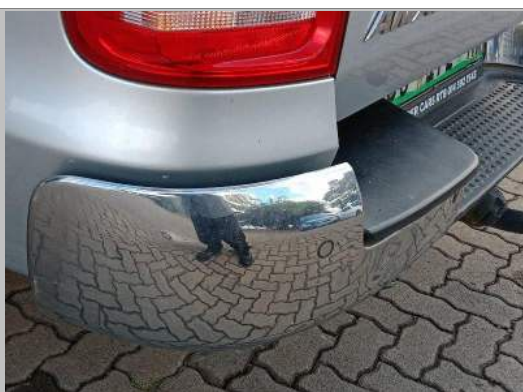
| Rear bumper Dented | Repair |

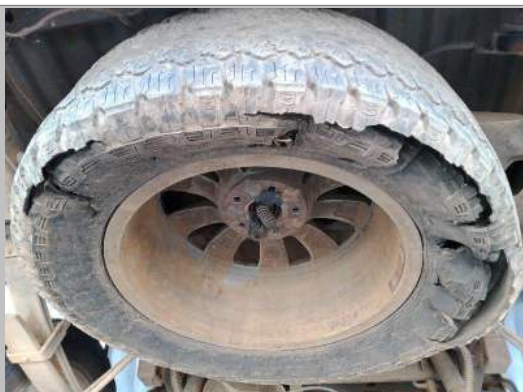
| Spare Tyre Damaged | Replace |
