CONDITION REPORT

Report No:  
2017301980  
DATE  
23/09/2026

| Manufacturer | VOLKSWAGEN | Registration Number | FVY755L |
| Model | AMAROK 3.0 TDI D-CAB 4MOTION HIGHLINE PLUS 190KW DSL PU AT [2021-2023] | Register Number | |

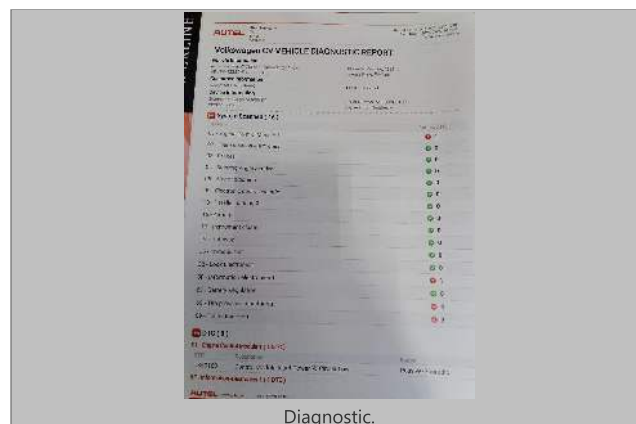
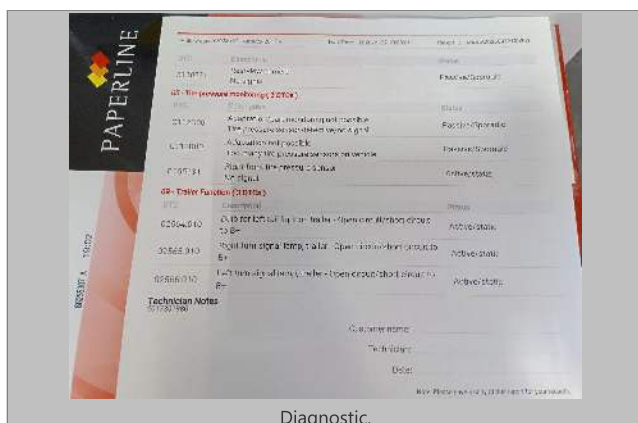
Diagnostic.

| No | System | Code | Description | Status |
|---|---|---|---|---|
| 1 | ENGINE CONTROL MODULE 1 | U350100 | CONTROL MODULE INPUT POWER A CIRCUIT LOW | |

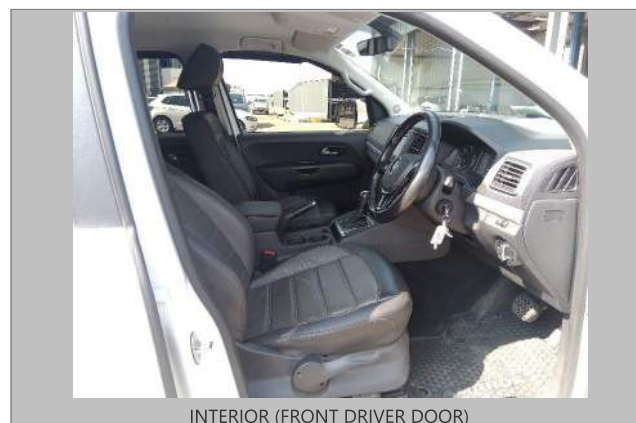
INTERIOR (FRONT DRIVER DOOR)

General Comments: ACCORDING TO THE AGE AND MILEAGE OF THE VEHICLE, NORMAL WEAR AND TEAR MARKS ARE VISIBLE ON THE INTERIOR, EXTERIOR, ELECTRICAL AND MECHANICAL PARTS. 8 DTC'S AT TIME OF TESTING SEE DTC REPORT. Electrical Components and Instruments: Central locking malfunctioning driver side door does not unlock with key fob. After opening door from the inside driver side door opens correctly from the outside. vehicle electronics malfunctioning.

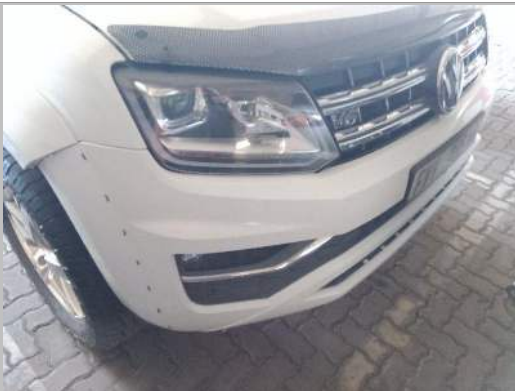
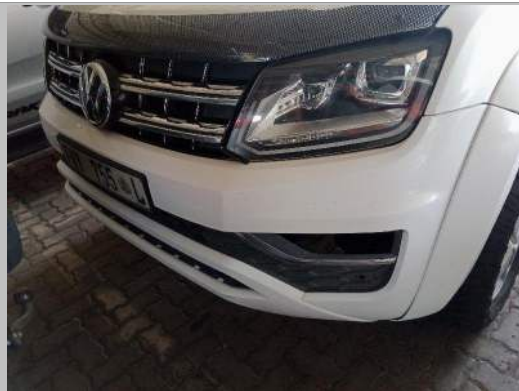
| Front Bumper Damaged | Repair |

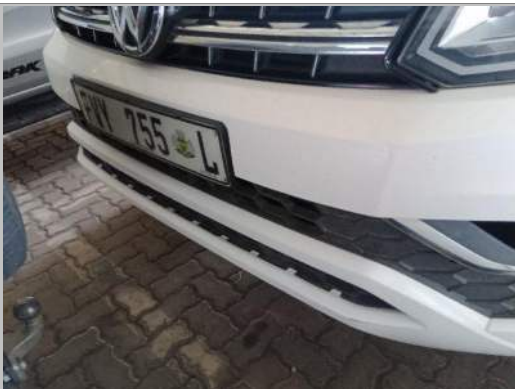
| Grill Damaged | Repair |

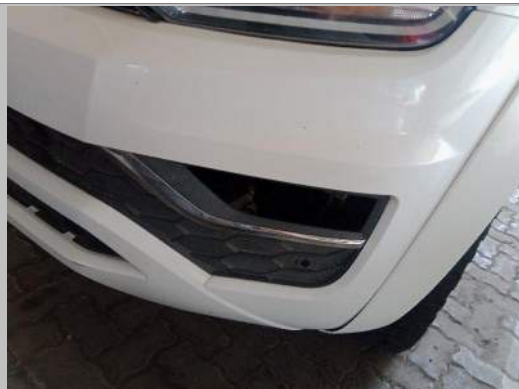
| Fog Light Front Left Damaged | Repair |

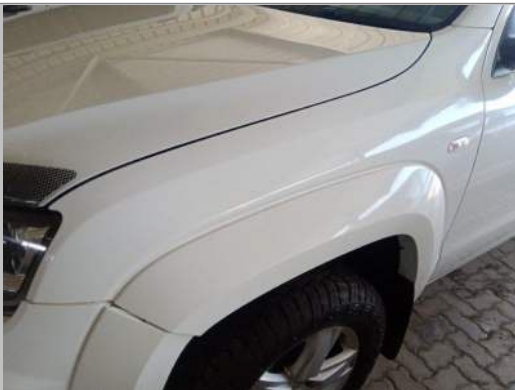
| Front Fender Left Damaged | Repair |

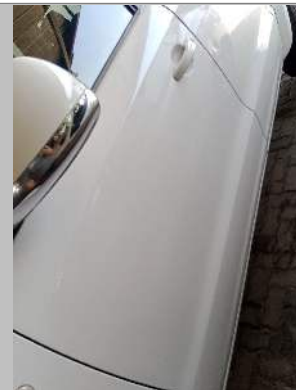
| Door Front Left Damaged | Repair |

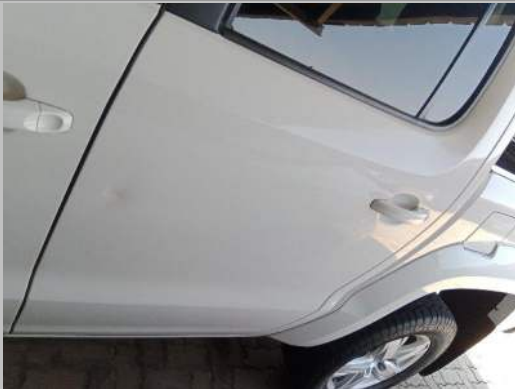
| Door Rear Left Damaged | Repair |

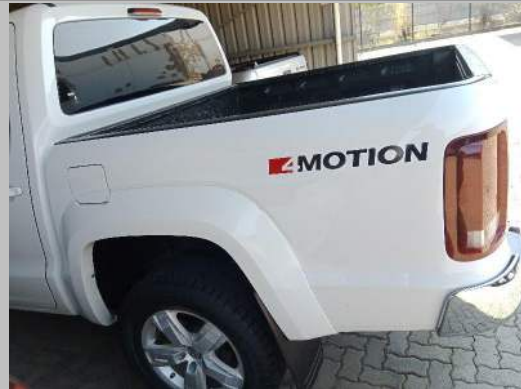
| Rear Fender Left Damaged | Repair |

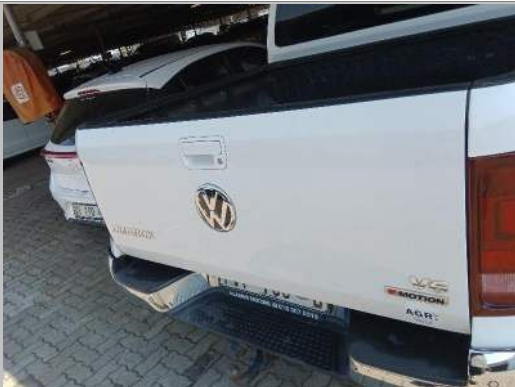
| Tailgate Damaged | Repair |

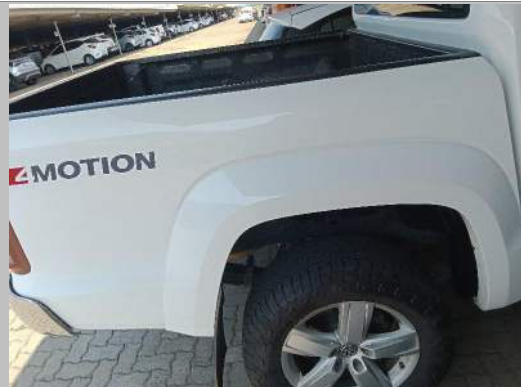
| Rear Fender Right Damaged | Repair |

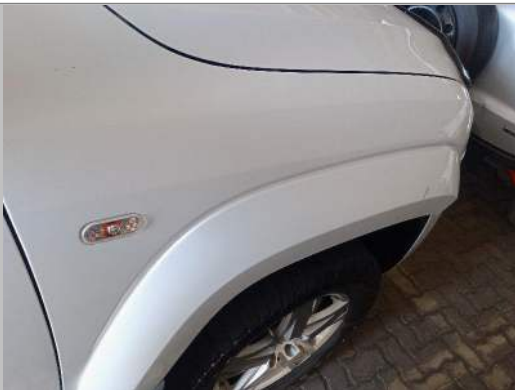
| Front Fender Right Damaged | Repair |

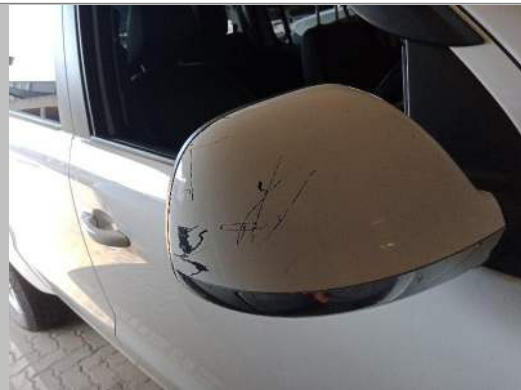
| Side Mirror Right Damaged | Replace |

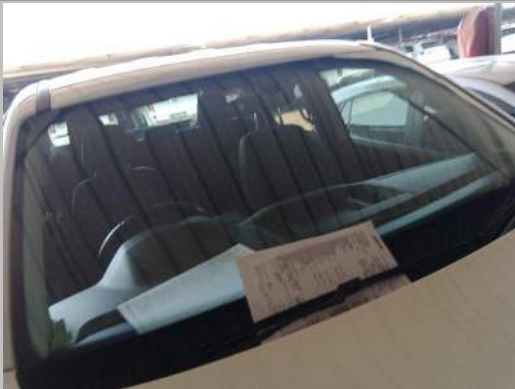
| Windscreen Damaged | Replace |

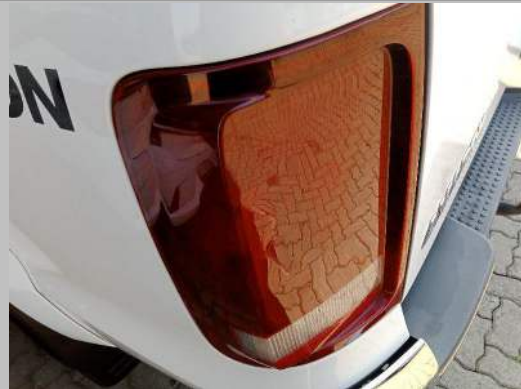
| Tail Light Left Damaged | Repair |

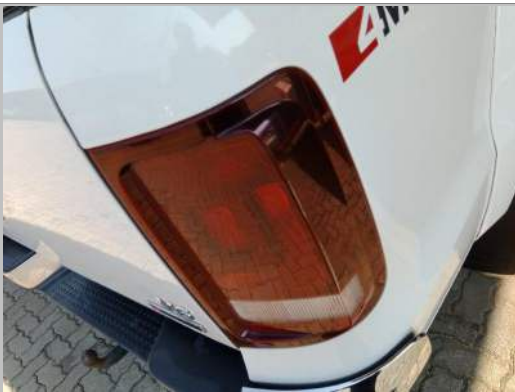
| Tail Light Right Damaged | Repair |

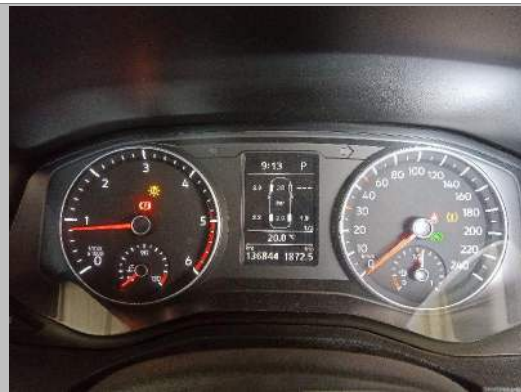
| Engine Management Lights Set | Repair |

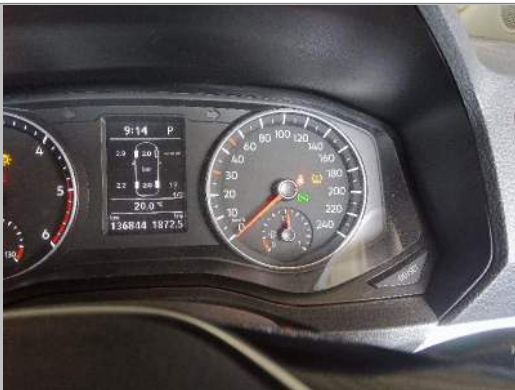
| Fuel Gauge Defective | Repair |

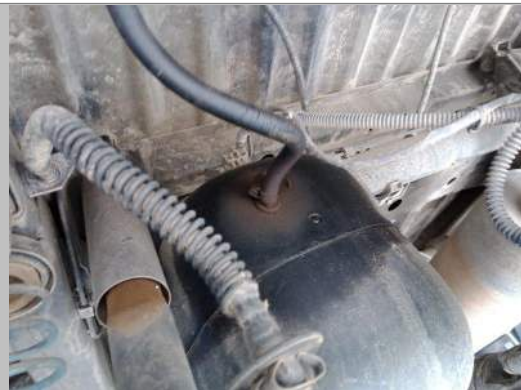
| Fuel Tank Leak | Repair |

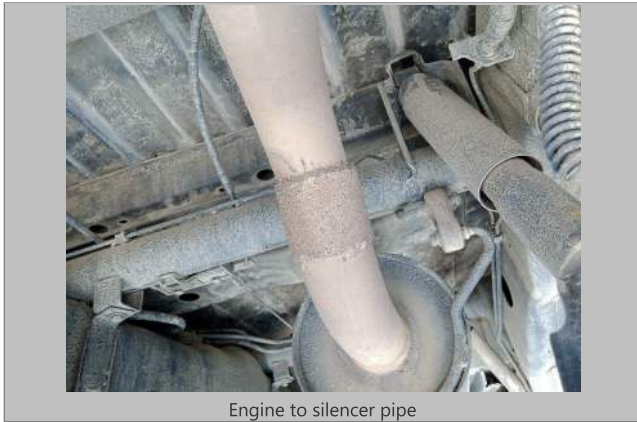
| Engine to silencer pipe Welded | Replace |
