## CONDITION REPORT

Report No:  
2017304779  
DATE  
29/09/2026

| Manufacturer | VOLKSWAGEN | Registration Number | MG44SYGP |
| Model | KOMBI T6 LWB 2.0 TDI COMFORTLINE MPV<br>DSL 103KW DSG [2016-2018] | Register Number | |

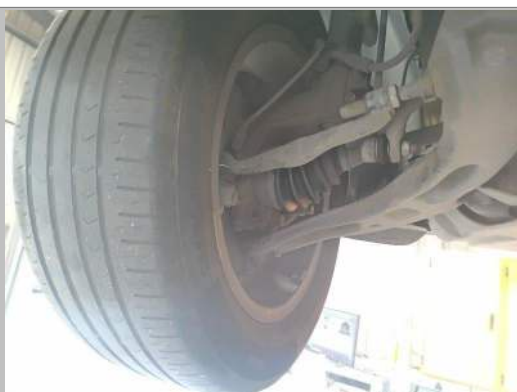
LF TYRE TREAD

| | Size | Load/Speed Index | Manufacture | Model | Type* | Production Date | Tread Depth (mm) |
|---|---|---|---|---|---|---|---|
| Front Left | 235/55R17 | 103W | Continental | Contact | V | 4024 | 0 mm |

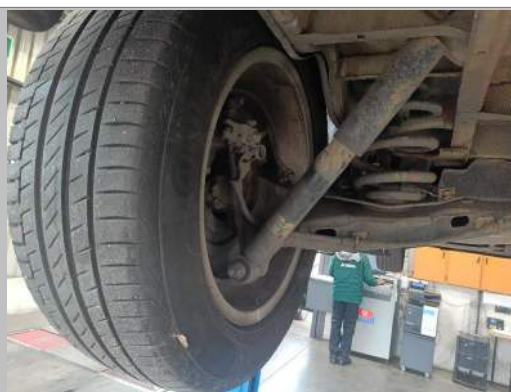
LR TYRE TREAD

| | Size | Load/Speed Index | Manufacture | Model | Type* | Production Date | Tread Depth (mm) |
|---|---|---|---|---|---|---|---|
| Rear Left | 235/55R17 | 103W | Continental | Contact | V | 2225 | 6 mm |

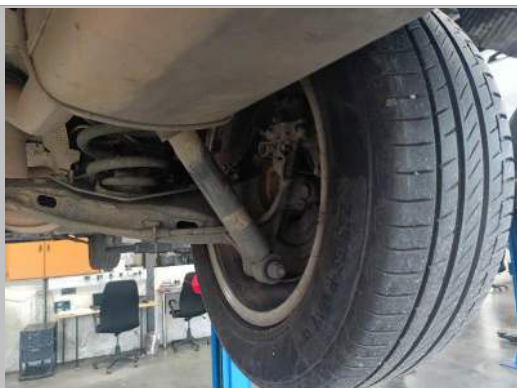
RR TYRE TREAD

| | Size | Load/Speed Index | Manufacture | Model | Type* | Production Date | Tread Depth (mm) |
|---|---|---|---|---|---|---|---|
| Rear Right | 235/55R17 | 103W | Continental | Contact | V | 1425 | 3 mm |

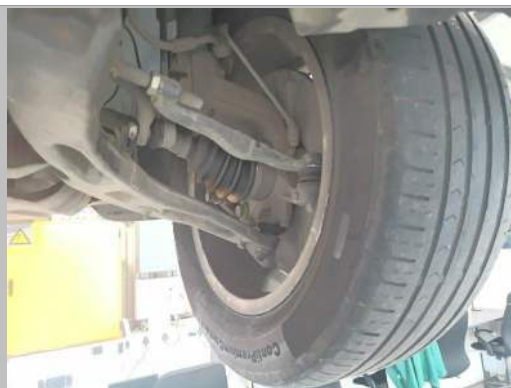
RF TYRE TREAD

| | Size | Load/Speed Index | Manufacture | Model | Type* | Production Date | Tread Depth (mm) |
|---|---|---|---|---|---|---|---|
| Front Right | 235/55R17 | 103W | Continental | Contact | V | 4024 | 2 mm |

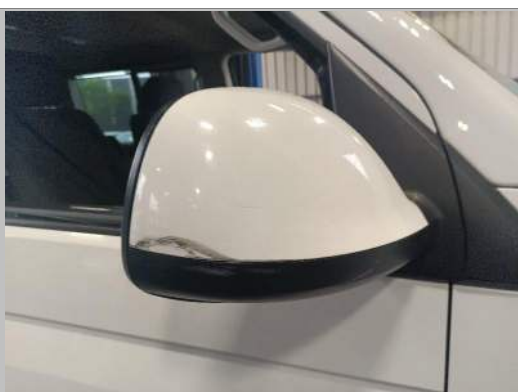
| Damage | Repair Way |
|---|---|
| Side Mirror Right Paintwork • Scratched | Repair |

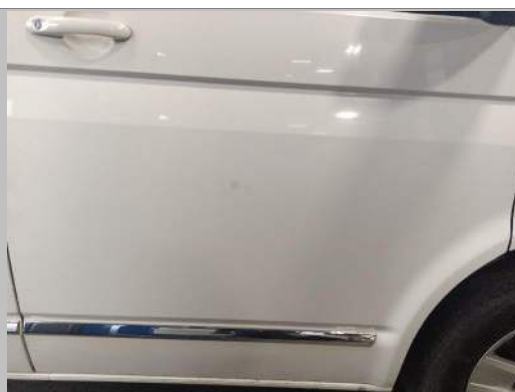
| Damage | Repair Way |
|---|---|
| Door Front Right Paintwork • Scratched | Repair |

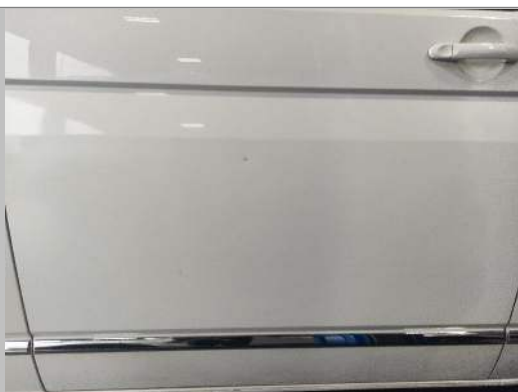
| Damage | Repair Way |
|---|---|
| Sliding Door Paintwork • Scratched | Repair |

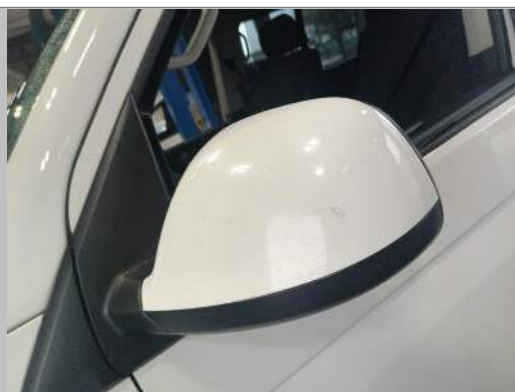
| Damage | Repair Way |
|---|---|
| Side Mirror Left Paintwork • Scratched | Repair |

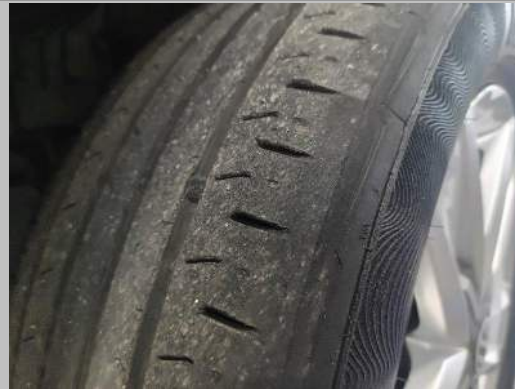
| Damage | Repair Way |
|---|---|
| Tyre Front Left Smooth | Replace |

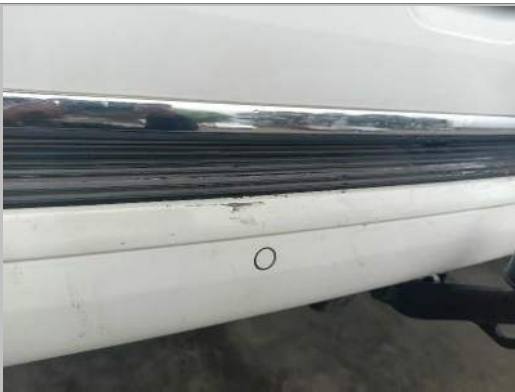
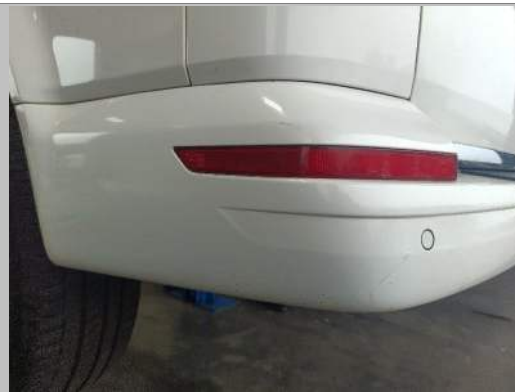
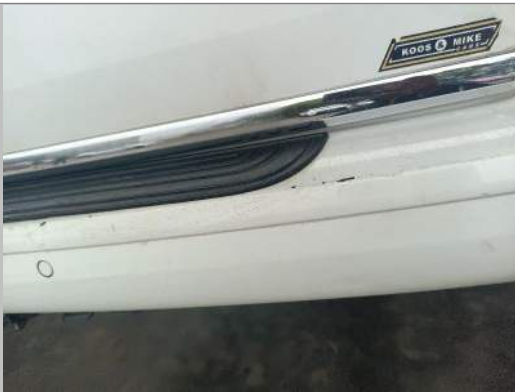
| Damage | Repair Way |
|---|---|
| Rear bumper Paintwork • Scratched | Repair |
