## CONDITION REPORT

Report No:  
2016941265  
DATE  
10/07/2025

| Manufacturer | VOLKSWAGEN | Registration Number | JZ43KKGP |
| Model | TIGUAN ALLSPACE 1.4 TSI TRENDLINE 110KW DSG [2018-2019] | Register Number | |

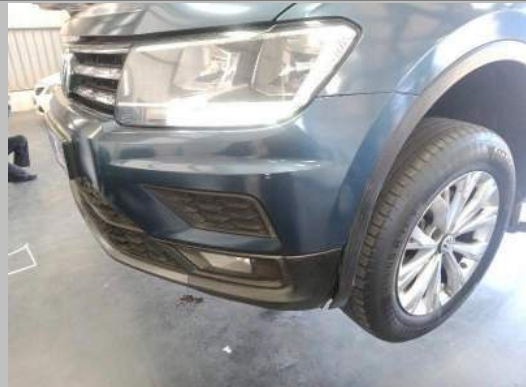
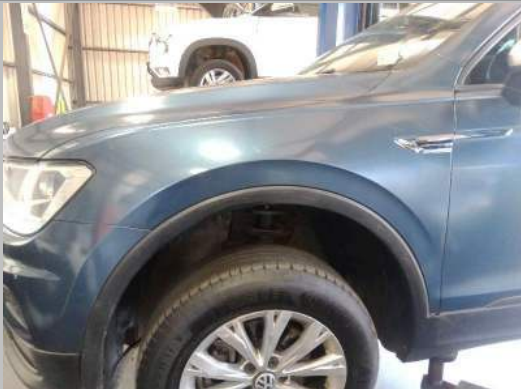
| Damage | Repair Way |
|---|---|
| Front Bumper Residual Traces of Repair | Repair |

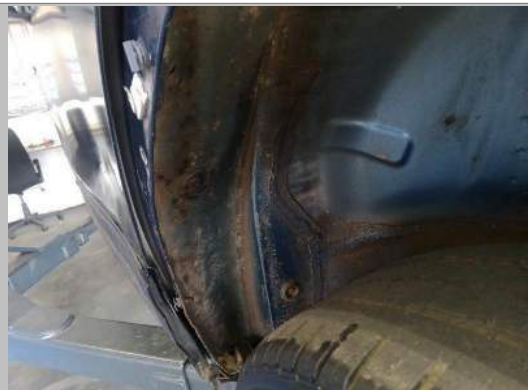
| Damage | Repair Way |
|---|---|
| Rear Fender Left Residual Traces of Repair | Repair |

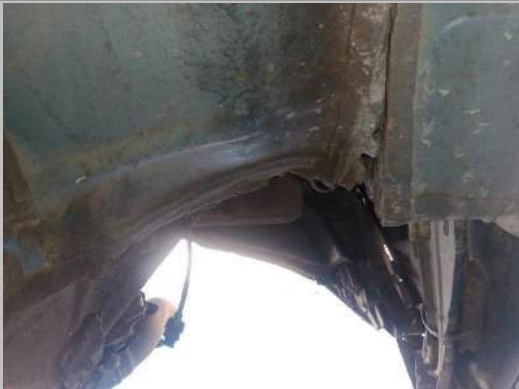
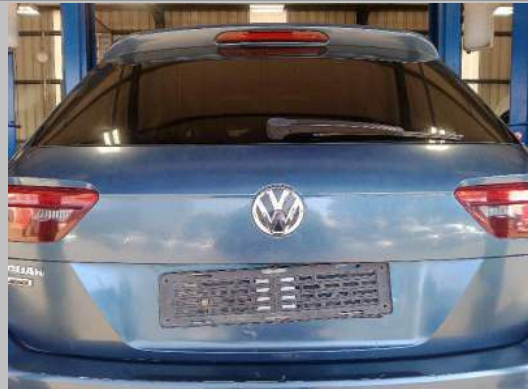
| Damage | Repair Way |
|---|---|
| Rear Fender Left / Inner Tray Residual Traces of Repair | Repair |

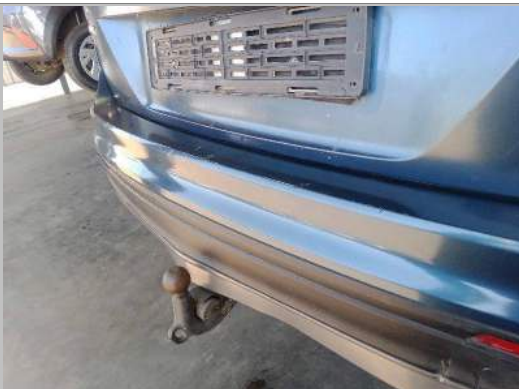
| Damage | Repair Way |
|---|---|
| Boot Lid / Hatch door Residual Traces of Repair | Repair |

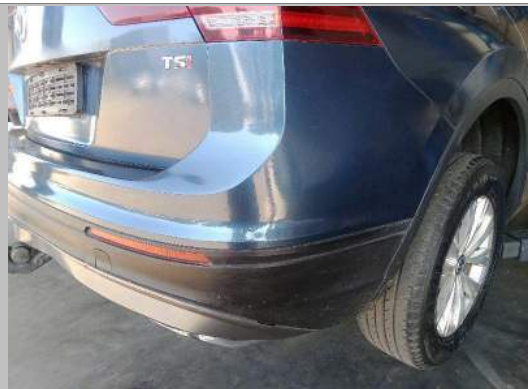
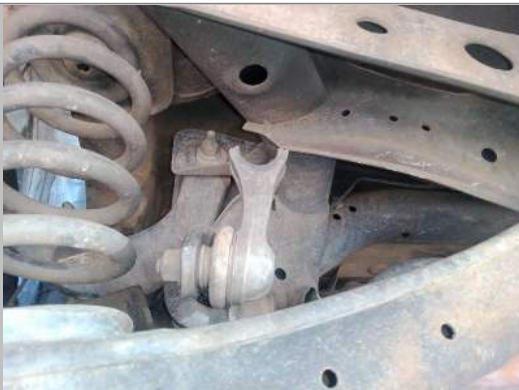
| Damage | Repair Way |
|---|---|
| Rear bumper Paintwork • Scratched | Repair |

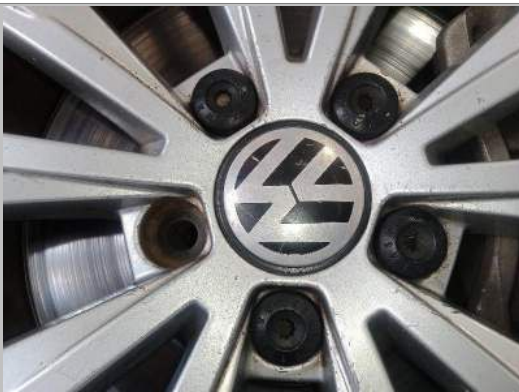
| Damage | Repair Way |
|---|---|
| Tyre Front Right Smooth | Replace |

| | Size | Load/Speed Index | Manufacture | Model | Type* | Production Date | Tread Depth (mm) |
|---|---|---|---|---|---|---|---|
| Front Right | 215/65R17 | 99V | Bridgestone | Dueler | V | 1617 | 0 mm |

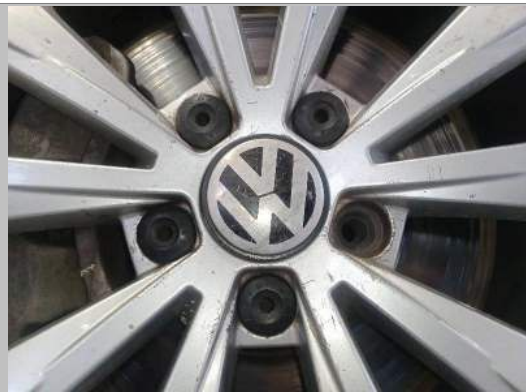
| Damage | Repair Way |
|---|---|
| Bolt(s) / Nut(s) Front Wheel Right Missing | Replace |

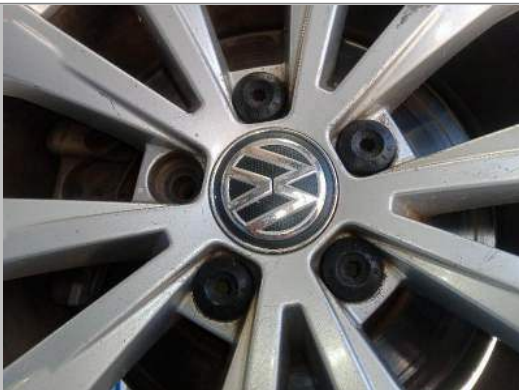
| Damage | Repair Way |
|---|---|
| Bolt(s) / Nut(s) Front Wheel Left Missing | Replace |

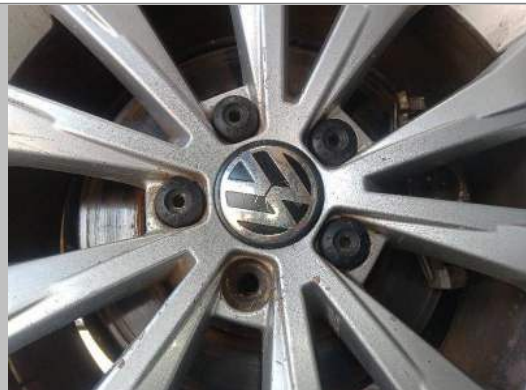
| Damage | Repair Way |
|---|---|
| Bolt(s) / Nut(s) Rear Wheel Left Missing | Replace |
