## CONDITION REPORT

Report No:  
2016924173  
DATE  
25/06/2025

| Manufacturer | VOLKSWAGEN | Registration Number | LCH503NW |
| Model | TIGUAN ALLSPACE 1.4 TSI TRENDLINE 110KW<br>DSG [2018-2019] | Register Number | |

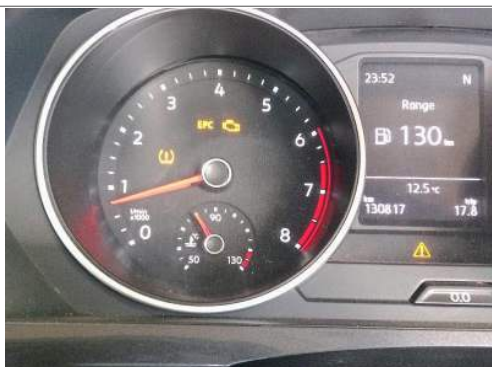
Warning lights illuminated

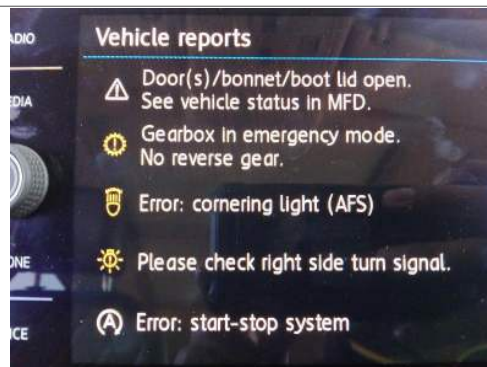
Warning lights illuminated

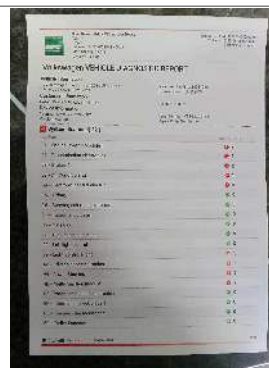
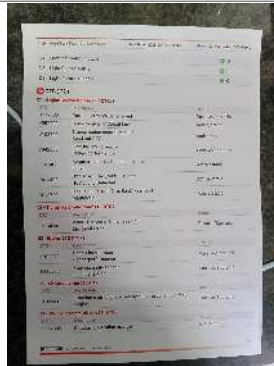
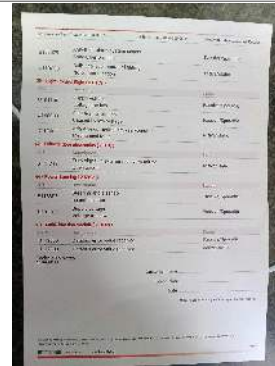
Diagnostic test

| No | System | Code | Description | Status |
|---|---|---|---|---|
| 1 | ENGINE CONTROL MODULE | U112300 | DATABUS ERROR VALUE RECEIVED | |

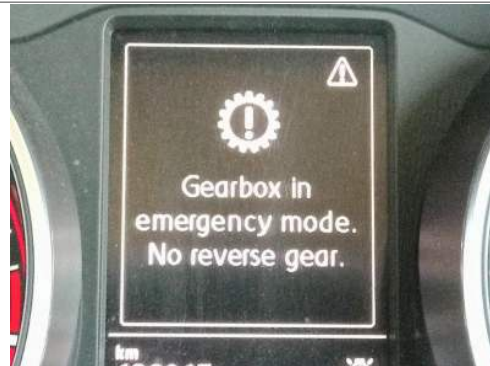
Warning lights illuminated

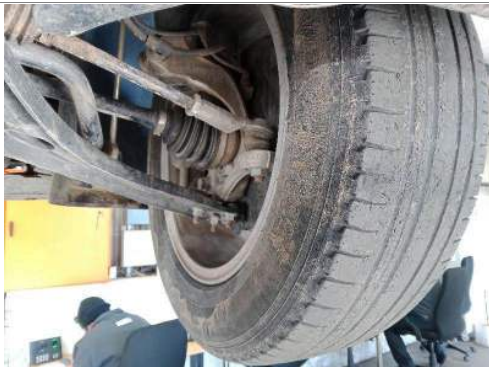
RF TYRE TREAD

| | Size | Load/Speed Index | Manufacture | Model | Type* | Production Date | Tread Depth (mm) |
|---|---|---|---|---|---|---|---|
| Front Right | 215/65R17 | 99V | Pirelli | Scorpion | V | 3719 | 1 mm |

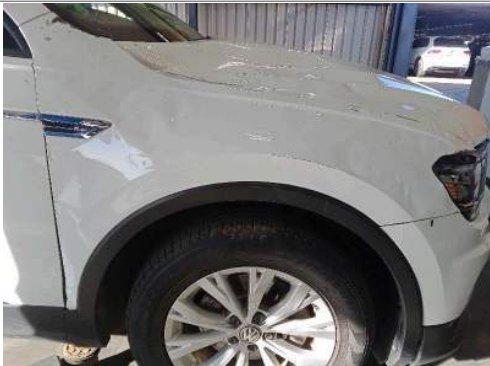
Front Fender Right

| | Damage | Repair Way |
|---|---|---|
| | Engine Oil Leak<br>Radiator Damaged<br>Headlight Left Damaged<br>Side Mirror Right Damaged<br>Front Bumper Damaged<br>Bonnet Damaged<br>Front Fender Left Damaged<br>Front Fender Right Damaged<br>Rear Fender Left Residual Traces of Repair<br>Door Front Right Damaged<br>Door Rear Left Residual Traces of Repair<br>Windscreen Cracked<br>Parking Brake Performance Left / Right Difference out of legal range<br>Gearbox Oil Leak<br>Radiator Cradle Damaged<br>Gear Selections Insufficient<br>Clutch Operation Insufficient<br>No reverse gear<br>Body exterior<br>Body exterior<br>Undercarriage<br>Multiple warning lights illuminated | Repair<br>Repair<br>Replace<br>Replace<br>Replace<br>Repair<br>Repair<br>Repair<br>Repair<br>Repair<br>Repair<br>Replace<br>Repair<br>Replace<br>Replace<br>Repair<br>Replace<br>Replace<br>Repair<br>Repair<br>Repair<br>Repair<br>Signs of spray work done on some body panels<br>Minor dents scratches stone chips on some body pan<br>Undercarriage is covered<br>Repair |
