CONDITION REPORT

Report No: 2016205000

MFC Auction House
M57 Pretoria Rd, Glenmarais, KEMPTON PARK
Gauteng

| Manufacturer | VOLKSWAGEN | Registration Number | JM17JYGP |

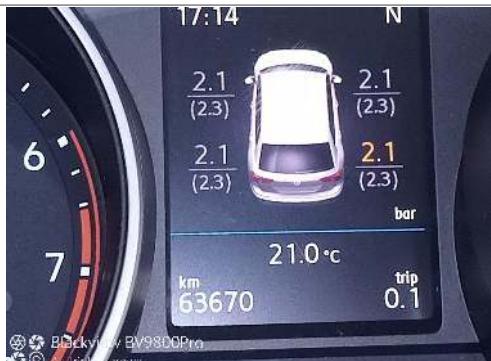
ODOMETER

| Km Reading | 63,670 KM | Fuel | PETROL |

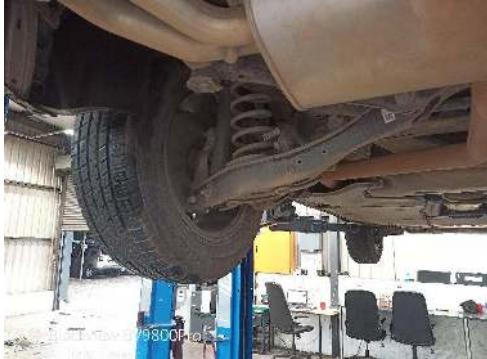
LR TYRE TREAD

| | Size | Load/Speed Index | Manufacture | Model | Type* | Production Date | Tread Depth (mm) |
|---|---|---|---|---|---|---|---|
| Rear Left | 225/65R17 | 102H | Hifly | Vigorous | V | 1122 | 4 mm |

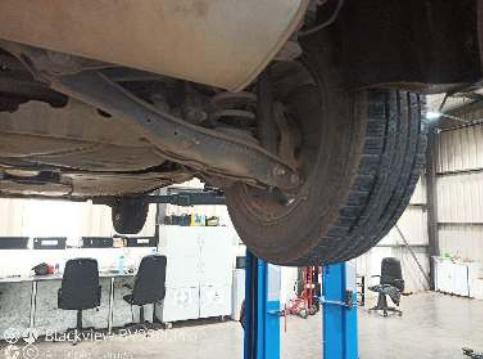
RR TYRE TREAD

| | Size | Load/Speed Index | Manufacture | Model | Type* | Production Date | Tread Depth (mm) |
|---|---|---|---|---|---|---|---|
| Rear Right | 225/65R17 | 102H | Hifly | Vigorous | V | 0120 | 4 mm |

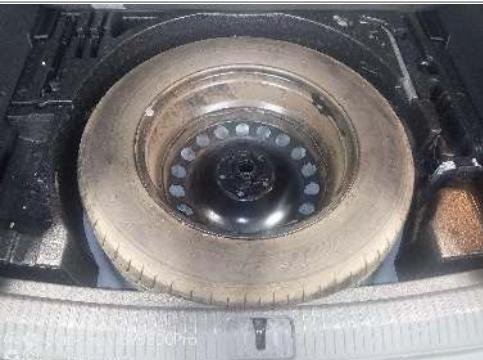
Spare wheel

| | Size | Load/Speed Index | Manufacture | Model | Type* | Production Date | Tread Depth (mm) |
|---|---|---|---|---|---|---|---|
| Spare | 215/65R17 | 99V | Falken | Ziex | V | //// | 4 mm |
