CONDITION REPORT

Report No:  
2017303559  
DATE  
25/09/2026

| Manufacturer | VOLKSWAGEN | Registration Number | KVV783NW |
| Model | T-CROSS 1.0 TSI 85KW HIGHLINE DSG [2022-2024] | Register Number | |

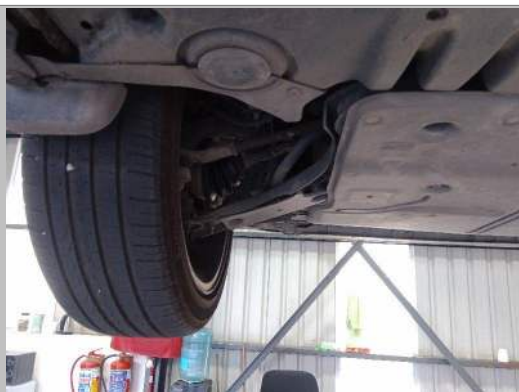
LF TYRE TREAD

| | Size | Load/Speed Index | Manufacture | Model | Type* | Production Date | Tread Depth (mm) |
|---|---|---|---|---|---|---|---|
| Front Left | 215/45R18 | 89V | Pirelli | Radial | V | 3425 | 2 mm |

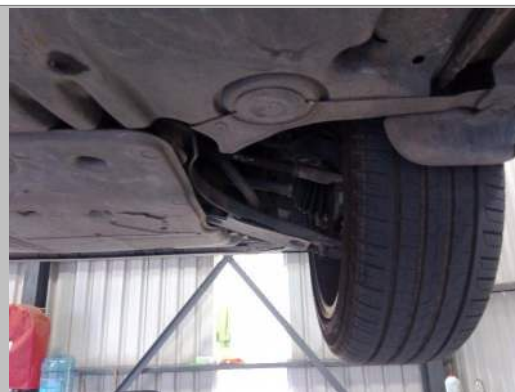
RF TYRE TREAD

| | Size | Load/Speed Index | Manufacture | Model | Type* | Production Date | Tread Depth (mm) |
|---|---|---|---|---|---|---|---|
| Front Right | 215/45R18 | 89V | Pirelli | Radial | V | 3425 | 2 mm |

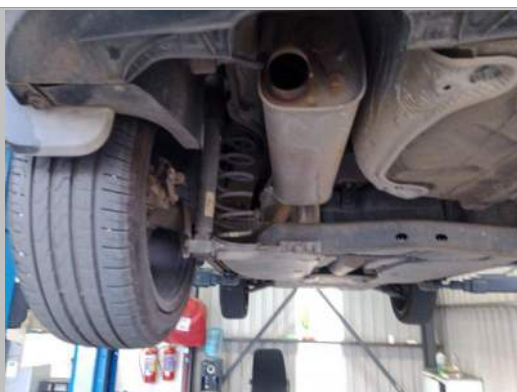
LR TYRE TREAD

| | Size | Load/Speed Index | Manufacture | Model | Type* | Production Date | Tread Depth (mm) |
|---|---|---|---|---|---|---|---|
| Rear Left | 215/45R18 | 89V | Pirelli | Radial | V | 1925 | 3 mm |

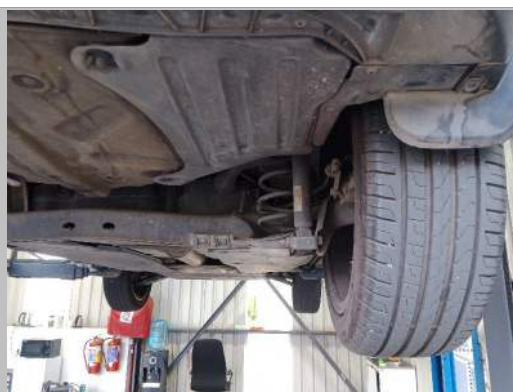
RR TYRE TREAD

| | Size | Load/Speed Index | Manufacture | Model | Type* | Production Date | Tread Depth (mm) |
|---|---|---|---|---|---|---|---|
| Rear Right | 215/45R18 | 89V | Pirelli | Radial | V | 1925 | 3 mm |

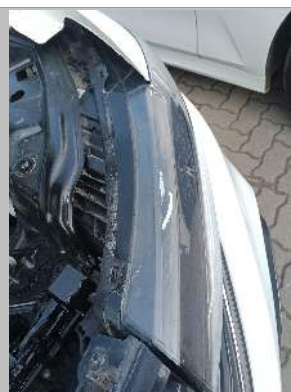
Headlight Left Damaged

Replace

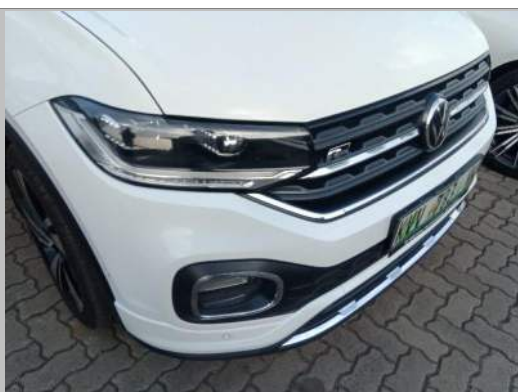
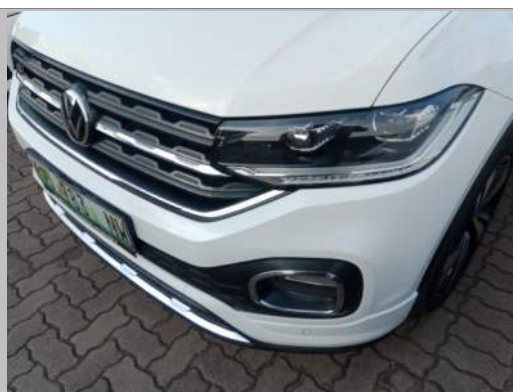
Front Bumper Damaged

Repair

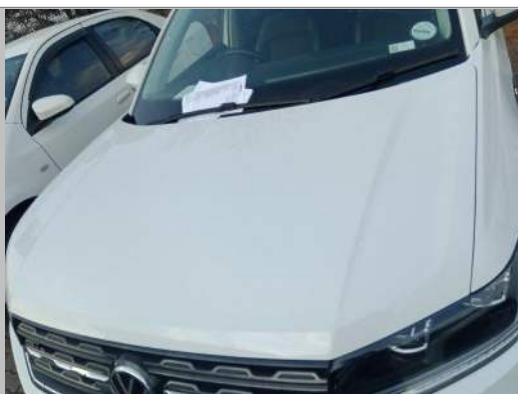
Bonnet Damaged

Repair

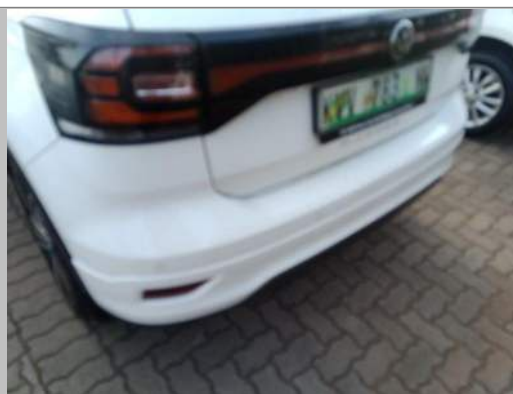
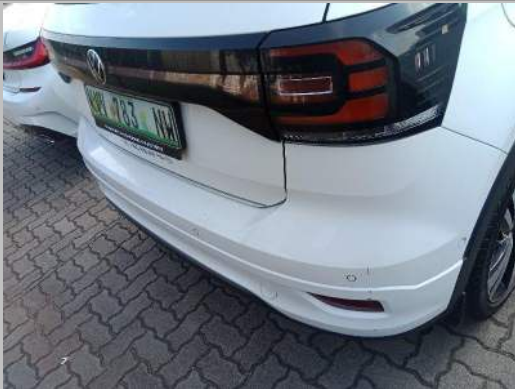
Rear bumper Damaged

Repair

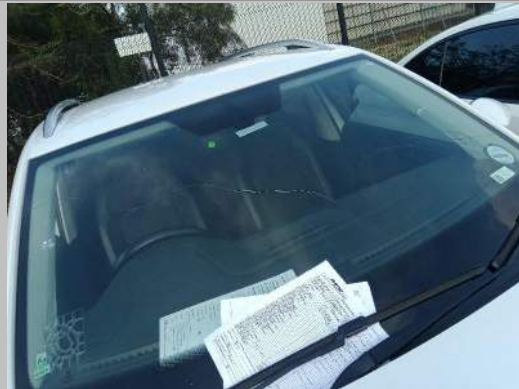
Windscreen Damaged

Repair

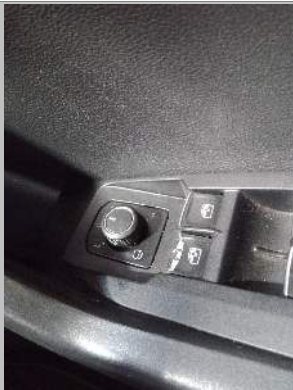
Switch Electrical Window Winder front left Damaged

Replace
