CONDITION REPORT

Report No: 2016842818

Vehicle Type	PASSENGER VEHICLE	Registered Owner	
Manufacturer	VOLKSWAGEN	Registration Number	DG25HHGP
Model	JETTA 6 1.6 TDI COMFORTLINE DSL DSG [2014-2015]	Register Number	
VIN	WVWZZZ16ZEM052850	Date Of First Licensing	
Engine Number		Last COR	
Doors	4	License Expiry Date	31/01/2026
Color	SILVER	Power / Displacement	
Year Model	2014	Paint Finish	TWO COAT METALLIC
Km Reading	186,902 KM	Fuel	DIESEL
Cab / Body Type	SEDAN	Transmission	AUTOMATIC

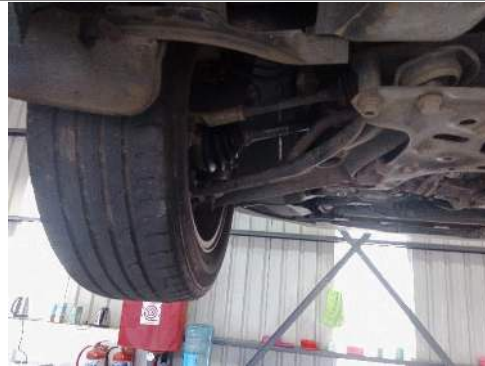
LF TYRE TREAD

Size	Load/Speed Index	Manufacture	Model	Type*	Production Date	Tread Depth (mm)
Front Left	205/55R16	91V	Continental	Contipremium	V	3420	0 mm
Front Right	205/55R16	91V	Continental	Contipremium	V	0221	2 mm
Rear Left	205/55R16	91V	Continental	Contipremium	V	0221	2 mm
Rear Right	205/55R16	91V	Continental	Contipremium	V	3420	1 mm

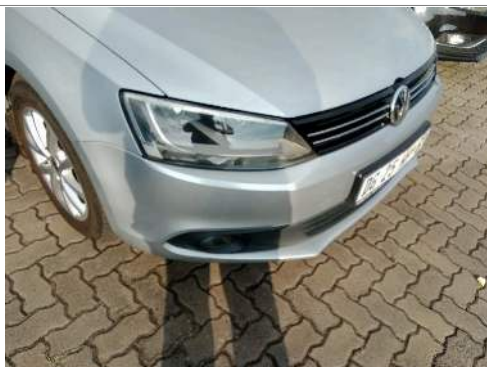
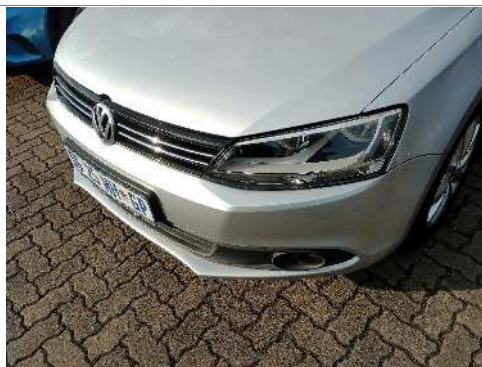
Damage	Repair Way
Engine Oil Leak	Repair
Front Bumper Damaged	Repair
Bonnet Damaged	Repair
Door Front Left Damaged	Repair
Door Front Right Damaged	Repair
Door Rear Left Damaged	Repair
Rear bumper Damaged	Repair
Sill Panel Right Damaged	Repair
Tyre Front Left Worn	Replace
Gearbox Oil Leak	Repair
