MFC Auction House  
M57 Pretoria Rd, Glenmarais, KEMPTON PARK  
Gauteng

| Manufacturer | VOLKSWAGEN | Registration Number | KLR619NW |
| Model | JETTA 6 GP 1.4 TSI COMFORTLINE [2015-2017] | Register Number | |
| VIN | WVWZZZ16ZGM005020 | Date Of First Licensing | |

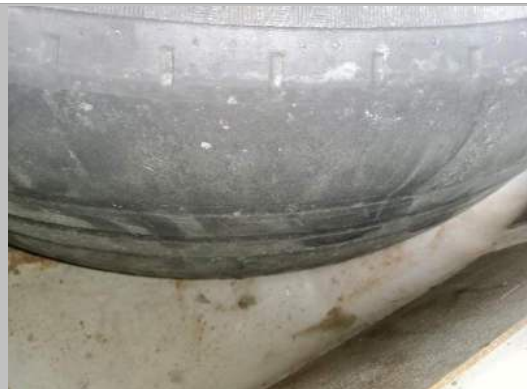
| Damage | Repair Way |
|---|---|
| Spare Tyre Smooth | Replace |

| | Size | Load/Speed Index | Manufacture | Model | Type* | Production Date | Tread Depth (mm) |
|---|---|---|---|---|---|---|---|
| Spare | 195/65R15 | 91V | Apollo | Manchester u | V | 0000 | 0 mm |

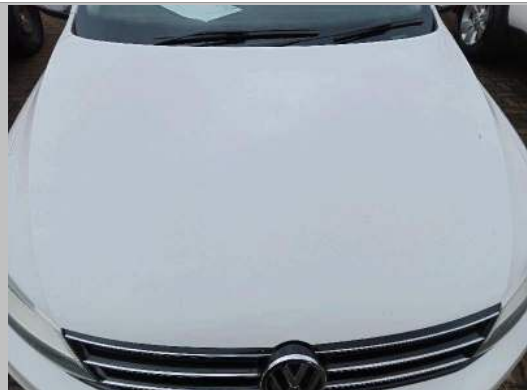
| Damage | Repair Way |
|---|---|
| Bonnet Paintwork • Scratched | Repair |

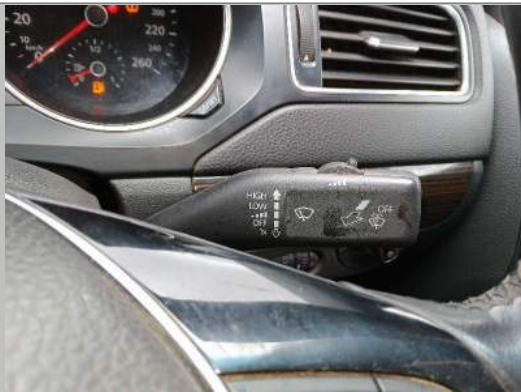
| Damage | Repair Way |
|---|---|
| Wiper Switch Defective | Repair |

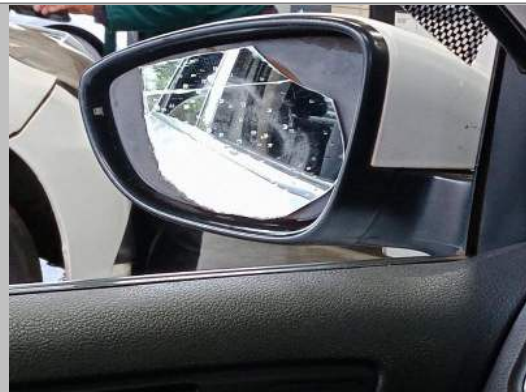
| Damage | Repair Way |
|---|---|
| Side Mirror Left Damaged | Replace |

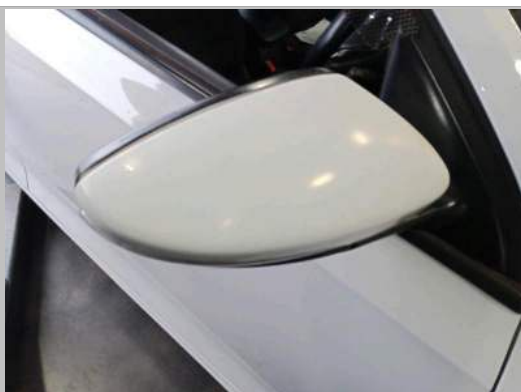
| Damage | Repair Way |
|---|---|
| Side Mirror Right Paintwork • Discoloured | Repair |

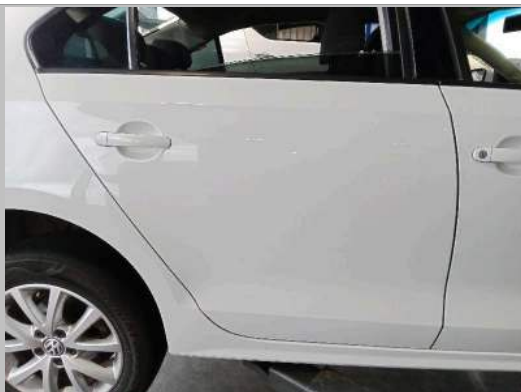
| Damage | Repair Way |
|---|---|
| Door Rear Right Paintwork • Scratched | Repair |

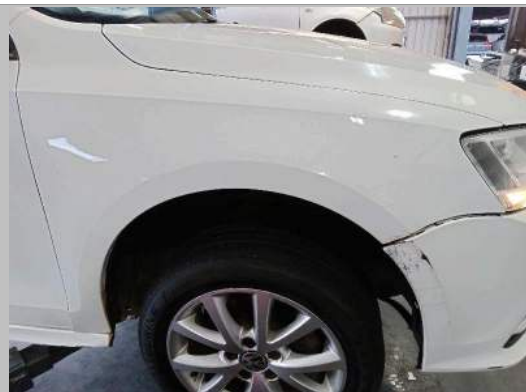
| Damage | Repair Way |
|---|---|
| Front Fender Right Paintwork • Scratched | Repair |

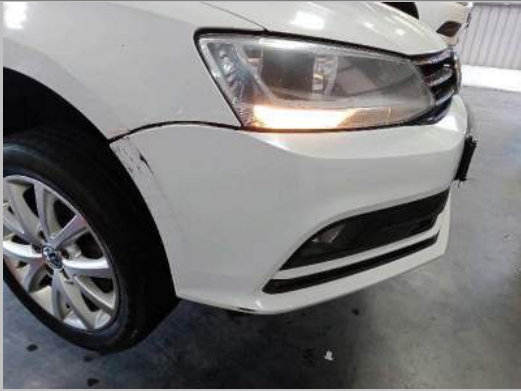
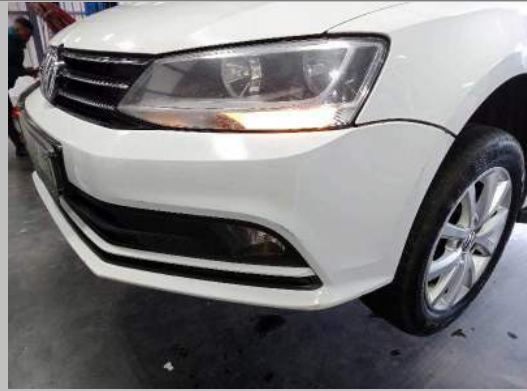
| Damage | Repair Way |
|---|---|
| Front Bumper Paintwork • Scratched | Repair |

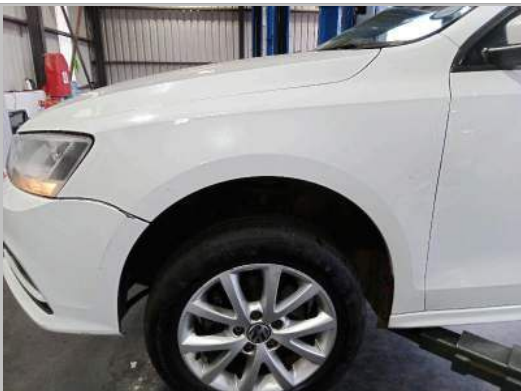
| Damage | Repair Way |
|---|---|
| Front Fender Left Paintwork • Scratched | Repair |

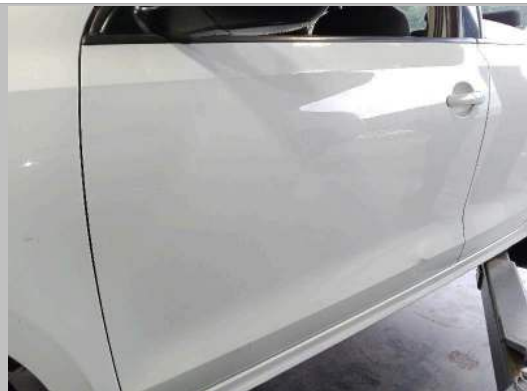
| Damage | Repair Way |
|---|---|
| Door Front Left Dented | Repair |

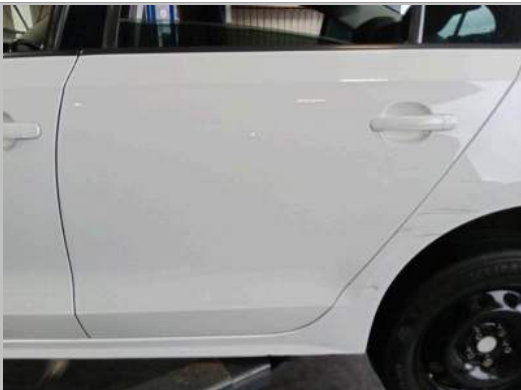
| Damage | Repair Way |
|---|---|
| Door Rear Left Paintwork • Scratched | Repair |

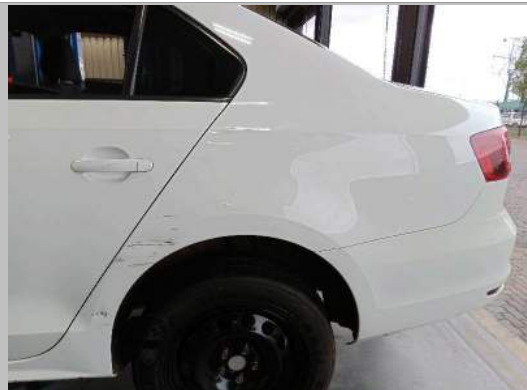
| Damage | Repair Way |
|---|---|
| Rear Fender Left Paintwork • Scratched | Repair |

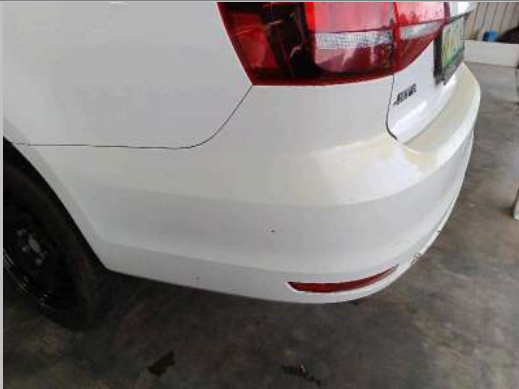
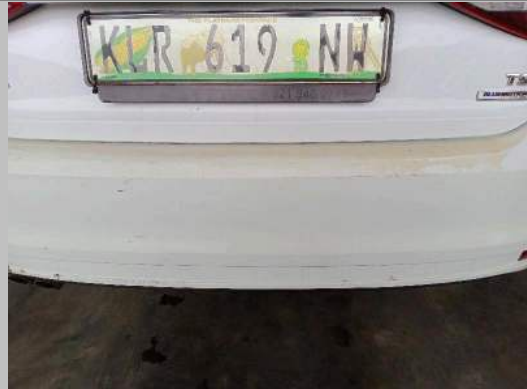
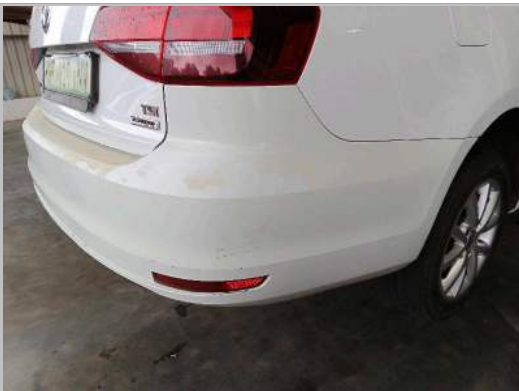
| Damage | Repair Way |
|---|---|
| Rear bumper Paintwork • Discoloured | Repair |

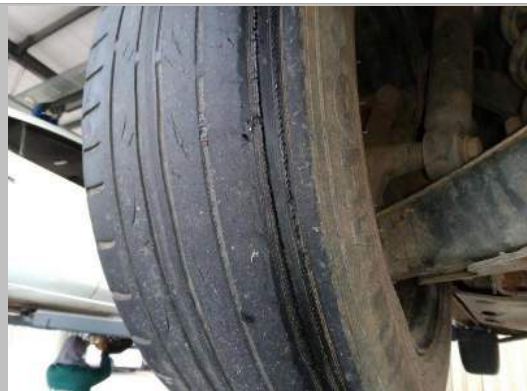
| Damage | Repair Way |
|---|---|
| Tyre Rear Left Damaged | Replace |

| | Size | Load/Speed Index | Manufacture | Model | Type* | Production Date | Tread Depth (mm) |
|---|---|---|---|---|---|---|---|
| Rear Left | 205/60R16 | 96V | Kumho | Ecsta | V | 3319 | 0 mm |

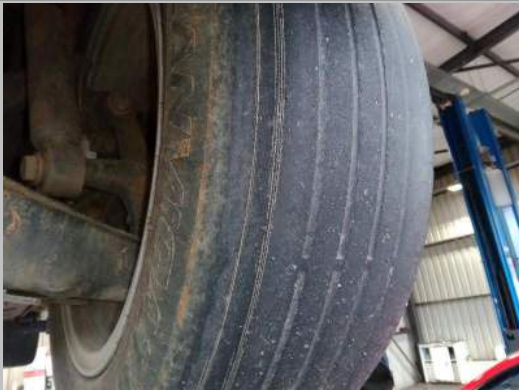
| Damage | Repair Way |
|---|---|
| Tyre Rear Right Damaged | Replace |

| | Size | Load/Speed Index | Manufacture | Model | Type* | Production Date | Tread Depth (mm) |
|---|---|---|---|---|---|---|---|
| Rear Right | 205/60R16 | 92V | Lanvigator | Comfort | V | 4121 | 0 mm |

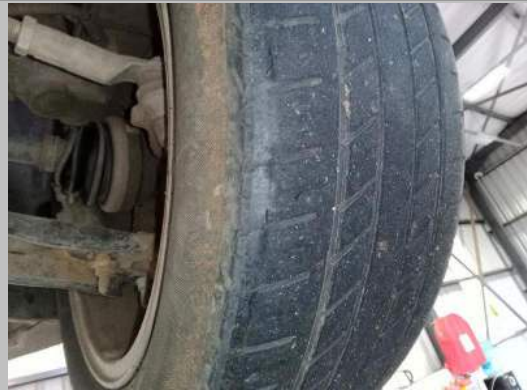
| Damage | Repair Way |
|---|---|
| Tyre Front Right Excessive Wear & Tear | Replace |

| | Size | Load/Speed Index | Manufacture | Model | Type* | Production Date | Tread Depth (mm) |
|---|---|---|---|---|---|---|---|
| Front Right | 205/55R16 | 91V | Firestone | Touring | V | 2122 | 0 mm |

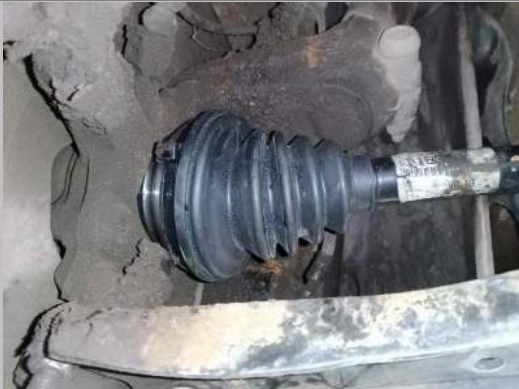
| Damage | Repair Way |
|---|---|
| CV Joint(s) Boot(s) Front Left (inner/outer) Defective | Repair |

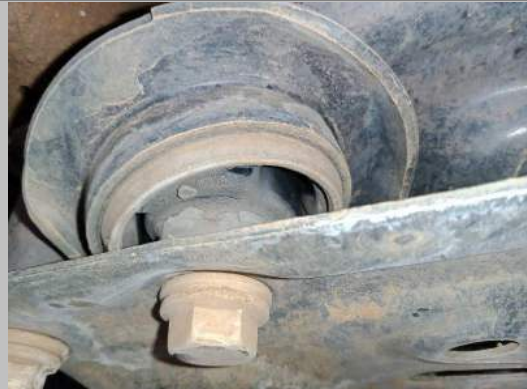
| Damage | Repair Way |
|---|---|
| Control Arm Bush(es) Front Axle Left Cracked | Replace |

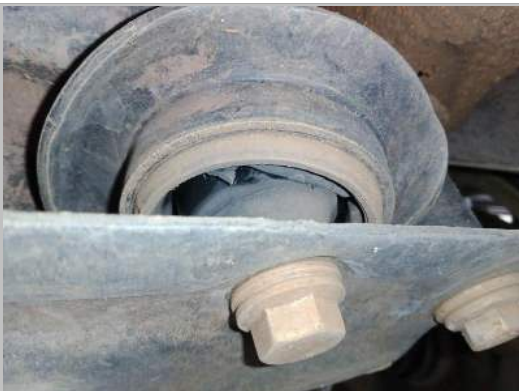
| Damage | Repair Way |
|---|---|
| Control Arm Bush(es) Front Axle Right Cracked | Replace |
