MFC Auction House  
M57 Pretoria Rd, Glenmarais, KEMPTON PARK  
Gauteng

Vehicle Type	PASSENGER VEHICLE	Registered Owner	MFC
Manufacturer	VOLKSWAGEN	Registration Number	FMP001L
Model	GOLF	Register Number	
VIN	WVWZZZ1KZDK008612	Date Of First Licensing	
Engine Number		Last COR	
Doors	2	License Expiry Date	31/07/2023
Color	SILVER	Power / Displacement	
Year Model		Paint Finish	M - METALLIC
Km Reading	171,289 KM	Fuel	PETROL
Cab / Body Type	COUPE	Transmission	AUTOMATIC

## CONDITION REPORT

Report No: 2016213124

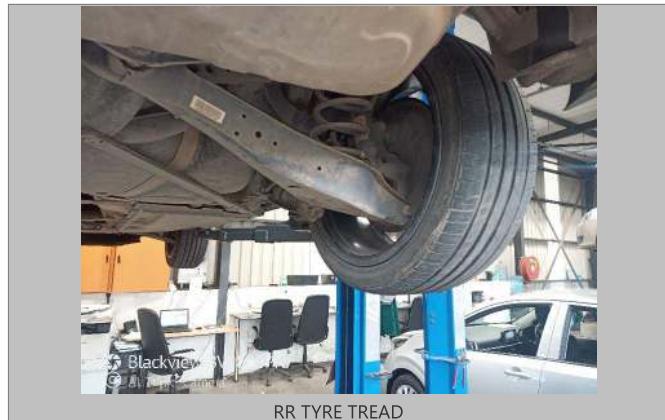
RR TYRE TREAD

Size	Load/Speed Index	Manufacture	Model	Type*	Production Date	Tread Depth (mm)
Front Left	225/40R18	92Y	Zeetex	Hp5000 max	V	1323	4 mm
Front Right	225/40R18	92Y	Zeetex	Hp5000 max	V	1323	4 mm
Rear Left	235/40R18	95W	Winrun	R330	V	3820	0 mm
Rear Right	225/40R18	92W	Habillead	Sport max	V	1018	2 mm

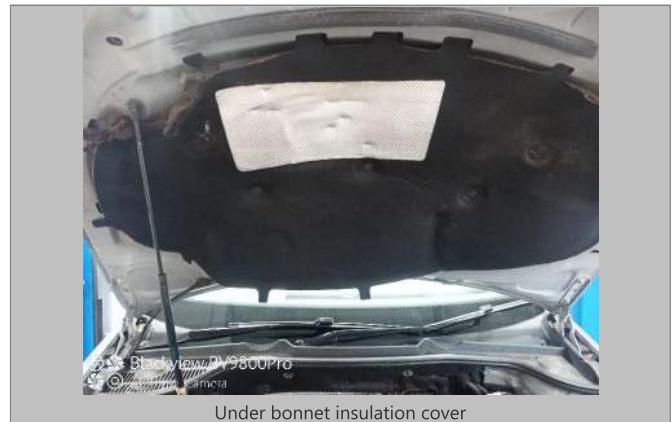
Damage	Repair Way
Engine Oil Sweat	Repair
Under bonnet insulation cover Defective	Repair
Center Console / Cubbyhole + Lid Damaged	Repair
Switch Electrical Window Winder front left Missing	Repair
Switch Electrical Window Winder front right Missing	Repair
Seat Front Right Torn / Cut	Repair
Mirror Adjusters Damaged	Repair
Front Bumper Dented	Repair
Front Fender Left Paintwork • Scratched	Repair
Front Fender Right Dented	Repair
Rear Fender Left Paintwork • Scratched	Repair
Door Front Left Paintwork • Scratched	Repair
Rear bumper Paintwork • Scratched	Repair
Control Arm Bush(es) Front Axle Left Cracked	Replace
Control Arm Bush(es) Front Axle Right Cracked	Replace
Tyre Rear Left Damaged	Replace
Belly plates Loose / Excessive Play	Repair
