## CONDITION REPORT

Report No:  
2017290740  
DATE  
27/08/2026

| Manufacturer | VOLKSWAGEN | Registration Number | LHK687MP |
| Model | GOLF 6 1.4 TSI COMFORTLINE 5-DR DSG [2012-2013] | Register Number | |

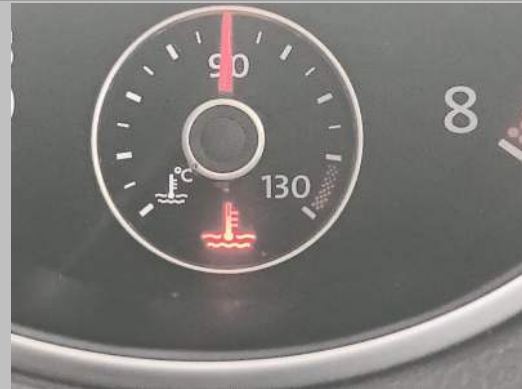
| Damage | Repair Way |
|---|---|
| Warning lights illuminated | Repair |

Warning lights illuminated

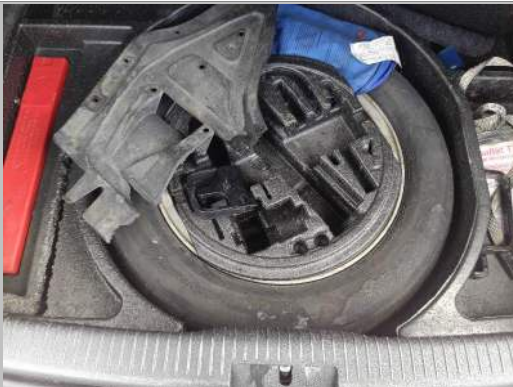
Sparewheel

| | Size | Load/Speed Index | Manufacture | Model | Type* | Production Date | Tread Depth (mm) |
|---|---|---|---|---|---|---|---|
| Spare | 205/60R16 | 92V | Hankook | Kinergy | V | /////// | 1 mm |

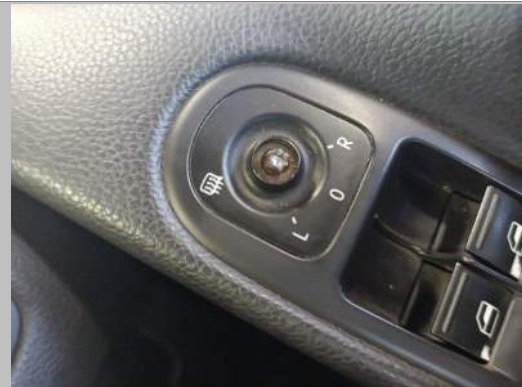
| Damage | Repair Way |
|---|---|
| Side Mirror Right Damaged | Replace |

Electric mirror knob damaged

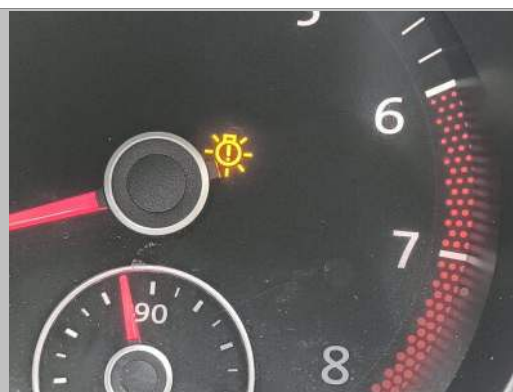
Warning lights illuminated

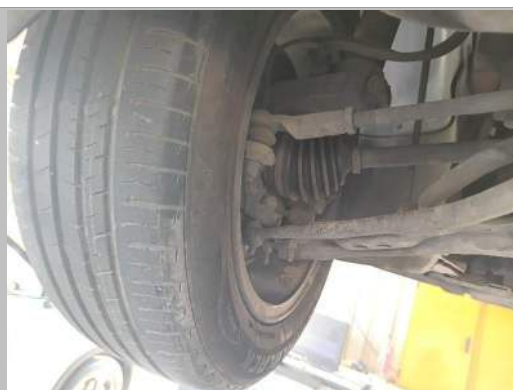
LF TYRE TREAD

| | Size | Load/Speed Index | Manufacture | Model | Type* | Production Date | Tread Depth (mm) |
|---|---|---|---|---|---|---|---|
| Front Left | 205/55R16 | 91V | Royal black | Mile | V | 4623 | 3 mm |

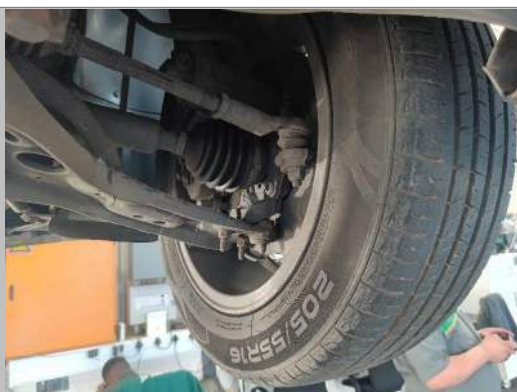
RF TYRE TREAD

| | Size | Load/Speed Index | Manufacture | Model | Type* | Production Date | Tread Depth (mm) |
|---|---|---|---|---|---|---|---|
| Front Right | 205/55R16 | 91V | Royal black | Mile | V | 4623 | 1 mm |

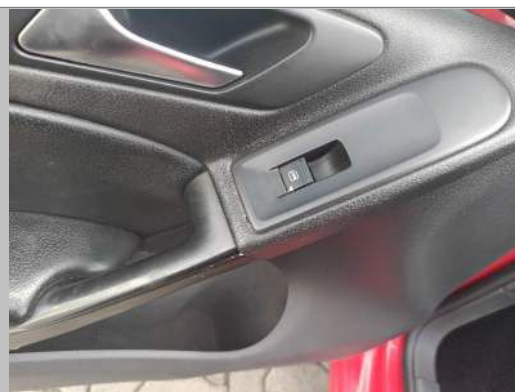
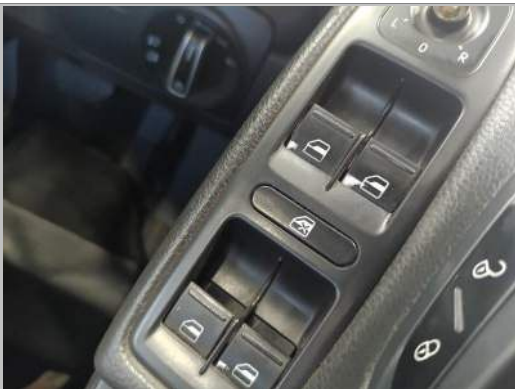
| Damage | Repair Way |
|---|---|
| Switch Electrical Window Winder front left Defective | Repair |

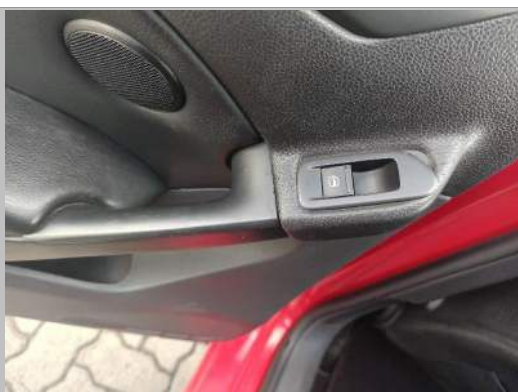
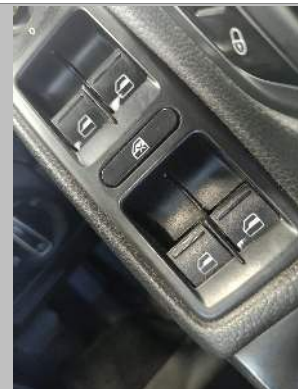
| Damage | Repair Way |
|---|---|
| Switch Electrical Window Winder rear left Defective | Repair |

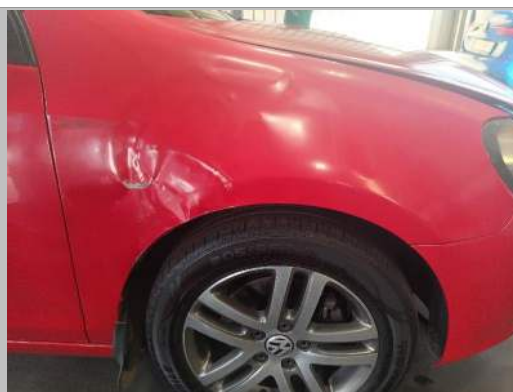
| Damage | Repair Way |
|---|---|
| Front Fender Right Damaged | Repair |

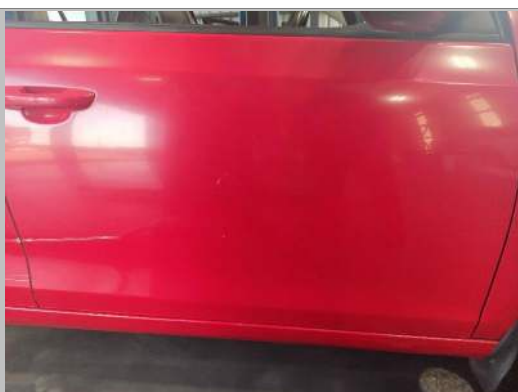
| Damage | Repair Way |
|---|---|
| Door Front Right Paintwork • Scratched | Repair |

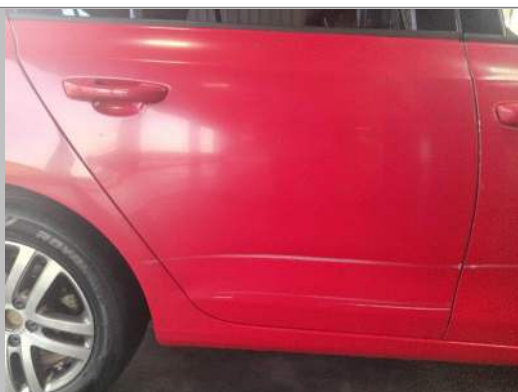
| Damage | Repair Way |
|---|---|
| Rear Fender Right Paintwork • Scratched | Repair |

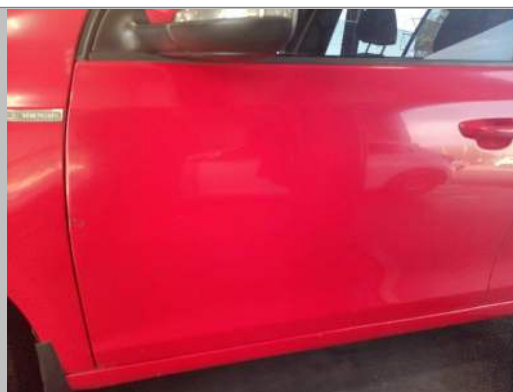
| Damage | Repair Way |
|---|---|
| Door Front Left Paintwork • Flaking | Repair |

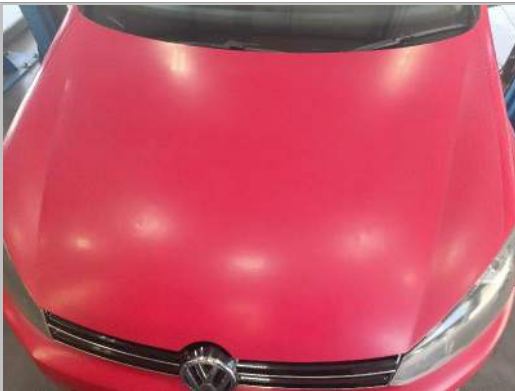
| Damage | Repair Way |
|---|---|
| Bonnet Paintwork • Dull | Repair |

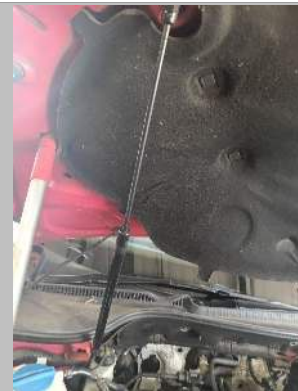
| Damage | Repair Way |
|---|---|
| Bonnet stay and shocks Defective | Repair |

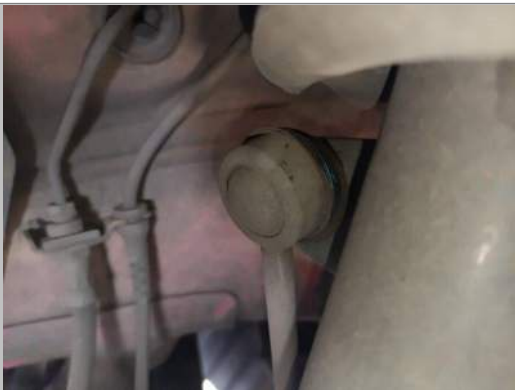
| Damage | Repair Way |
|---|---|
| Stabilizer Mounting Front Right Damaged | Replace |

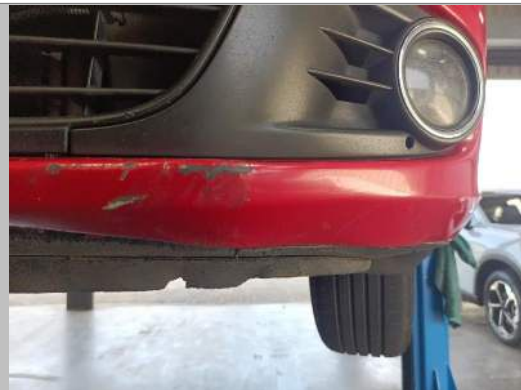
| Damage | Repair Way |
|---|---|
| Front Bumper Paintwork • Scratched | Repair |

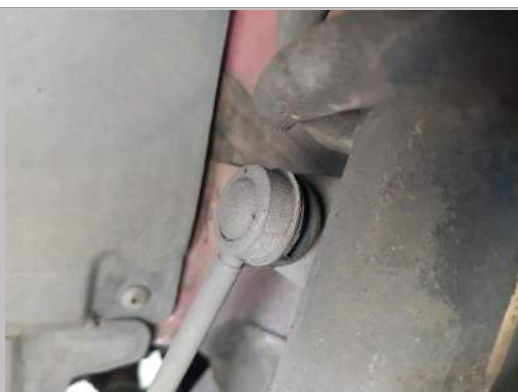
| Damage | Repair Way |
|---|---|
| Stabilizer Mounting Front Left Damaged | Replace |

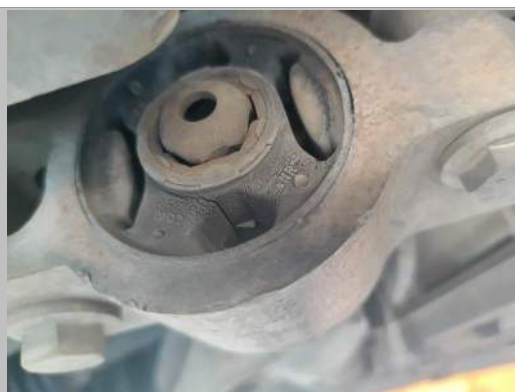
| Damage | Repair Way |
|---|---|
| Control Arm Bush(es) Front Axle Left Cracked | Replace |

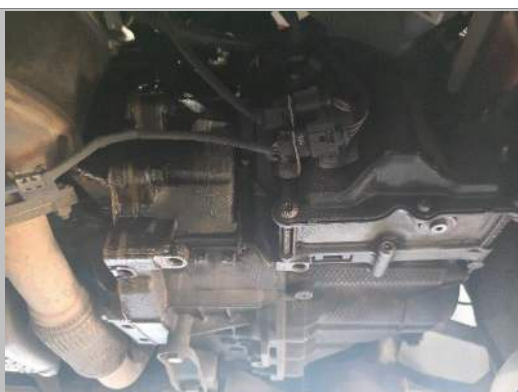
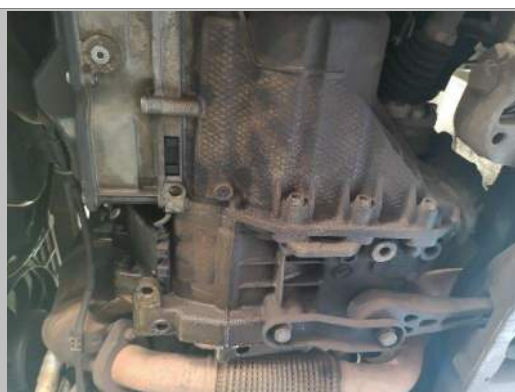
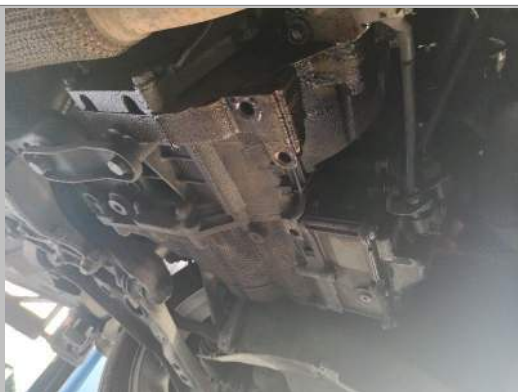
| Damage | Repair Way |
|---|---|
| Gearbox Oil Leak | Repair |

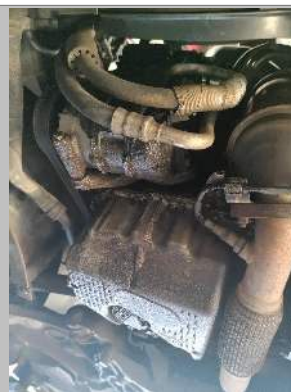
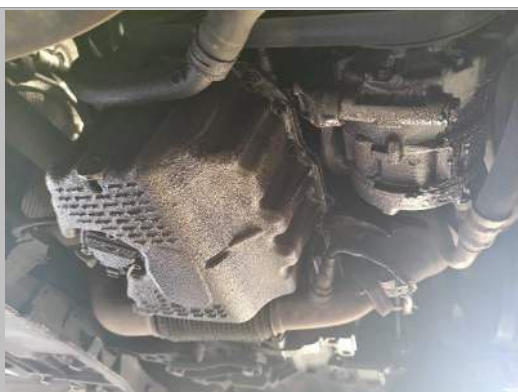
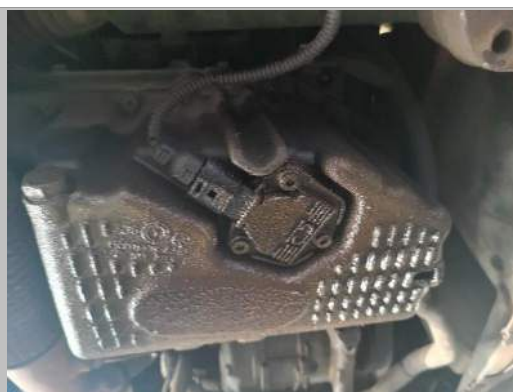
| Damage | Repair Way |
|---|---|
| Engine Oil Leak | Repair |

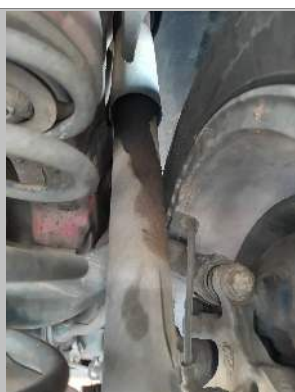
| Damage | Repair Way |
|---|---|
| Shock Absorber Rear Right Sweat | Repair |

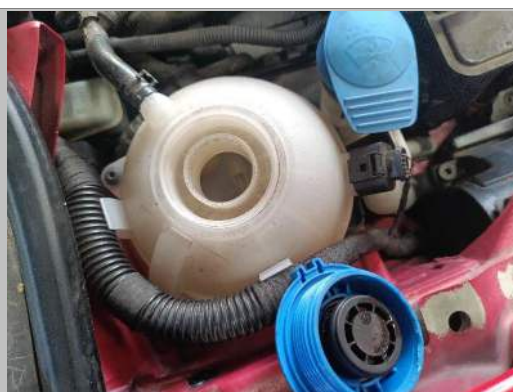
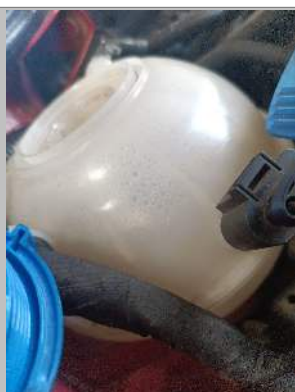
| Damage | Repair Way |
|---|---|
| Water level Insufficient | Repair |
