CONDITION REPORT

Report No: 2016489888

MFC Auction House
M57 Pretoria Rd, Glenmarais, KEMPTON PARK
Gauteng

Vehicle Type	PASSENGER VEHICLE	Registered Owner	
Manufacturer	VOLKSWAGEN	Registration Number	HC50ZLGP
Model	POLO	Register Number	
VIN	WVWZZZ60ZJT063252	Date Of First Licensing	
Engine Number		Last COR	
Doors	4	License Expiry Date	13/08/2024
Color	SILVER	Power / Displacement	
Year Model		Paint Finish	M - METALLIC
Km Reading	201,985 KM	Fuel	PETROL
Cab / Body Type	SEDAN	Transmission	MANUAL

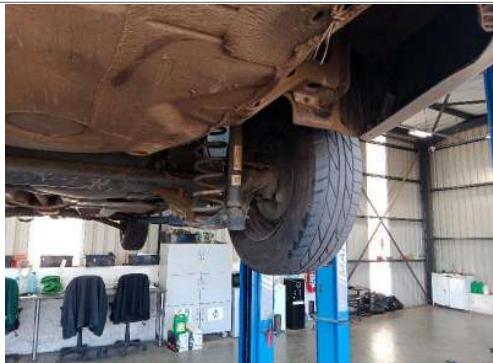
RR TYRE TREAD

Size	Load/Speed Index	Manufacture	Model	Type*	Production Date	Tread Depth (mm)
Front Left	185/70R14	88T	Firestone	T series	V	0000	4 mm
Front Right	185/70R14	88T	Firestone	T series	V	0000	4 mm
Rear Left	185/70R14	88T	Firestone	T series	V	0000	4 mm
Rear Right	175/70R14	84H	Autogrip	Grip200	V	4622	2 mm
Spare	185/70R14	88T	Firestone	T series	V	0000	4 mm

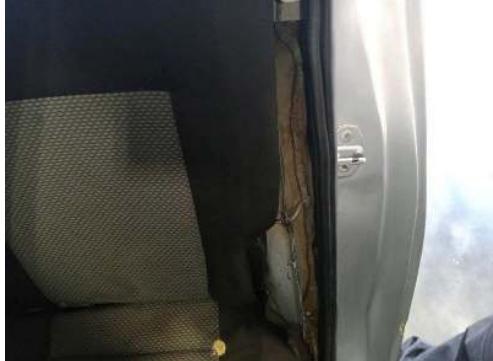
L/R inner seat panel missing

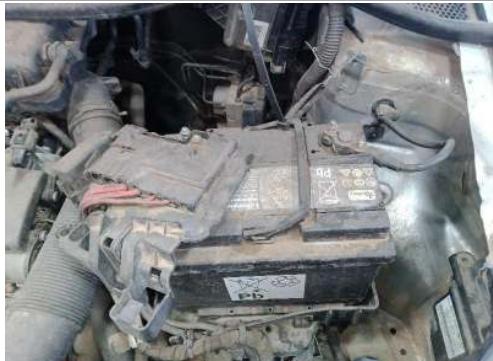
Battery loose

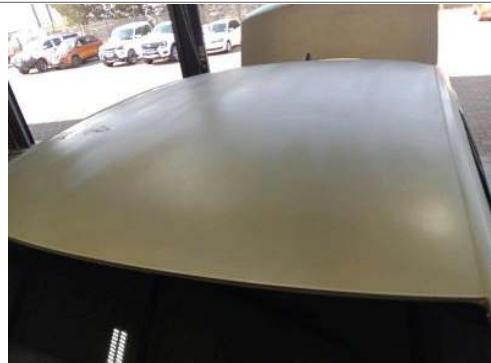
Damage	Repair Way
Rear bumper Paintwork • Scratched	Repair
Roof Paintwork • Discoloured	Repair
Service Brake Performance Front Axle Left / Right	Repair
Difference out of legal range	Replace
Radiator Cradle Missing	Replace
Both left side safety handle missing	Replace
Antenna missing	Replace
L/R inner seat panel missing	Replace
Both front fender liner missing	Replace
Steering noisy	Repair

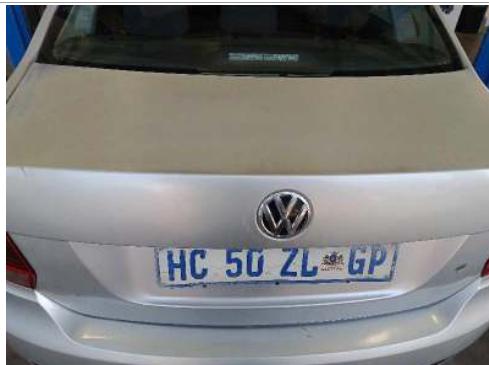
Door Front Right Dented	Repair
Door Rear Left Cracked	Repair
Door Rear Right Paintwork • Scratched	Repair
Boot Lid / Hatch door Paintwork • Discoloured	Repair
