## CONDITION REPORT

Report No:  
2016961407  
DATE  
29/07/2025

| Manufacturer | VOLKSWAGEN | Registration Number | JZ71XJGP |
| Model | POLO SEDAN 1.6 COMFORTLINE [2019-2021] | Register Number | |

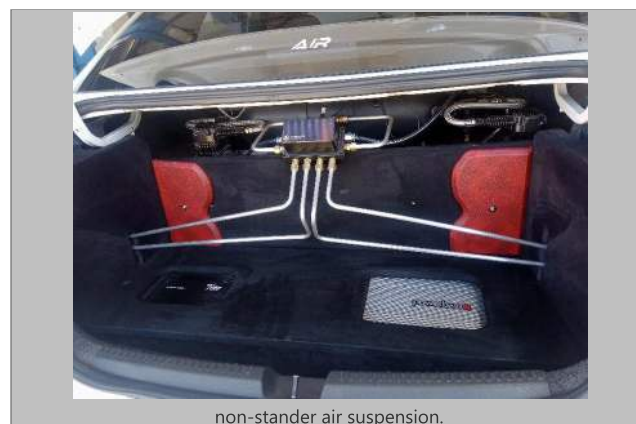
Axle and Suspension: non-standard air suspension fitted to Vehicle. left rear air suspension does not hold pressure.

non-stander air suspension.

| Damage | Repair Way |
|---|---|
| Air Suspension Front Left Defective | Replace |
| Air Suspension Front Right Defective | Replace |
| Air Suspension Rear Left Defective | Replace |
| Air Suspension Rear Right Defective | Replace |

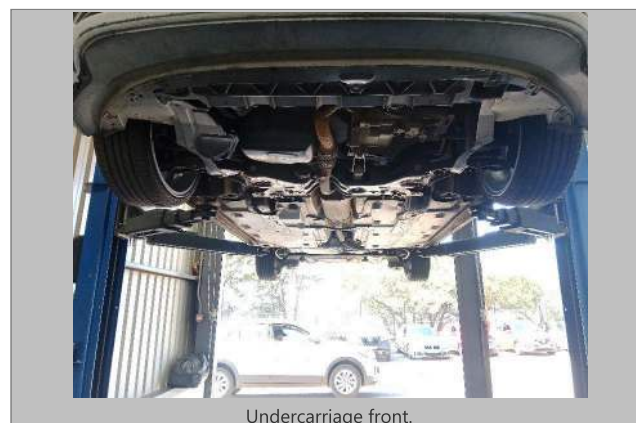
Undercarriage front.

Undercarriage: Vehicle is a cut and join. vehicle is unsafety drive.

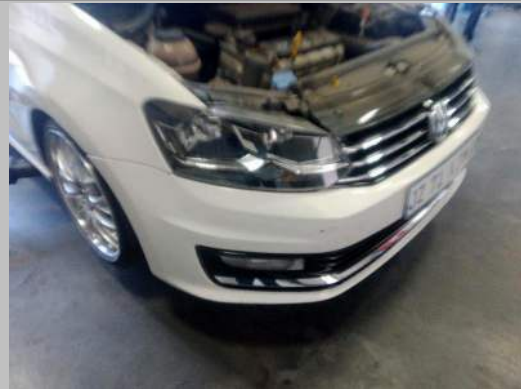
| Damage | Repair Way |
|---|---|
| Front Bumper Damaged | Repair |

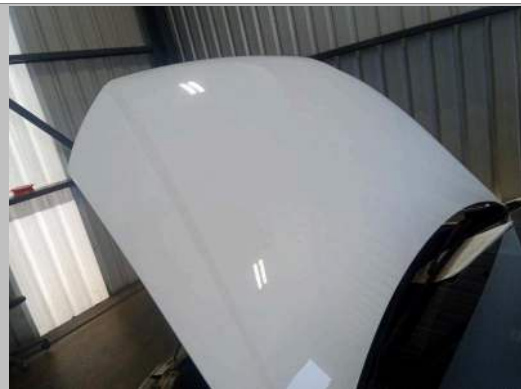
| Damage | Repair Way |
|---|---|
| Bonnet Damaged | Repair |

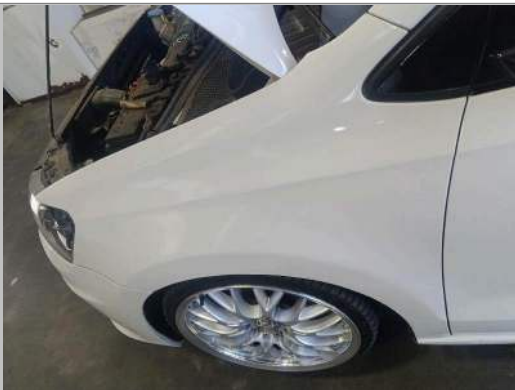
| Damage | Repair Way |
|---|---|
| Front Fender Left Damaged | Repair |

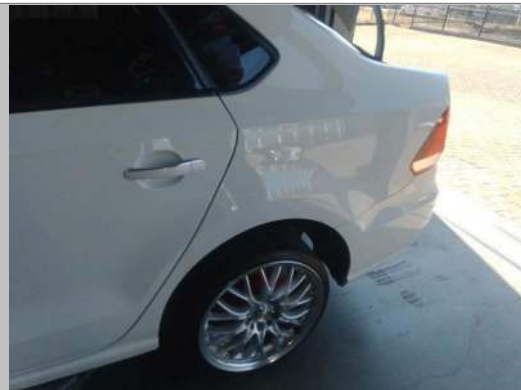
| Damage | Repair Way |
|---|---|
| Rear Fender Left Damaged | Repair |

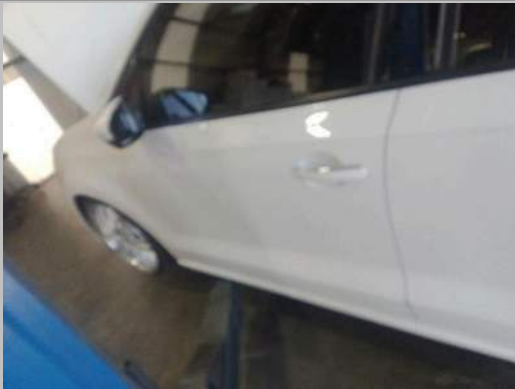
| Damage | Repair Way |
|---|---|
| Door Front Left Damaged | Repair |

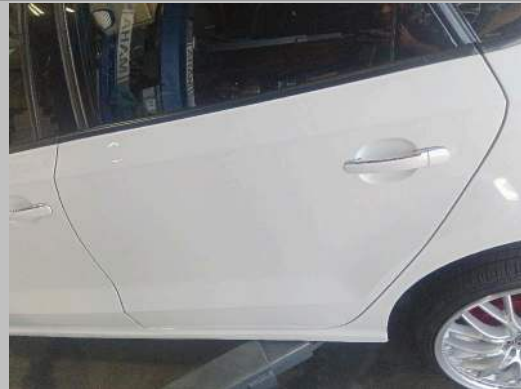
| Damage | Repair Way |
|---|---|
| Door Rear Left Damaged | Repair |

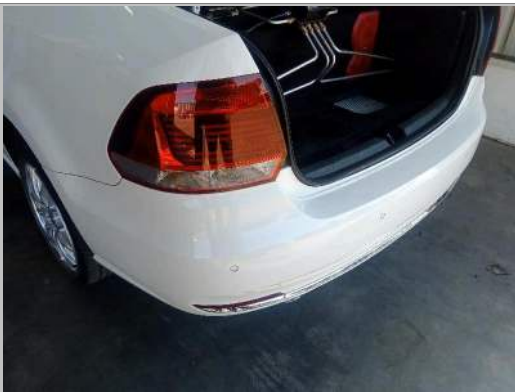
| Damage | Repair Way |
|---|---|
| Rear bumper Damaged | Repair |

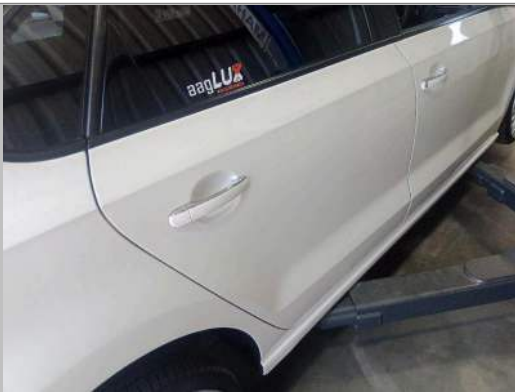
| Damage | Repair Way |
|---|---|
| Door Rear Right Damaged | Repair |

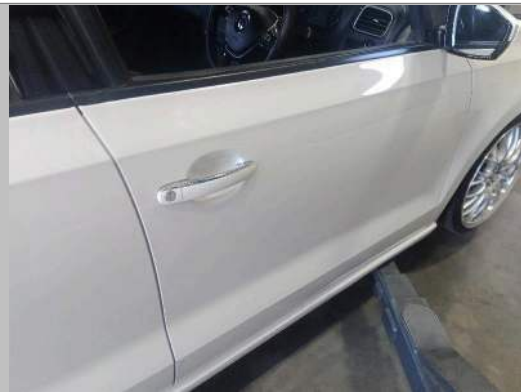
| Damage | Repair Way |
|---|---|
| Door Front Right Damaged | Repair |

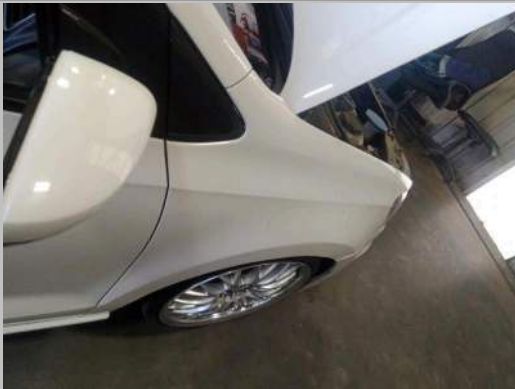
| Damage | Repair Way |
|---|---|
| Front Fender Right Damaged | Repair |

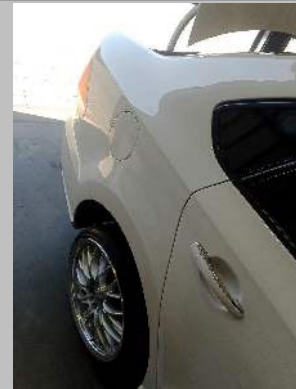
| Damage | Repair Way |
|---|---|
| Rear Fender Right Damaged | Repair |

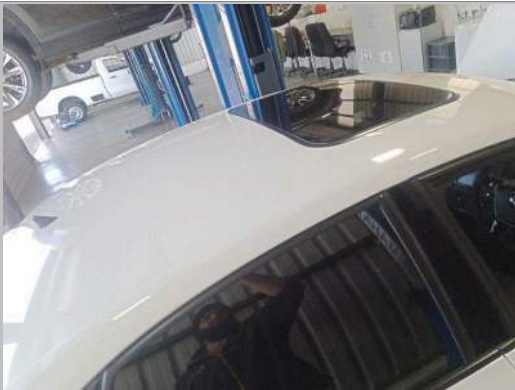
| Damage | Repair Way |
|---|---|
| Roof Damaged | Repair |

General Comments: ACCORDING TO THE AGE AND MILEAGE OF THE VEHICLE, NORMAL WEAR AND TEAR MARKS ARE VISIBLE ON THE INTERIOR, EXTERIOR, ELECTRICAL AND MECHANICAL PARTS. Body • Exterior: Minor dents and scratches and stone chips to some body panels. Signs of repair work done to somebody panels. Poor alignment to somebody panels. non-standard sunroof fitted to vehicle.

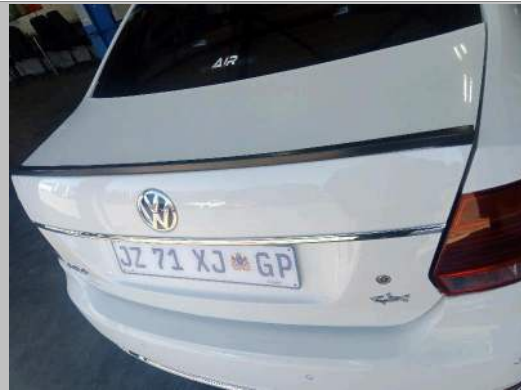
| Damage | Repair Way |
|---|---|
| Boot Lid / Hatch door Damaged | Repair |

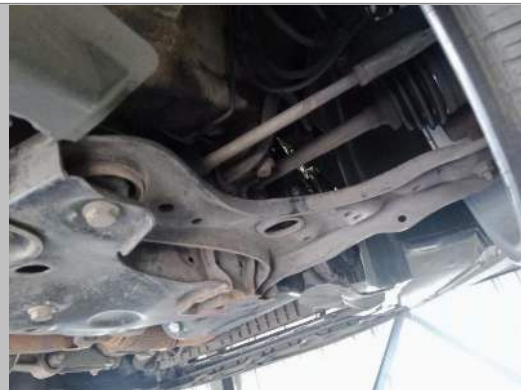
| Damage | Repair Way |
|---|---|
| Control Arm Bush(es) Front Axle Right Worn | Replace |

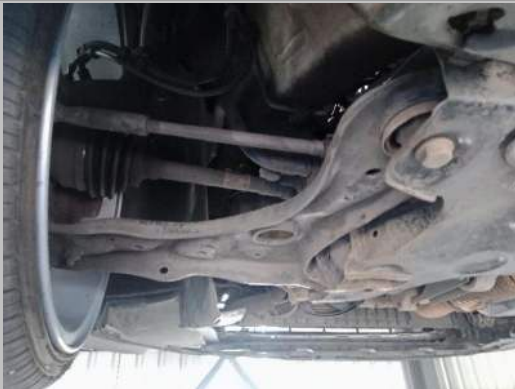
| Damage | Repair Way |
|---|---|
| Control Arm Bush(es) Front Axle Left Worn | Replace |

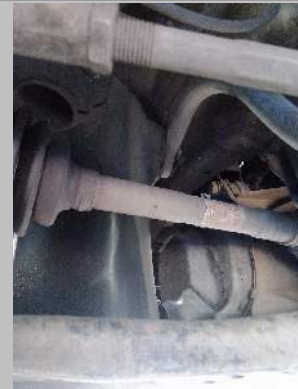
| Damage | Repair Way |
|---|---|
| Stabilizer Mounting Front Left Damaged | Replace |

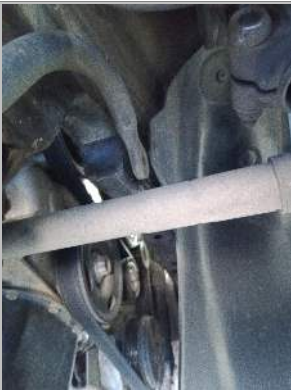
| Damage | Repair Way |
|---|---|
| Stabilizer Mounting Front Right Damaged | Replace |

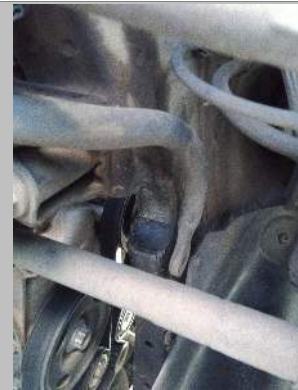
| Damage | Repair Way |
|---|---|
| Main Beam Right Damaged | Replace |

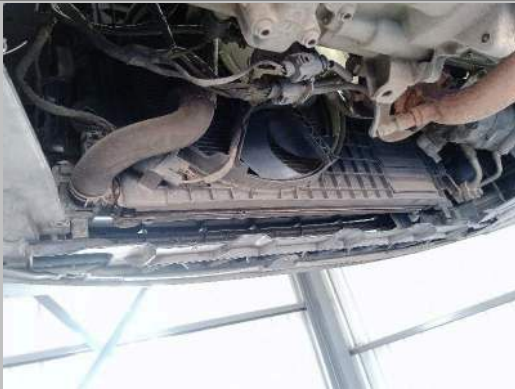
| Damage | Repair Way |
|---|---|
| Radiator Cradle Damaged | Repair |

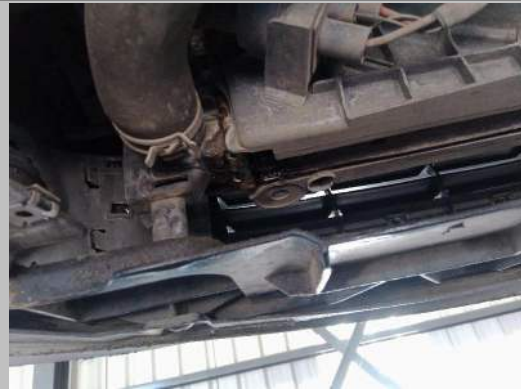
| Damage | Repair Way |
|---|---|
| Radiator Water Leak | Repair |
