## CONDITION REPORT

Report No:  
2017302493  
DATE  
23/09/2026

| Manufacturer | VOLKSWAGEN | Registration Number | MT44KPGP |
| Model | POLO SEDAN 1.6 COMFORTLINE [2019-2021] | Register Number | |

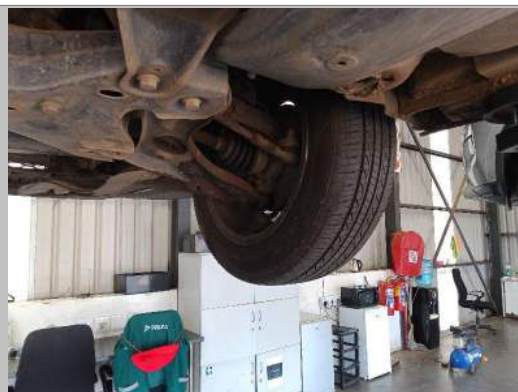
RF TYRE TREAD

| Front tires deferred name brand | Repair |

| | Size | Load/Speed Index | Manufacture | Model | Type* | Production Date | Tread Depth (mm) |
|---|---|---|---|---|---|---|---|
| Front Right | 185/60R15 | 84H | Anchee | Ac808 | V | 4225 | 3 mm |

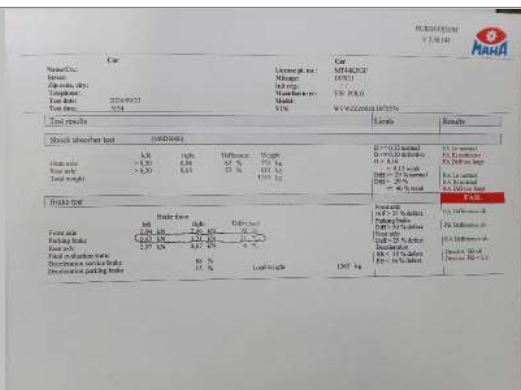
Shock and brake report

| Parking Brake Performance Left / Right Difference out of legal range | Repair |

| | Left | Right | | |
|---|---|---|---|---|
| Emergency / Parking | 0.8 | 1.2 | - | |

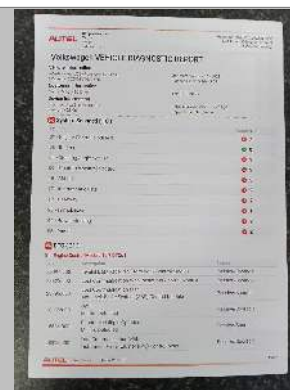
DIAGNOSTIC REPORT PAGE 1

| No | System | Code | Description | Status |
|---|---|---|---|---|
| 1 | PASSIVE SPORADIC | 28823:000 | LOST COMMUNICATION WITH RESTRAINTS CONTROL MODULE | |

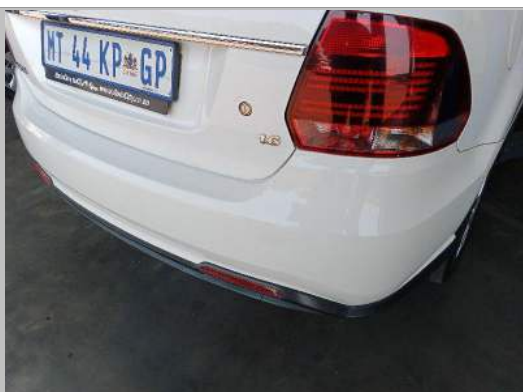
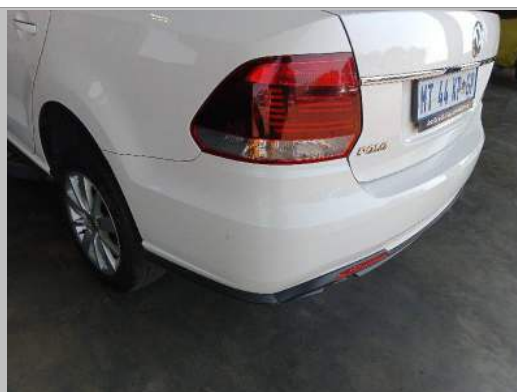
| Rear bumper Paintwork • Scratched | Repair |

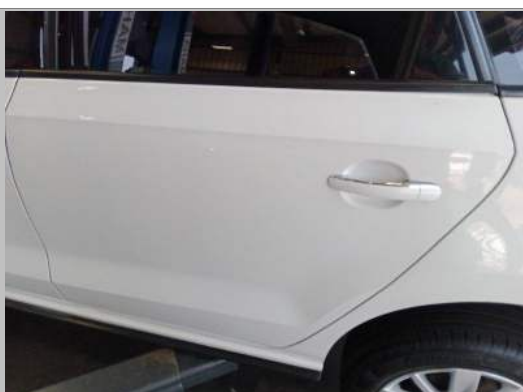
| Door Rear Left Paintwork • Scratched | Repair |

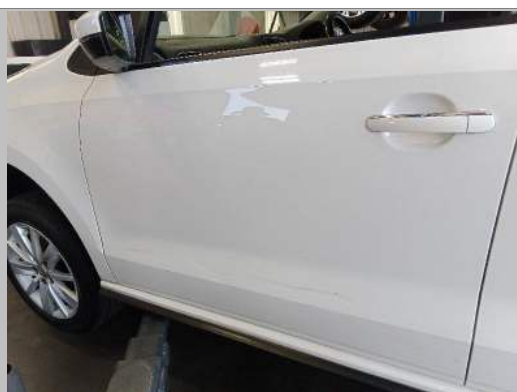
| Door Front Left Paintwork • Scratched | Repair |

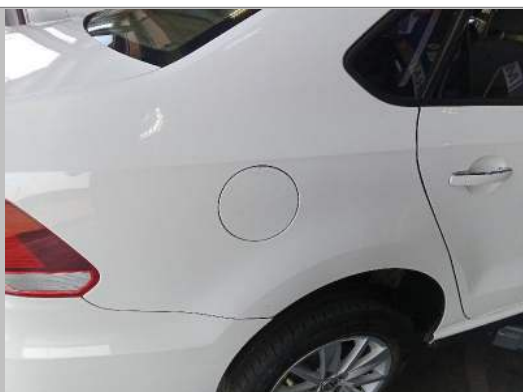
| Rear Fender Right Dented | Repair |

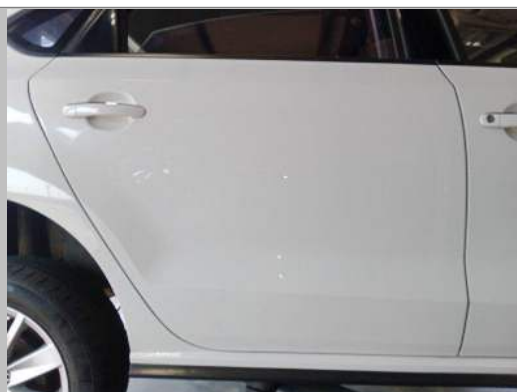
| Door Rear Right Paintwork • Scratched | Repair |

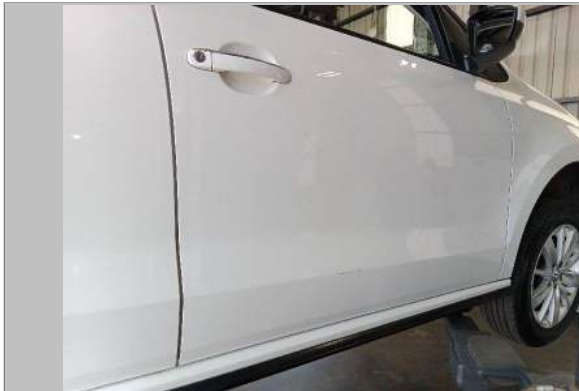
| Door Front Right Paintwork • Scratched | Repair |

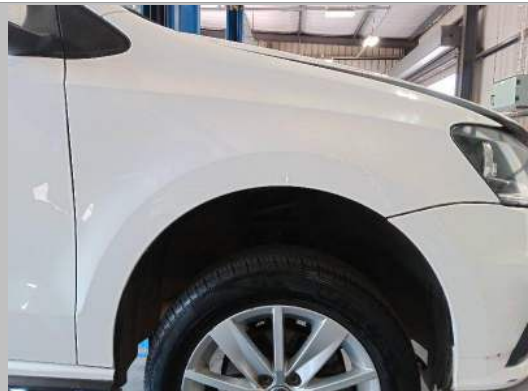
| Front Fender Right Paintwork • Scratched | Repair |

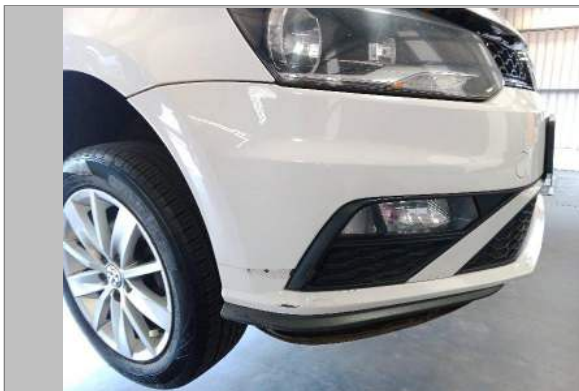
| Front Bumper Paintwork • Scratched | Repair |

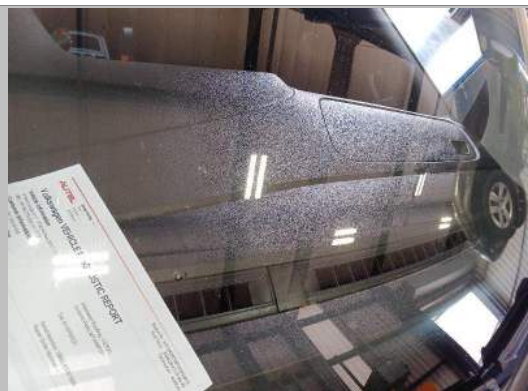
| Windscreen Chipped | Repair |
