MFC Auction House
M57 Pretoria Rd, Glenmarais, KEMPTON PARK
Gauteng

DEKRA MFC
M57 Pretoria Rd - 1619
KEMPTON PARK - GT
08610 33572

Vehicle Type	PASSENGER VEHICLE	Registered Owner	
Manufacturer	VOLKSWAGEN	Registration Number	JR20CZGP
Model	GOLF 7 2.0 TSI GTI PERFORMANCE PACK 5-DR DSG [2015-2017]	Register Number	
VIN	WVWZZZAUZGW054867	Date Of First Licensing	
Engine Number		Last COR	
Doors	5	License Expiry Date	30/11/2022
Color	WHITE	Power / Displacement	
Year Model	2016	Paint Finish	C - COMMON
Km Reading	299,129 KM	Fuel	PETROL
Cab / Body Type	HATCHBACK	Transmission	AUTOMATIC

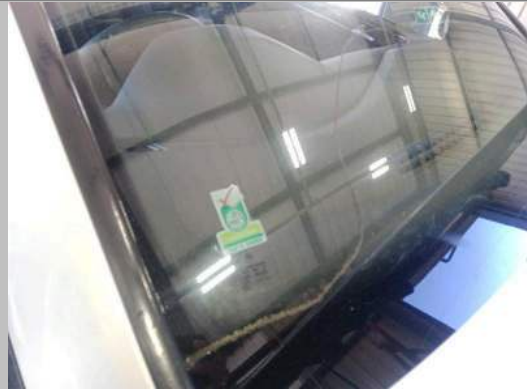
Damage	Repair Way
Engine Oil Leak	Repair
Hoses Oil Leak	Repair
Water level Insufficient	Repair
Air conditioner pump Damaged	Replace
Bonnet stay and shocks Insufficient	Replace
Switch Electrical Window Winder rear left Defective	Repair
Seat Front Left Torn / Cut	Repair
Seat Front Right Torn / Cut	Repair
Door Sealing Rubber Front Right Torn / Cut	Replace
Carpet Front Torn / Cut	Repair
Side Mirror Left Damaged	Repair
Side Mirror Right Paintwork • Scratched	Repair
Front Bumper Paintwork • Scratched	Repair
Bonnet Paintwork • Chipmarks	Repair
Rear Fender Left Damaged	Repair
Door Front Left Paintwork • Scratched	Repair
Door Rear Left Damaged	Repair
Fuel Flap Damaged	Repair
Windscreen Cracked	Replace

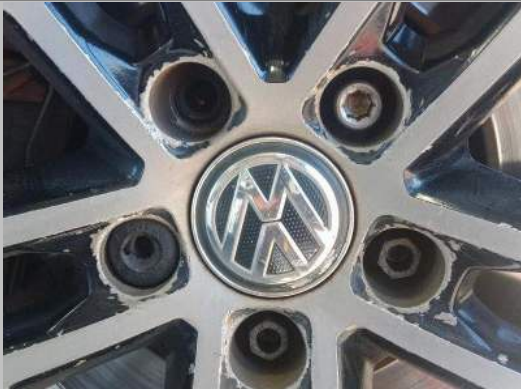
Damage	Repair Way
Stabilizer Mounting Rear Right Damaged	Replace
Tyre Front Right Damaged	Replace
Tyre Rear Right Smooth	Replace
Rim Rear Left Damaged	Repair
Rim Rear Right Welded	Replace
Bolt(s) / Nut(s) Rear Wheel Left Missing	Replace
Bolt(s) / Nut(s) Rear Wheel Right Missing	Replace
Belly plates Damaged	Replace
Gearbox Oil Leak	Repair
Alternator belt missing	Replace
Vehicle electronics malfunction	Repair
Boot does not open, electric malfunction	Repair
Vehicle push into Dekra parking	Repair
