DEKRA MFC  
M57 Pretoria Rd - 1619  
KEMPTON PARK - GT  
08610 33572

| Model | GOLF 7 2.0 TSI GTI 5-DR DSG [2016-2017] | Register Number | |

## CONDITION REPORT

Report No: 2016800274

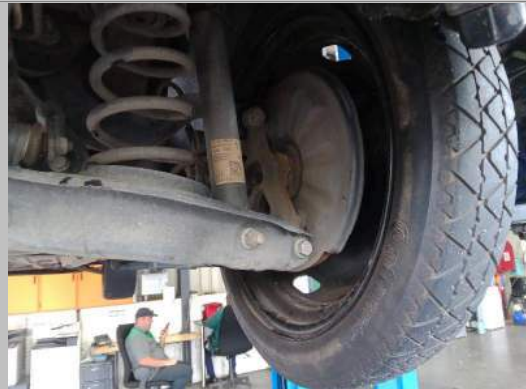
| Damage | Repair Way |
|---|---|
| Rear tyre size differs | Replace |

| | Size | Load/Speed Index | Manufacture | Model | Type* | Production Date | Tread Depth (mm) |
|---|---|---|---|---|---|---|---|
| Rear Right | T125/70R18 | 99M | Continental | Contact | V | 3522 | 5 mm |

RR TYRE TREAD

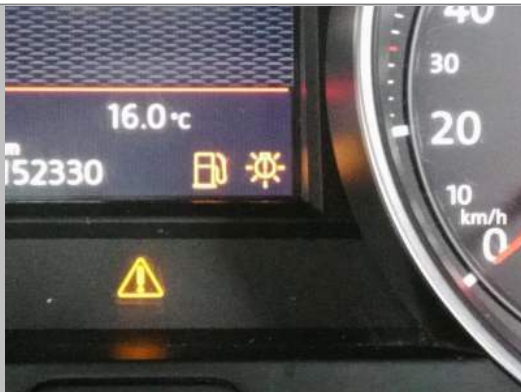
| No | System | Code | Description | Status |
|---|---|---|---|---|
| 1 | ENGINE CONTROL MODULE | P164E00 | OIL PRESSURE REGULATION VALVE ELECTRICAL ERROR | |

Warning lights illuminated

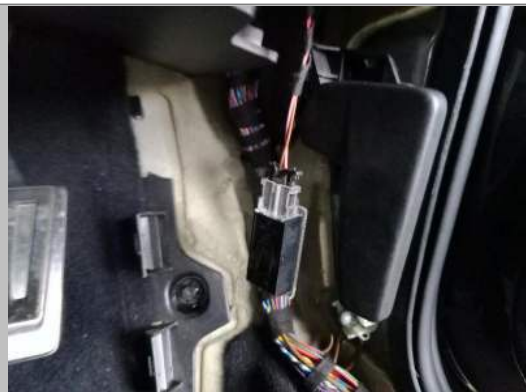
| Damage | Repair Way |
|---|---|
| Bonnet cable Damaged | Repair |

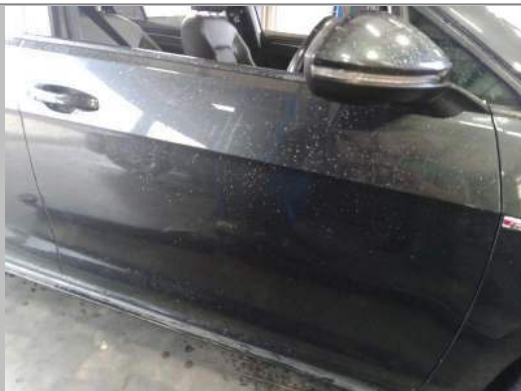
| Damage | Repair Way |
|---|---|
| Door Front Right Dented | Repair |

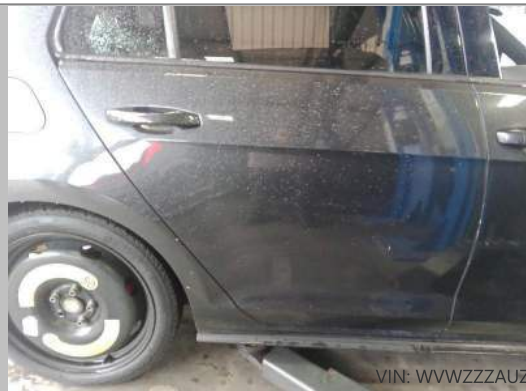
| Damage | Repair Way |
|---|---|
| Door Rear Right Residual Traces of Repair | Repair |

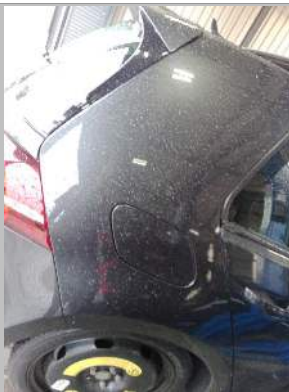
| Damage | Repair Way |
|---|---|
| Rear Fender Right Residual Traces of Repair | Repair |

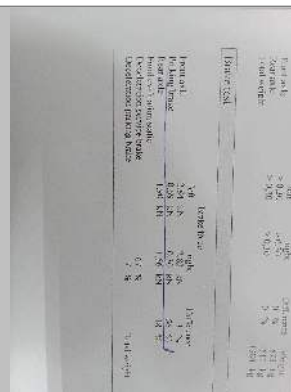
### Parking Brake Performance

| Damage | Repair Way |
|---|---|
| Parking Brake Performance Left / Right Difference out of legal range | Repair |

| | Left | Right | | |
|---|---|---|---|---|
| Emergency / Parking | 0.6 | 0.3 | - | |

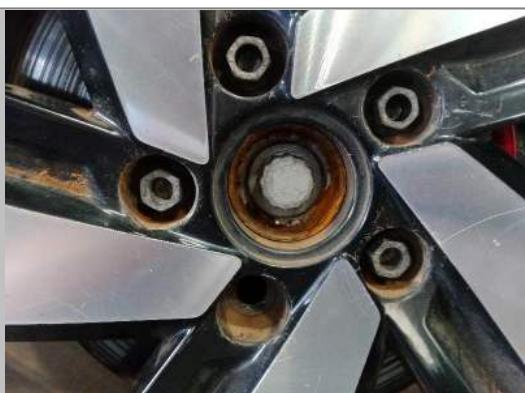
| Damage | Repair Way |
|---|---|
| Bolt(s) / Nut(s) Front Wheel Right Missing | Replace |

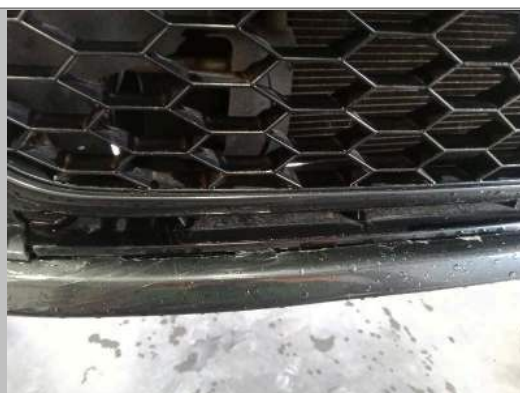
### Front Bumper

| Damage | Repair Way |
|---|---|
| Front Bumper Damaged | Repair |

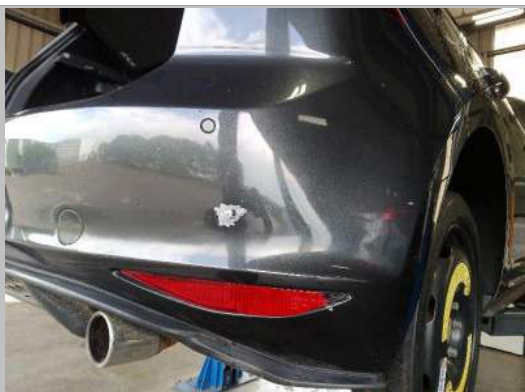
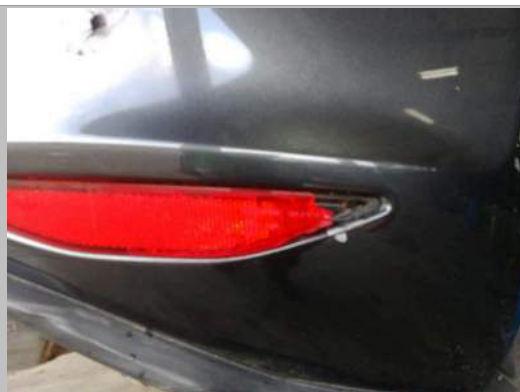
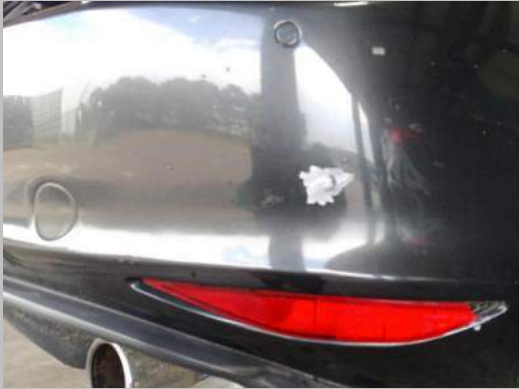
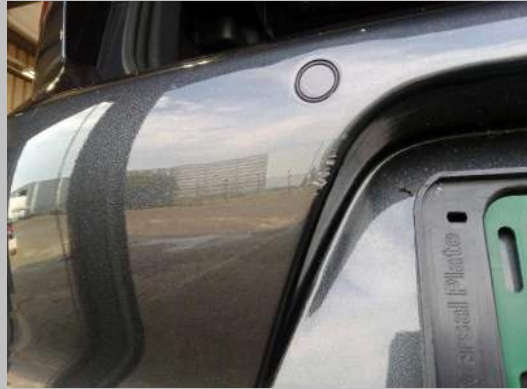
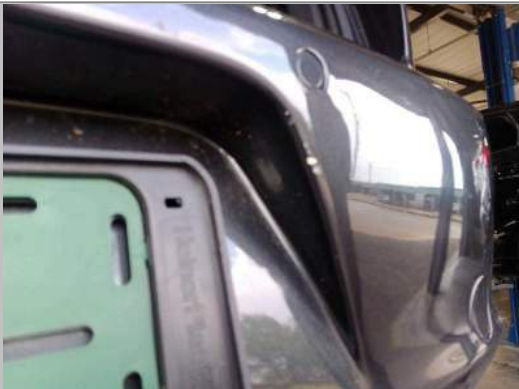
| Damage | Repair Way |
|---|---|
| Rear bumper Damaged | Repair |

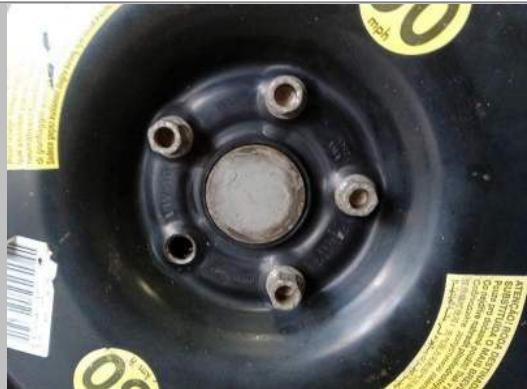
| Damage | Repair Way |
|---|---|
| Bolt(s) / Nut(s) Rear Wheel Right Missing | Replace |

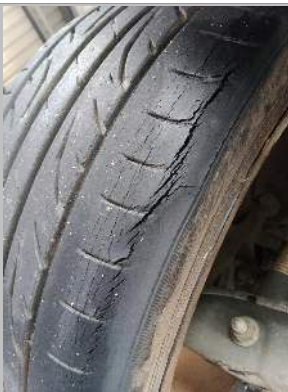
| Damage | Repair Way |
|---|---|
| Tyre Rear Left Excessive Wear & Tear | Replace |

| | Size | Load/Speed Index | Manufacture | Model | Type* | Production Date | Tread Depth (mm) |
|---|---|---|---|---|---|---|---|
| Rear Left | 225/40R18 | 92W | Dunlop | Sport | V | 2617 | 1 mm |

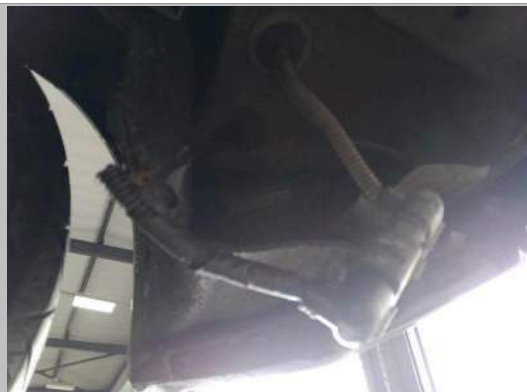
| Damage | Repair Way |
|---|---|
| Wiring connections Defective | Replace |

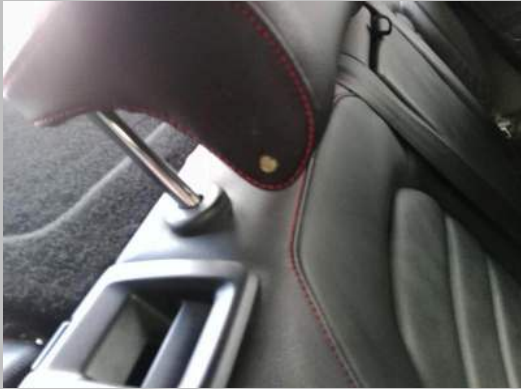
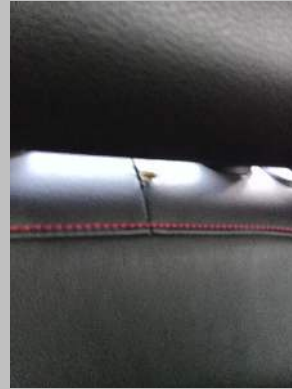
| Damage | Repair Way |
|---|---|
| Seat Rear Torn / Cut | Repair |

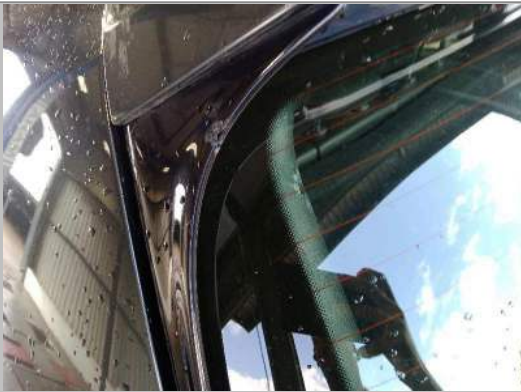
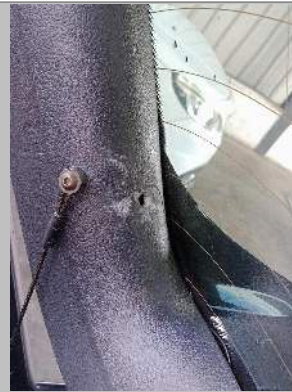
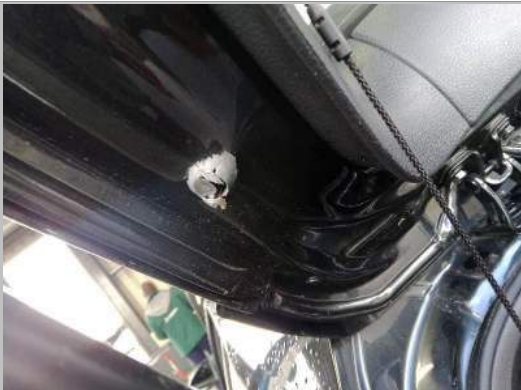
| Damage | Repair Way |
|---|---|
| Boot Lid / Hatch door Damaged | Repair |

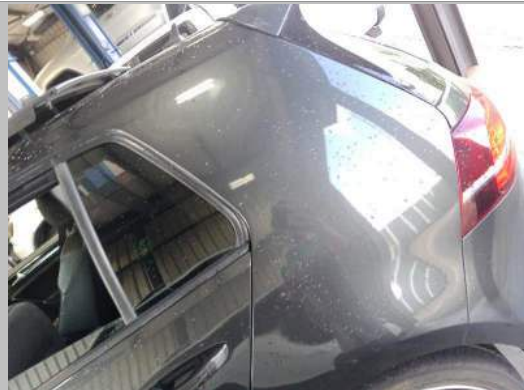
| Damage | Repair Way |
|---|---|
| Rear Fender Left Residual Traces of Repair | Repair |
